Columbia Crew Survival Investigation Report

NASA/SP-2008-565

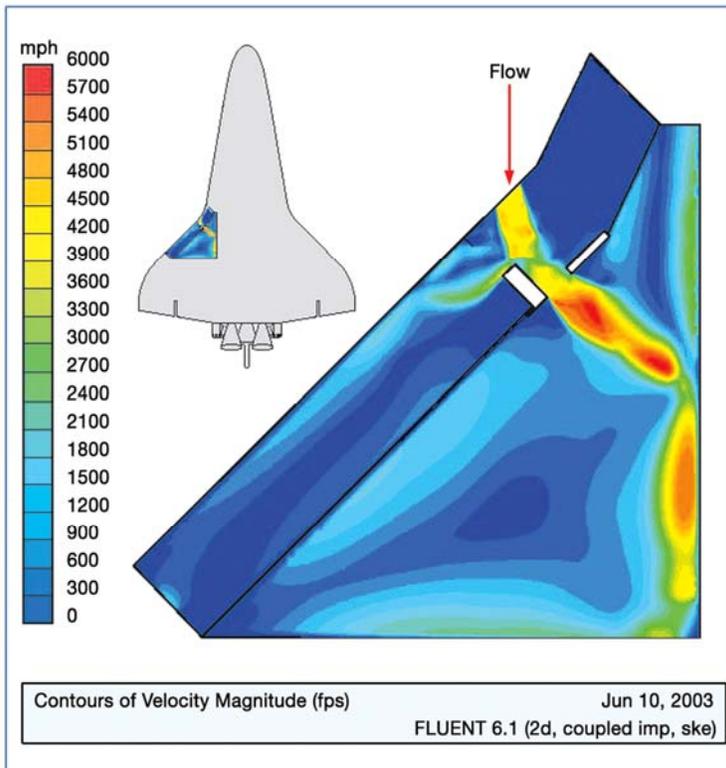
The CAIB concluded that the breach in the TPS on the leading edge of the left wing allowed hot gas to penetrate the wing and to work its way aft and inboard, toward the midbody fuselage and left main landing gear wheel well (figure 1.1-9). CAIB analysis showed that this eventually caused significant internal damage to *Columbia*'s left wing, changing the wing's aerodynamic properties. There were no indications to the crew of this ongoing damage. Throughout phase 2, the orbiter Flight Control System (FCS) corrected for the damage-induced yaw and roll moments, and control of the orbiter was maintained.⁸

Figure 1.1-9. The effects of wing Thermal Protection System damage as reported by the Columbia Accident Investigation Board.

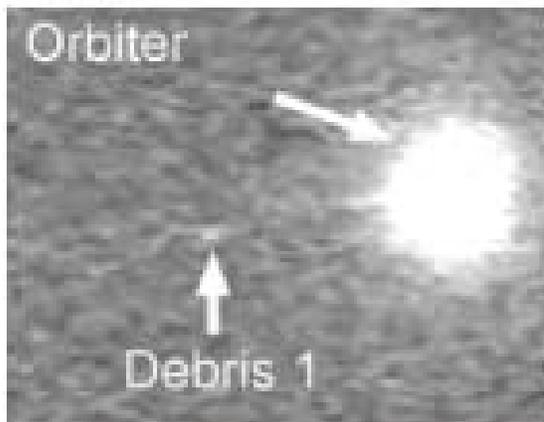
The first known debris shedding event on entry was identified as Debris 1 and most likely originated from the left wing. Debris 1 becomes visible on ground-based video at GMT 13:53:46 (EI+577). Later ballistic analysis estimated a release time of GMT 13:53:44.8 (EI+575).¹⁵ Luminosity measurements and calculated rates of deceleration were used to determine that the mass was < 8 lbs.¹⁶ Figure 1.1-13 shows the orbiter and the debris.

Figure 1.1-13. Video capture of the first observed incident of debris being shed. The orbiter is traveling from left to right in this image.

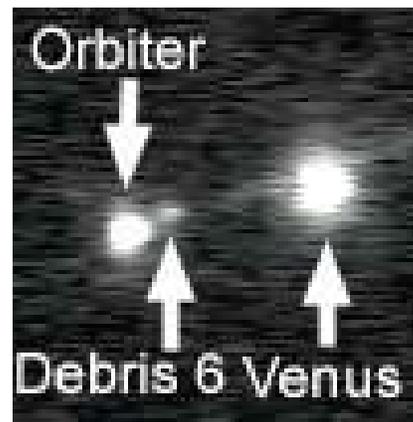
The brightest debris shedding event that occurred in this phase, Debris 6, is first visible on video at GMT 13:54:36 (EI+627) (figure 1.1-14). Ballistic estimates determined that the actual release time was 4 seconds earlier. Luminosity measurements and calculated rates of deceleration were used to determine that the mass was probably a few hundred pounds.¹⁷ There were no data from sensors, instrumental indications, or apparent crew recognition of this debris loss.

Figure 1.1-14. The brightest debris event known to have occurred prior to loss of signal. The orbiter is traveling from right to left.

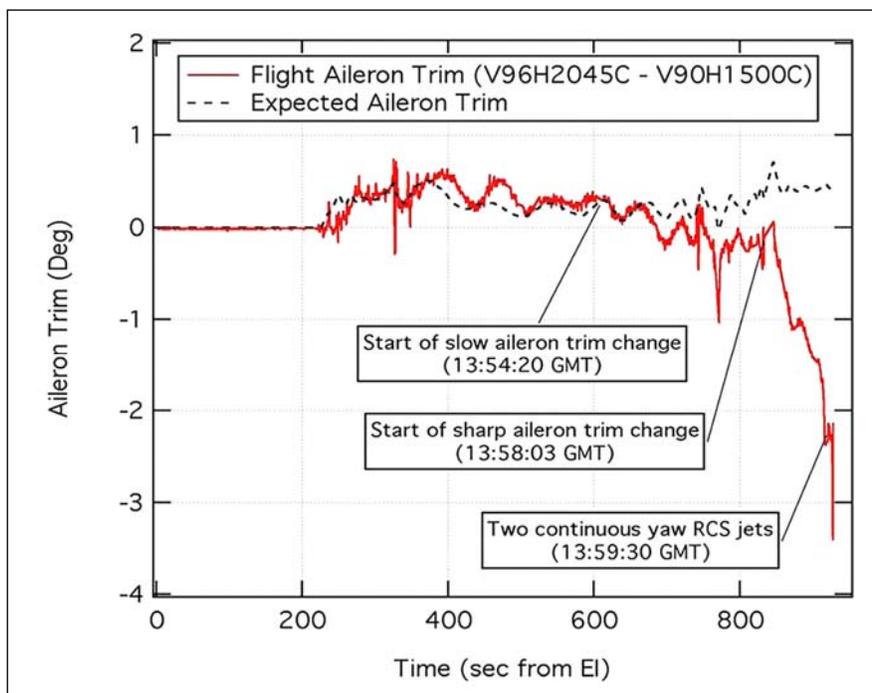
At approximately GMT 13:58:03 (EI+834), the aileron trim begins to diverge sharply from the expected values to counteract the increasing adverse moments due to the left wing damage (figure 1.1-15).

Figure 1.1-15. *Aileron trim discrepancy.*¹⁸

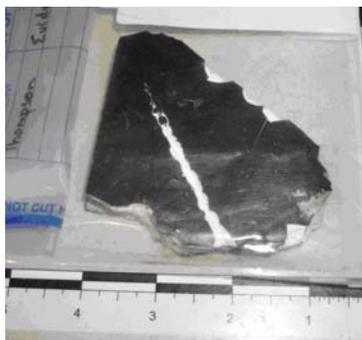
Ballistic analysis indicates that the westernmost piece of recovered *Columbia* debris was released at GMT 13:58:21 (EI+852). This debris, a tile from the left wing upper surface located just inboard of RCC panels 8 and 9, was found in Littlefield, Texas¹⁹ (figure 1.1-16).

Figure 1.1-16. *The Littlefield tile.* [Picture from the *Columbia* Reconstruction Database, debris item no. 14768]

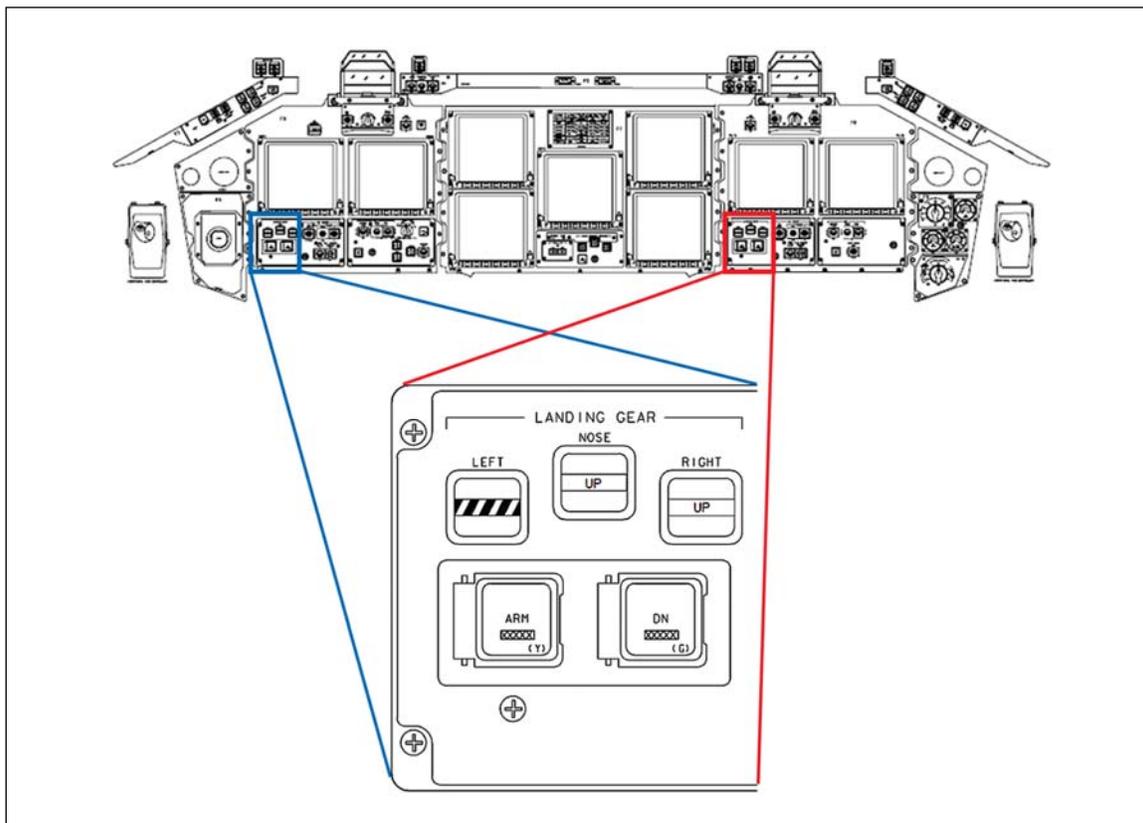
At GMT 13:59:06 (EI+897), 10 seconds after the fourth of four tire pressure fault messages, telemetry indicated the "LEFT MAIN GEAR DOWN" lock sensor transferred to "ON." Other sensors indicated that the landing gear door was still closed and the landing gear was locked in the up (stowed) position. These mixed signals caused the left landing gear position indicator to display a "barber pole" (figure 1.1-17), which indicates an indeterminate landing gear position. Post-accident analysis of the data and recovered debris indicates that the left landing gear was locked in the "up" position and the landing gear door was closed. The signal indicating that the gear was down was a false signal that was likely triggered by damage to the sensor system (sensor, wiring harness, etc.). Based on training experience, the crew was probably attempting to diagnose the situation given that it involved the same landing gear as the tire pressure messages and indicated a potential landing gear deployment problem.

Figure 1.1-17. Landing gear indicator panel, identical on both sides of the flight deck forward display panels. Left indicator showing "barber pole" (indeterminate position). [Adapted from the Space Shuttle Systems Handbook]

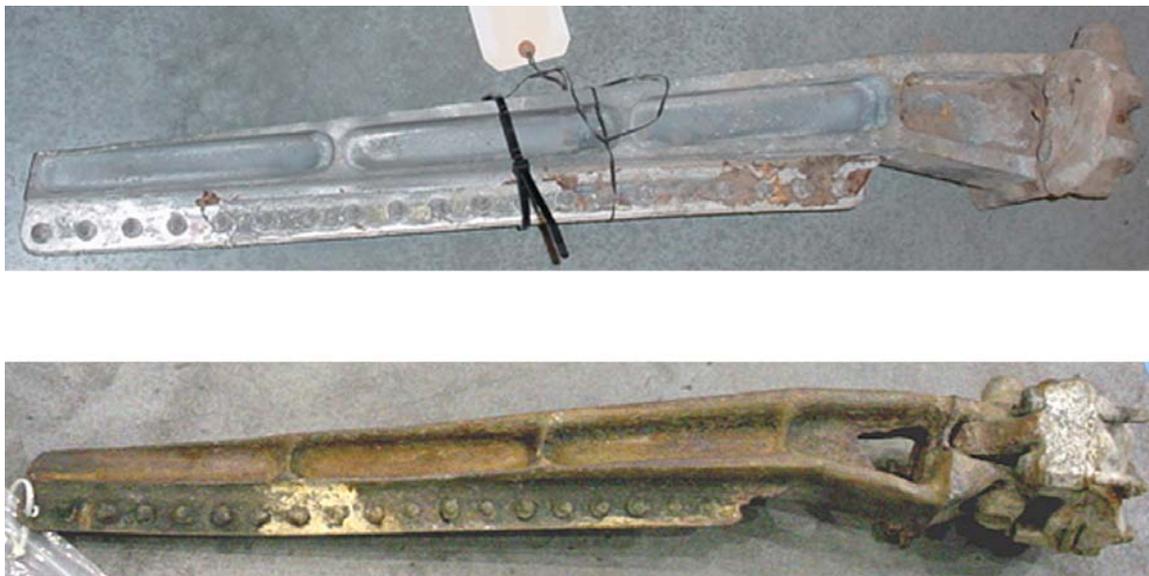
Figure 1.1-25. Port x-link, debris item no. 1678 (top), and starboard x-link, debris item no. 1765 (bottom), from the Columbia Reconstruction Database.

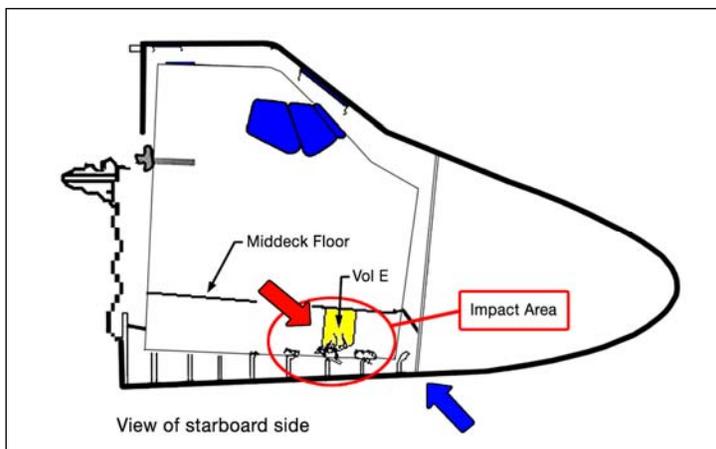
Figure 1.1-26. Scenario showing how the crew module pressure vessel could impact the forward fuselage, and the middeck Volume E could impact the crew module pressure vessel, with resultant damage.

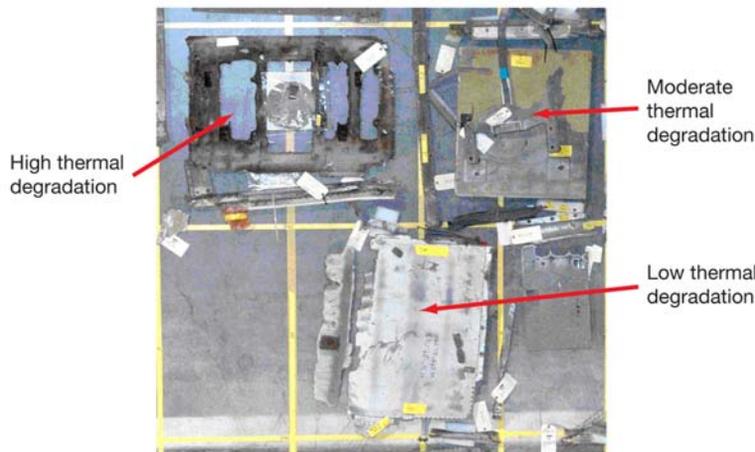
Figure 1.1-31. Middeck floor debris in original relative orientation showing varying thermal exposure.
