**Port x-link assessment**

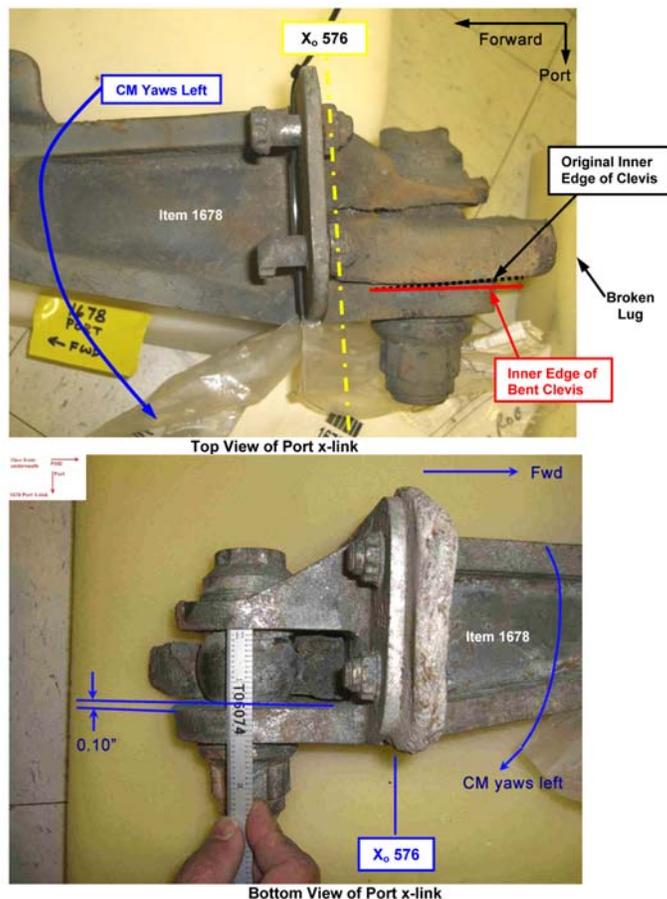
A portion of the X<sub>o</sub> 582 ring frame bulkhead and portside sill fitting, which has a lug that supports the port x-link, was recovered and inspected. The lug broke near its base mainly because of a bending load caused by the x-link and the forebody yawing to the left (figure 2.2-45). This yawing motion was identified by the yielding on the outboard flange of the clevis on the aft end of the port x-link (figure 2.2-46).

Figure 2.2-46. Views of the port x-link with about a 0.10-inch yield on the outboard side of the clevis.

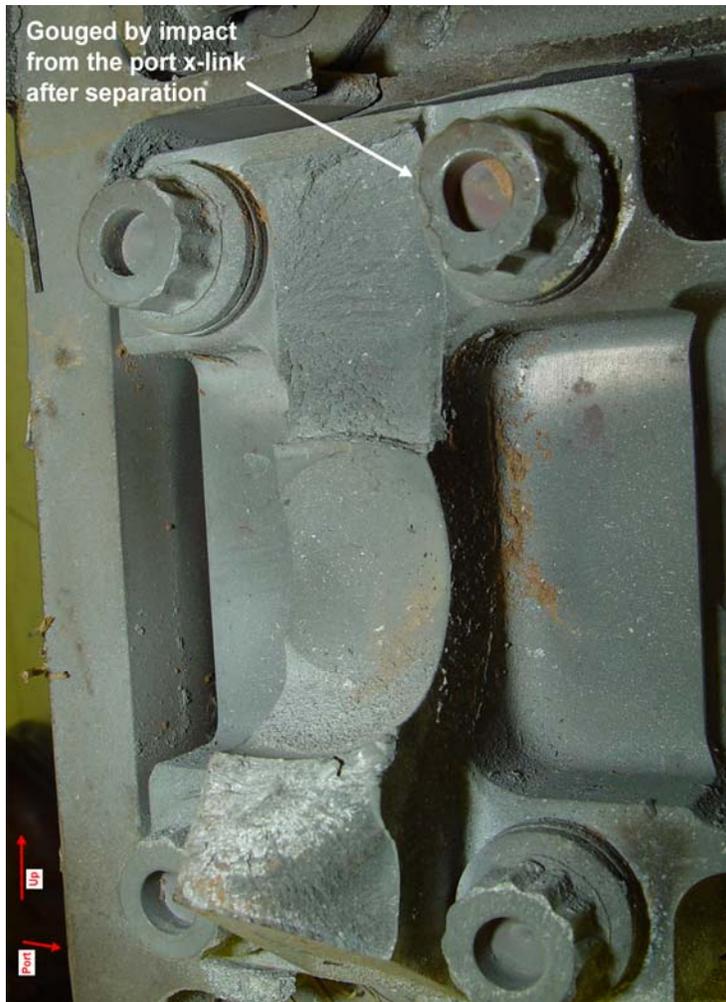
As shown in figure 2.2-47, the outboard upper bolt head was gouged and deformed by an impact from the broken lug, which remained in the port x-link clevis. This indicates that the forebody not only yawed to the left but also shifted to the left when it moved away from the midbody.

**Figure 2.2-47. Columbia Reconstruction Database debris item no. 2207, which includes the remainder of the lug fitting that supports the aft end of the port x-link.**

This implies that when this lug failed, the port x-link was still attached to the CM and the lug still had the structural support of the midbody sill or a large portion of the portside midbody/sill attached. On the portside, the FF and x-link separated from the midbody sill on the *forward* side of the X<sub>o</sub> 582 ring frame bulkhead. The remaining part of the portside X<sub>o</sub> 582 ring frame bulkhead and the sill joint gusset experienced little heat erosion (figures 2.2-48 and 2.2-49). These two items were found at longitude 94.0W and 94.3W, which are in the central portion of the midbody debris field (figure 2.2-16). It is possible that they stayed with the portside midbody sill, which is one of the heaviest parts of the midbody shell. No ballistic assessment was performed to confirm or deny this theory.

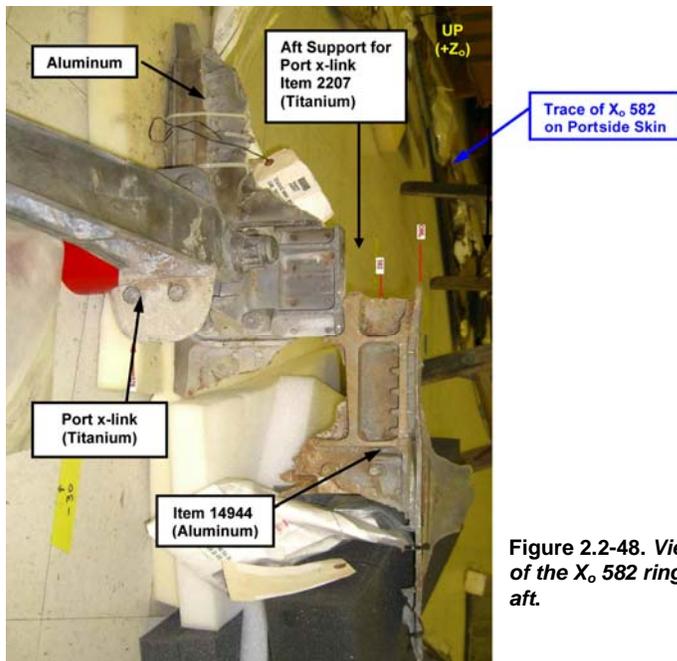
Figure 2.2-48. View of the port x-link and a portion of the X<sub>0</sub> 582 ring frame bulkhead debris items, looking aft.

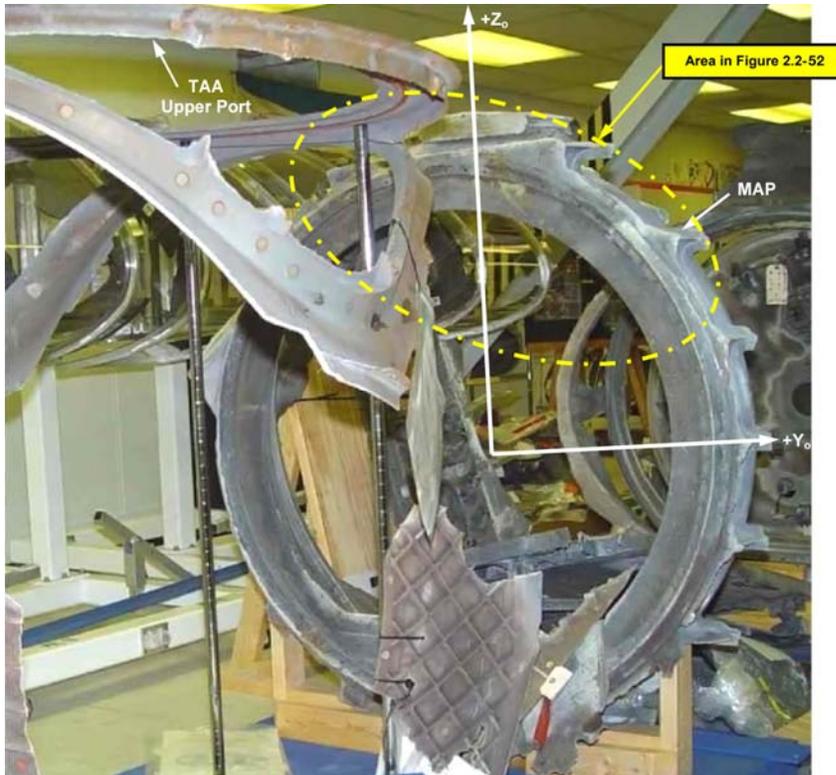
As shown in figures 2.2-51 through 2.2-54, the 12 high-strength bolts (180,000 pounds per square inch (psi)) that attached the forward ring of the TAA to the MAP failed with shanks still remaining in the inserts. This suggests that this area was subjected to high tension and bending while the remaining bolts were not subjected to the same loading. It implies that this TAA joint reacted to a bending moment ( $M_{TAA}$ ) plus aft tension loading (figure 2.2-54). When the aft end of the TAA was restrained by the SPACEHAB tunnel to the midbody, the forebody yawing left and pitching down relative to the midbody could create the same bending effects. This suggests that the TAA broke away from the MAP when the forebody separated from the midbody at the CE or shortly afterwards.

Figure 2.2-51. Tunnel adapter assembly and the manufacturing access panel debris, view looking forward at "B" hatch opening.

Darker shading color on the surface of the MAP, as was noted on figures 2.2-51 and 2.2-52, indicates that this area was shielded by the missing portion of the TAA ring and suggests that the MAP surface outside of the TAA ring was subjected to thermal flow before the TAA departure. If the TAA departed at the CE, the MAP or the aft bulkhead of the CM was exposed to the thermal flow for some period of time prior to the CE (figure 2.2-44). This would agree with the theory that the PLBDs were compromised prior to the CE.

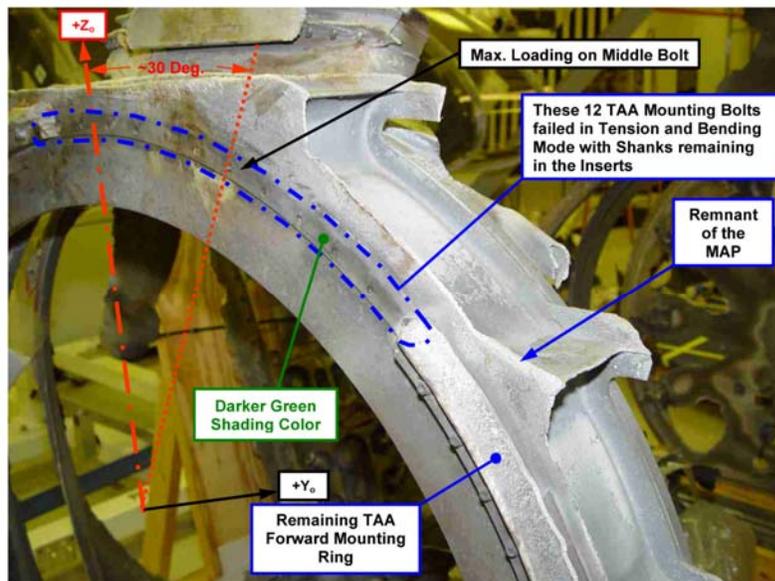
Figure 2.2-52. Tunnel adapter assembly debris showing that the bolt shanks failed mainly by tension and bending.

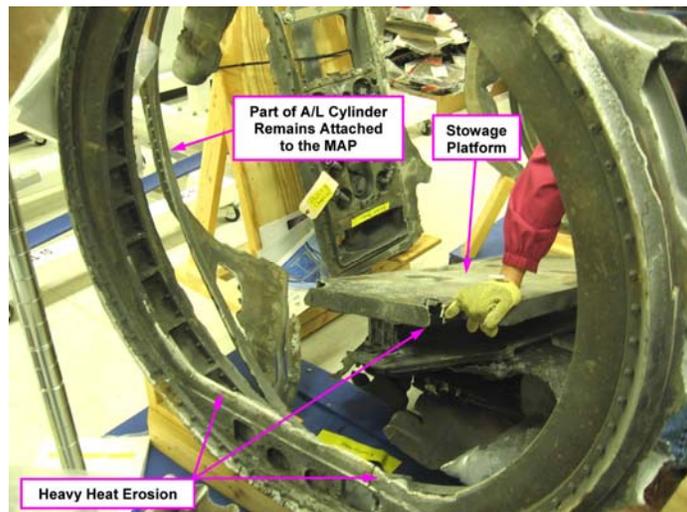
Extreme thermal erosion at the lower edge opening on the MAP where the forward end of the TAA is attached indicates that after the TAA broke away from the MAP, hot gas flowed in over the lower edge of the “B” opening in the MAP. This thermal flow also caused heat erosion to the two aft corners of the stowage platform, which was mounted to the airlock floor (figure 2.2-56). This is consistent with the rotational motion of the forebody post-CE, when such an exposure could have occurred.

Figure 2.2-56. View looking forward at the “B” hatch opening on the X<sub>0</sub> 576 bulkhead.

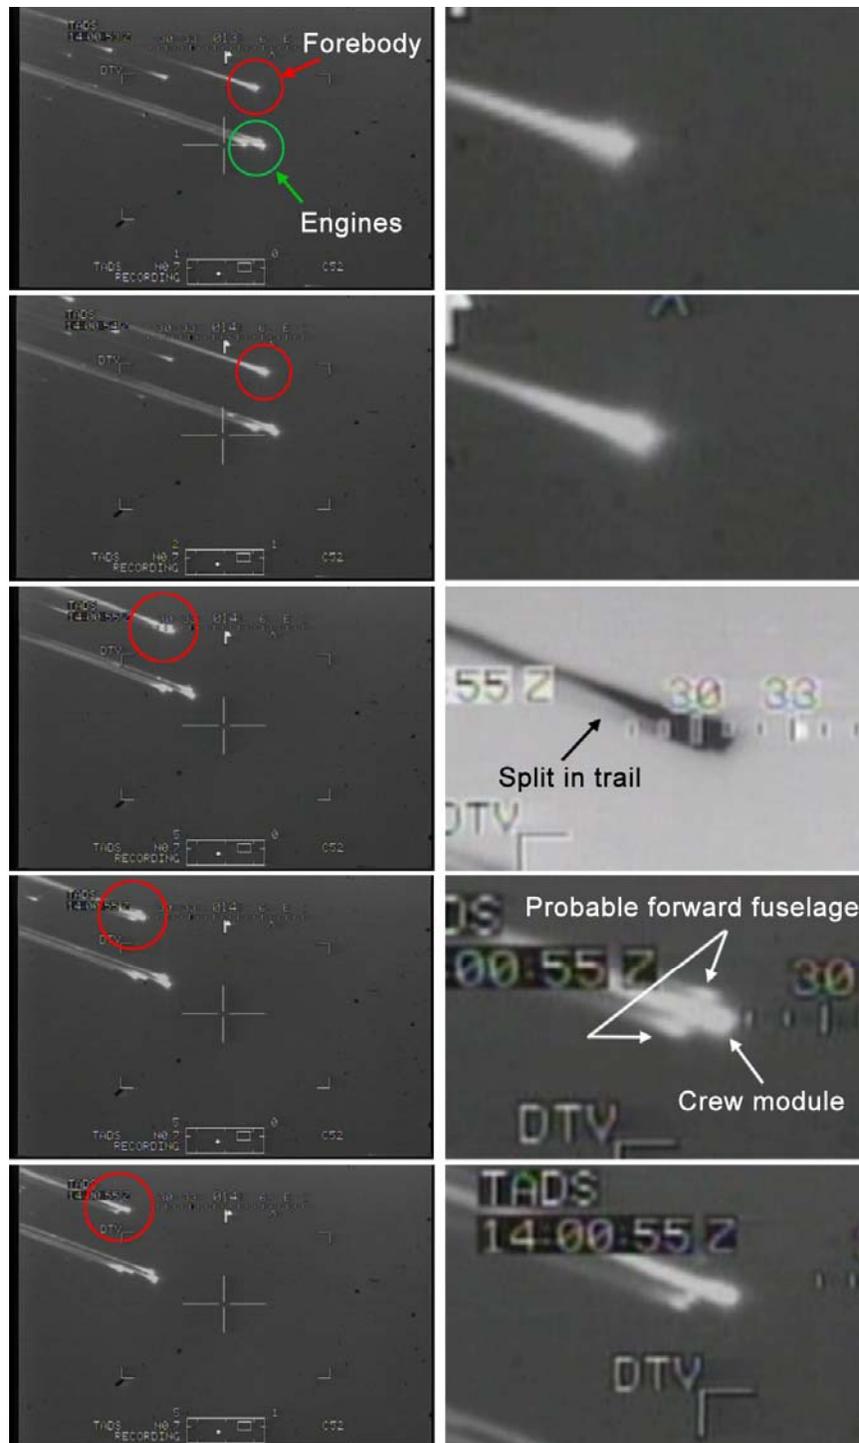
Figure 2.4-1 shows a set of five paired images covering less than 2 seconds of time. On the left is the original image and on the right is a close-up of the forebody and CM. The first frame shows when the forebody begins to brighten. The second frame, which was taken one-third of a second later, shows the slight increase in apparent size of the envelope of gases of the orbiter. The third image, almost 1 second later than the previous image, shows the first definitive indication (although it can be recognized a few frames earlier) that the forebody is beginning to fail. The magnified image has been inverted to emphasize the split in the trail of the forebody. The next frame, which occurs about one-third of a second later, shows what are believed to be two significant portions of the FF separating from the CM. The last image, taken one-fifth of a second later, shows how quickly the FF is breaking into pieces that are too small to be seen by the camera. The CM breaks up over the next 16 seconds.

Figure 2.4-1. Five time-paired images covering under 2 seconds of time showing the Crew Module Catastrophic Event. Image on the left is the full frame, image on the right is an enlarged view.

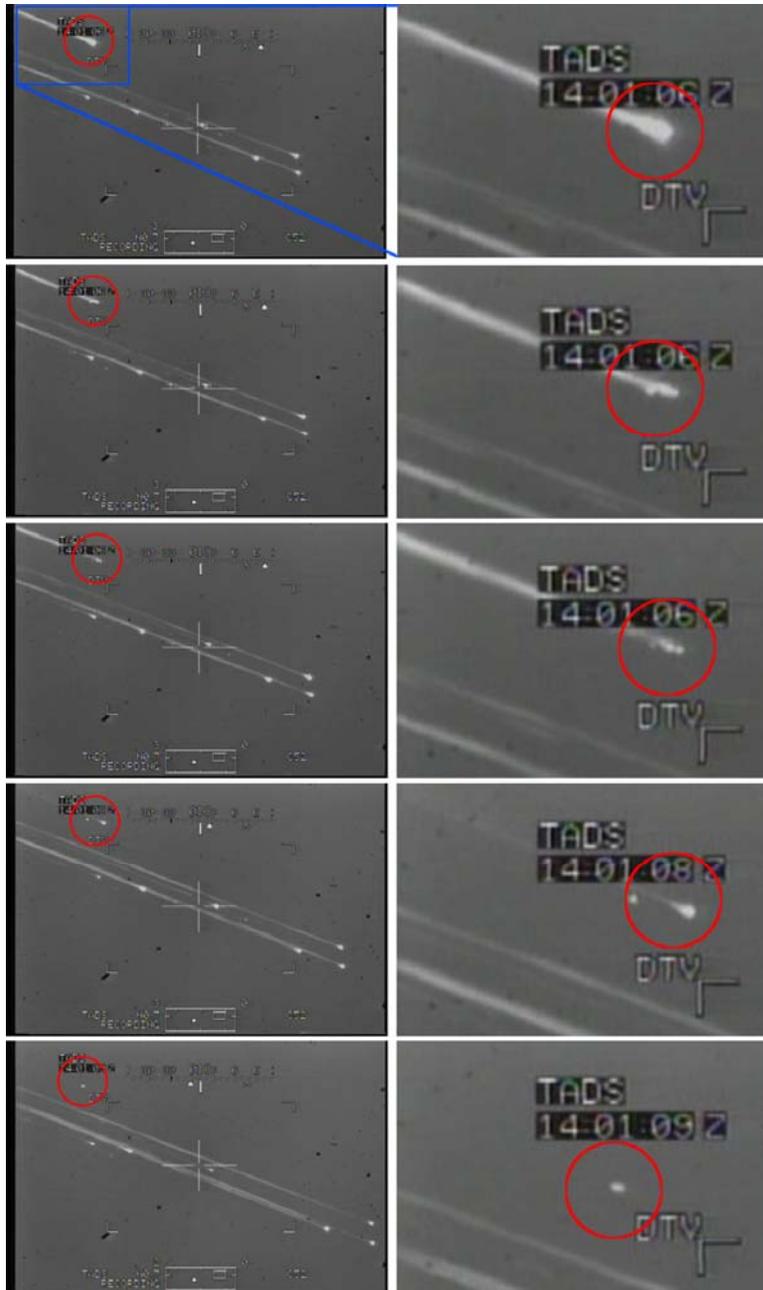
As the images illustrate, when structural integrity of the CM completely failed, it did so in a fraction of a second. The times for the images (figure 2.4-2), from top to bottom, are GMT 14:01:06.73, GMT 14:01:06.87, GMT 14:01:06.97, GMT 14.01.08.3, and GMT 14:01:09.67. In the next frame, the CM is no longer visible.

Figure 2.4-2. Apache video of the Total Dispersal, spanning from GMT 14:01:06.73 to GMT 14:01:09.67. The forebody/crew module is circled in red.

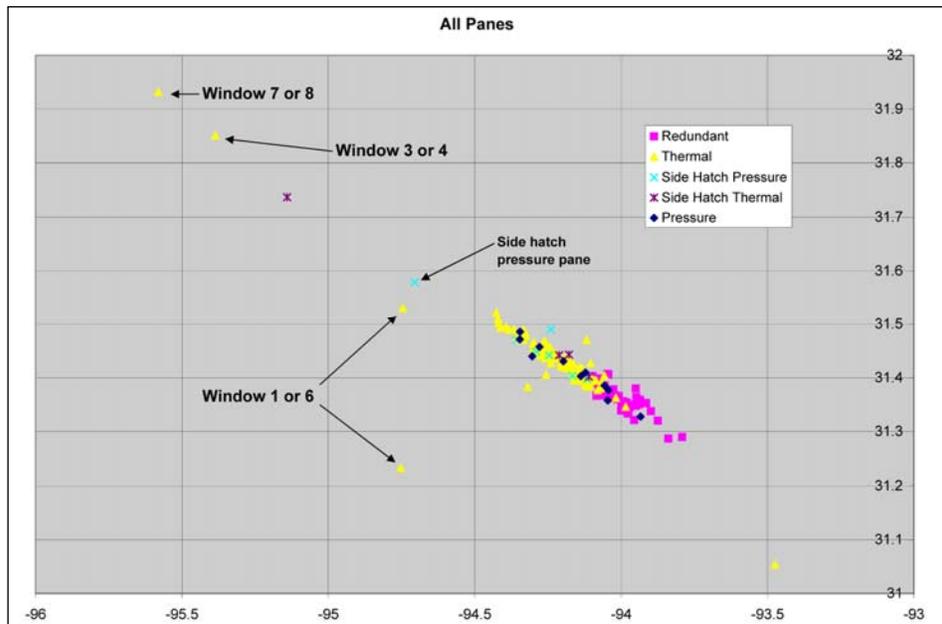
A different concern was whether the flexing of the structure under the varying loads at the LOC and the CE would cause the glass to shatter. The debris field analysis refuted that theory as well. Figure 2.4-8 shows the debris field coordinates for recovered glass.

Figure 2.4-8. Recovered debris field for window glass.

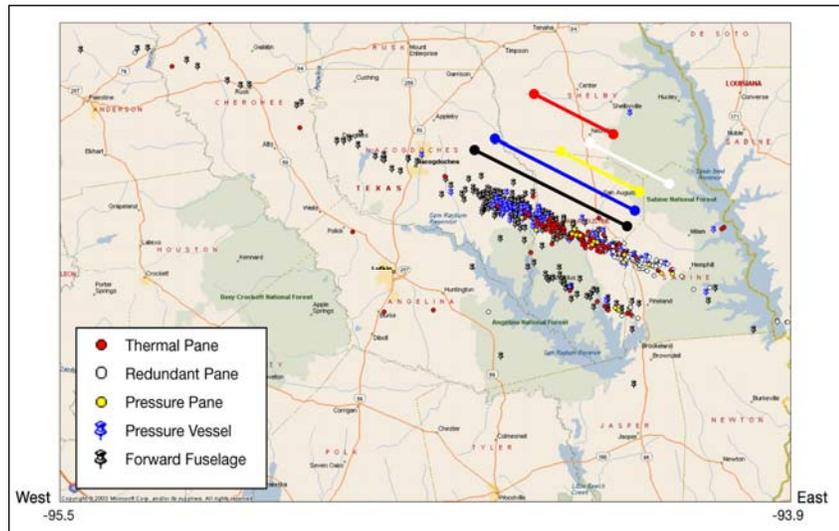
Figure 2.4-9. Debris field of the window panes, forward fuselage, and crew module pressure vessel.

Figure 2.4-9 shows that thermal pane debris was recovered east of the beginning of the main forebody debris, suggesting that the windows broke at or after the CMCE. Pressure panes were recovered west of the bulk of the redundant panes, possibly because the redundant panes were extraordinarily thick and heavy and may have traveled farther east because their ballistic number was higher. Determining the failure sequence of the windows based on ground plots alone was somewhat suspect because some of the window frames remained attached to other window frames as a unit, and the shape of the windows can potentially generate lift. Regardless, because the debris field does not contain significant pane debris west of the main CM debris field, it is concluded that the windows were not the source of a CM breach or a part of the initiating event of the forebody breakup.

**Finding.** The *Columbia* windows remained largely intact up until the CMCE and were not a cause of cabin depressurization.

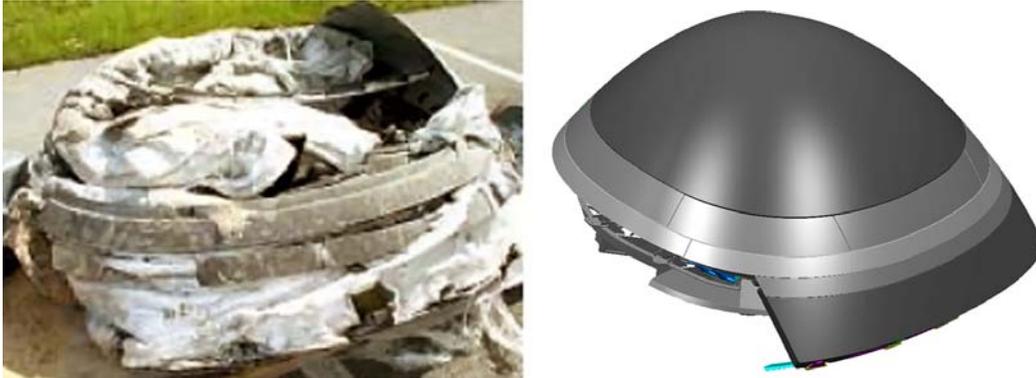
(>900°F) (486°C) will completely ablate it. The presence of Koropon indicates that the breakup of these elements was caused by mechanical overload rather than thermal effects.

**Figure 2.4-23. Nose cap Columbia Reconstruction Database debris item no. 1114 vs. the original nose cap with chin panel.**

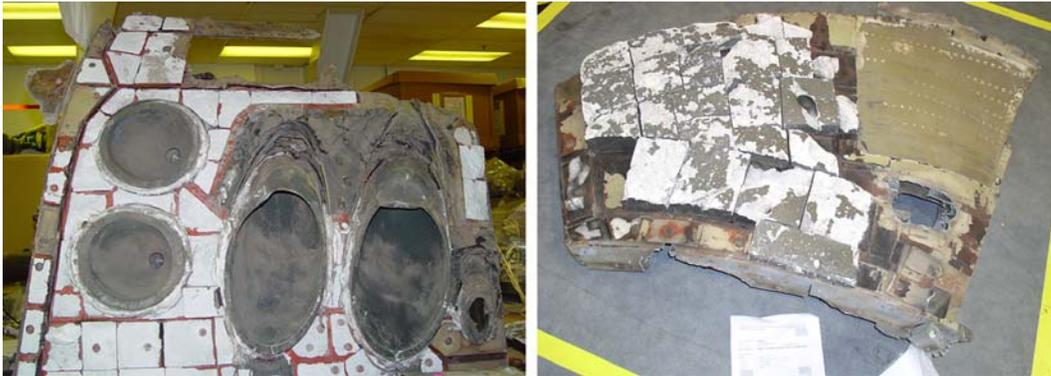
Some large pieces of the forward RCS were recovered (figure 2.4-24). These exhibit evidence of mechanical overload as the primary failure mechanism. Heating did not appear to play a significant role in the component degradation and appears to have occurred during or subsequent to the mechanical breakup.

**Figure 2.4-24. Two large forward Reaction Control System debris pieces, Columbia Reconstruction Database debris item nos. 792 (left) and 82061 (right).**

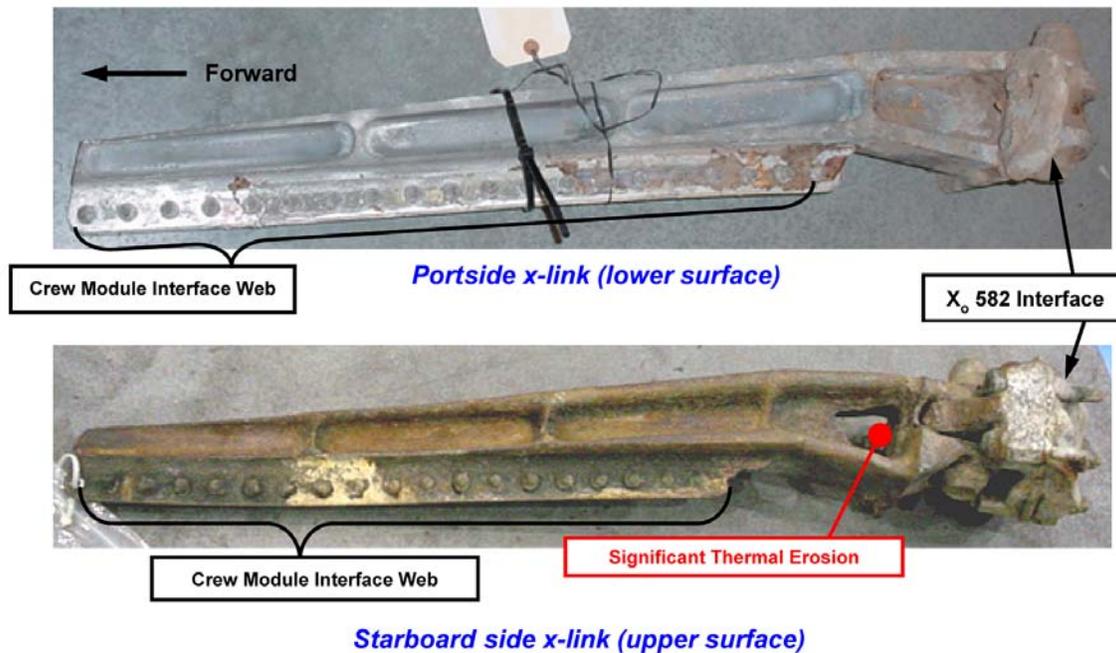
Both the port and the starboard x-links (figure 2.4-25) were recovered nearly intact with evidence of high heating. The titanium fittings on both links experienced significant thermal exposure/melting, predominantly on the upper surfaces. Additionally, the starboard side fitting experienced significantly greater heating and erosion than the portside.

**Figure 2.4-25. Crew module x-links, Columbia Reconstruction Database debris item nos. 1678 (top) and 1765 (bottom).**

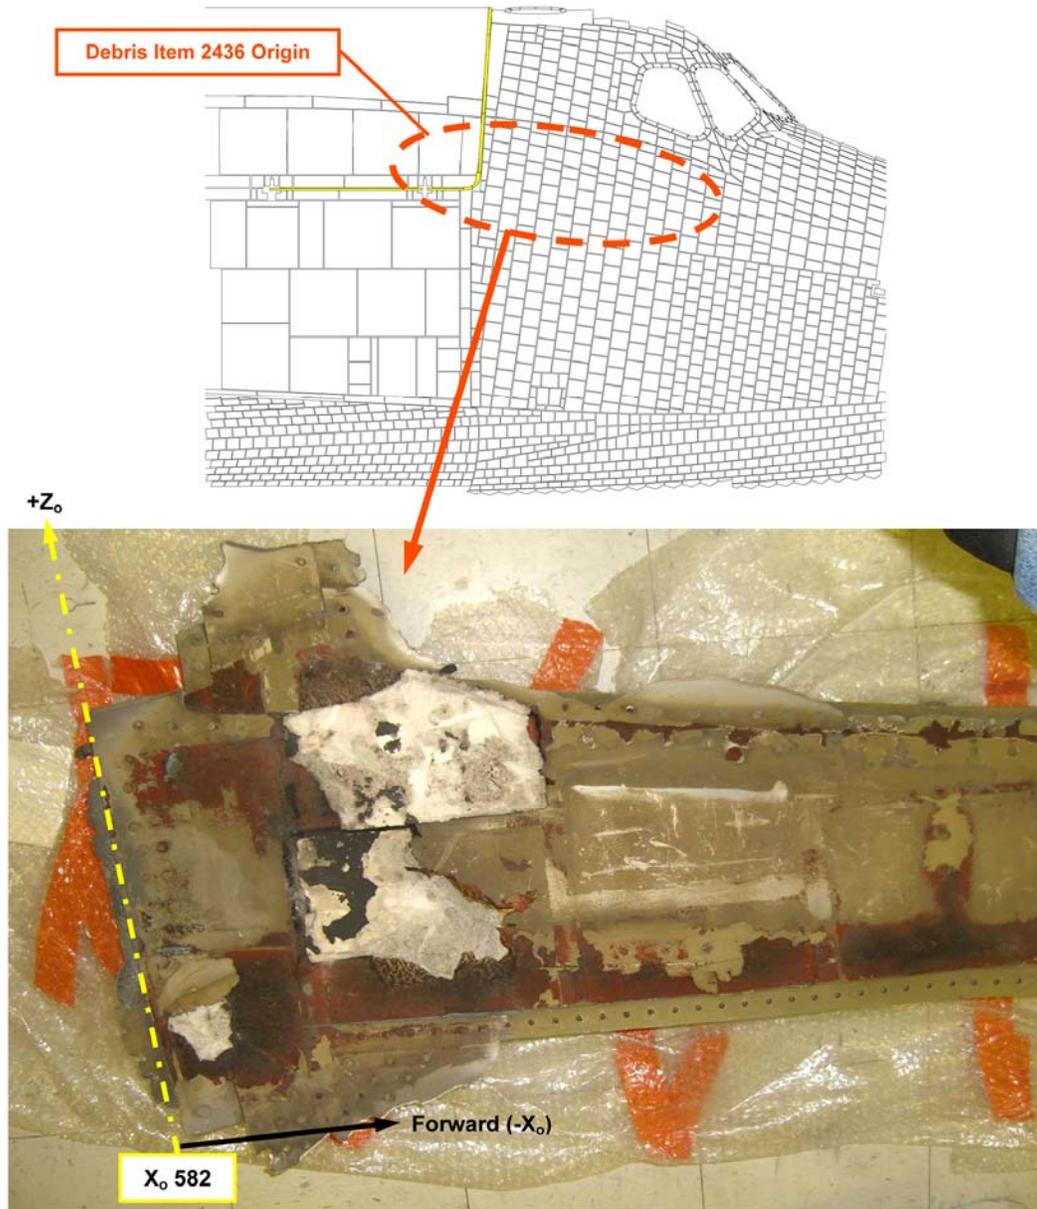
Debris item no. 2436 is a piece of FF skin panel outside of the starboard x-link (figure 2.4-26). It was subjected to heat erosion mainly at the aft edge (along the X<sub>o</sub> 582 ring frame bulkhead) (figure 2.4-27). The pattern of deposited molten aluminum on the inboard side indicates that it was subjected to thermal flow aft to forward over the x-link (see arrows, figure 2.4-27).

Figure 2.4-26. Starboard-side skin, view looking inboard, Columbia Reconstruction Database debris item no. 2436.

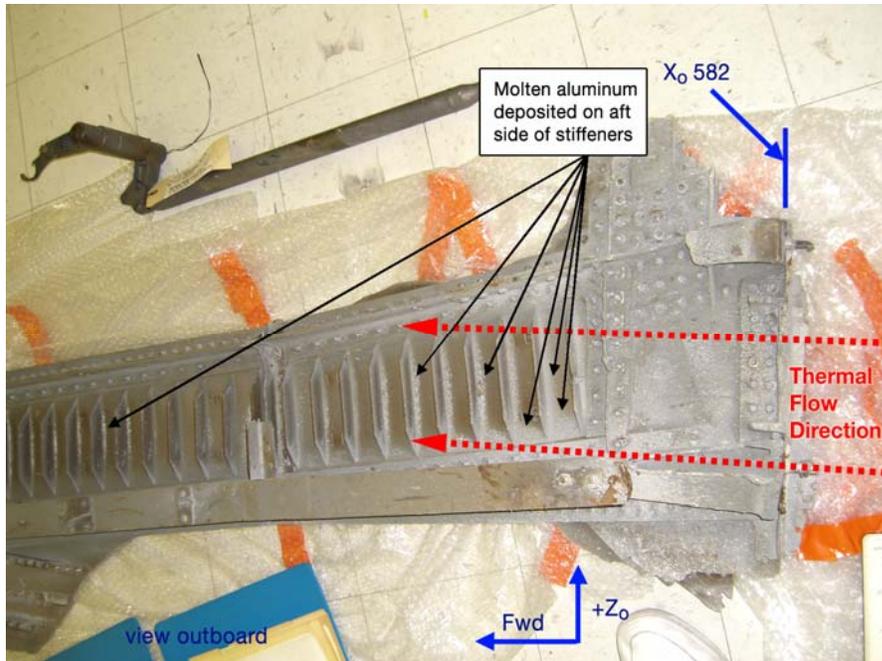
Figure 2.4-27. Inboard side of the starboard-side skin, Columbia Reconstruction Database debris item no. 2436.

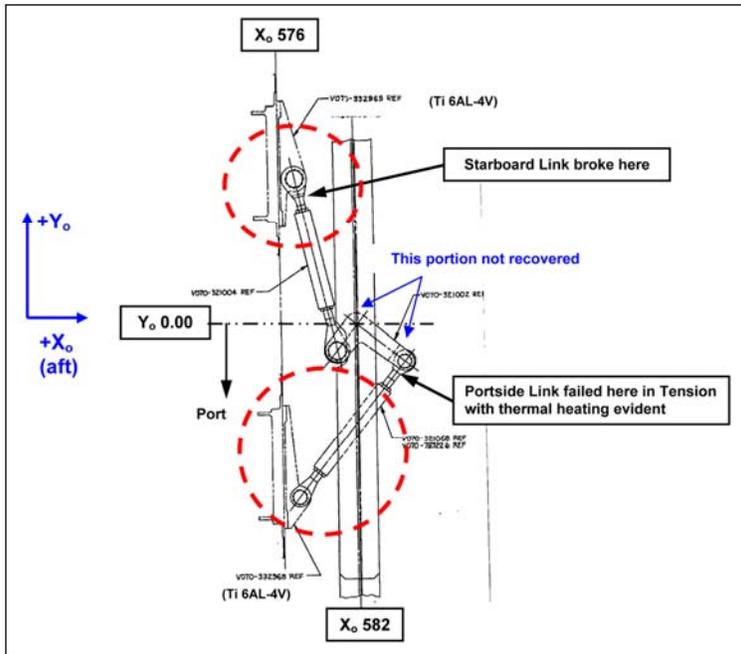
The y-links attach the aft bulkhead of the CM ( $X_o$  576) to the  $X_o$  582 ring frame bulkhead at the lower central portion of the bulkhead. It is possible that the two y-links remained intact at the CE, since most of the  $X_o$  582 ring frame bulkhead is believed to have stayed with the FF. After the CE, any Y-direction movement of the CM relative to the  $X_o$  582 ring frame bulkhead would exert high tension or compression loads on these links. Failure by tension is evident on the recovered debris of these links. The portside y-link shows that it also was softened by thermal exposure along with the tension failure. This portion protrudes beyond the  $X_o$  582 ring frame bulkhead, which would have been exposed periodically to hot gas flow following the CE as the forebody rotated (figures 2.4-28 and 2.4-29).

Figure 2.4-28. View looking from the top at the y-links.

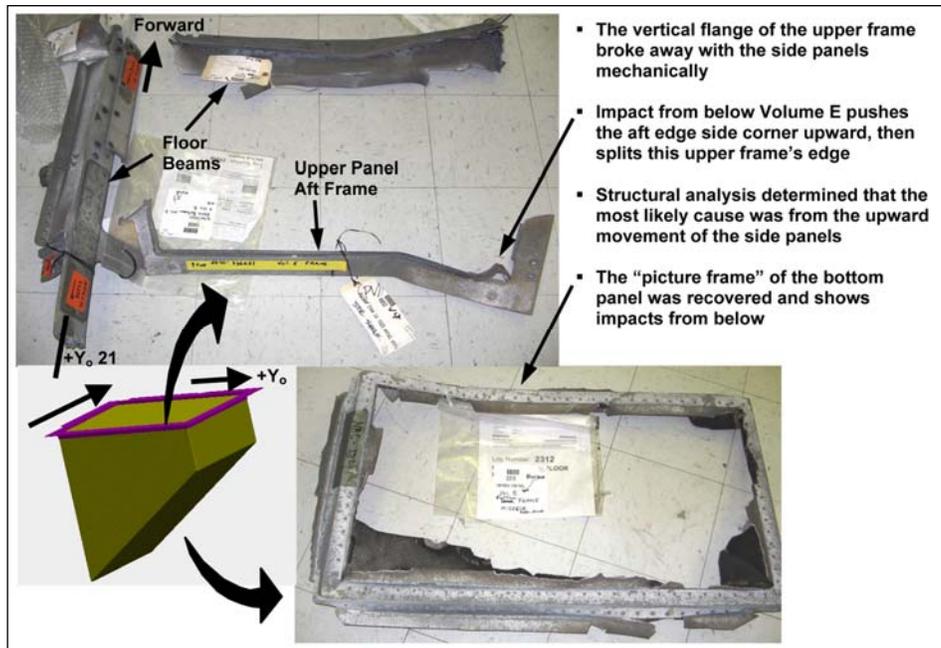
Figure 2.4-32. Volume E debris damage.

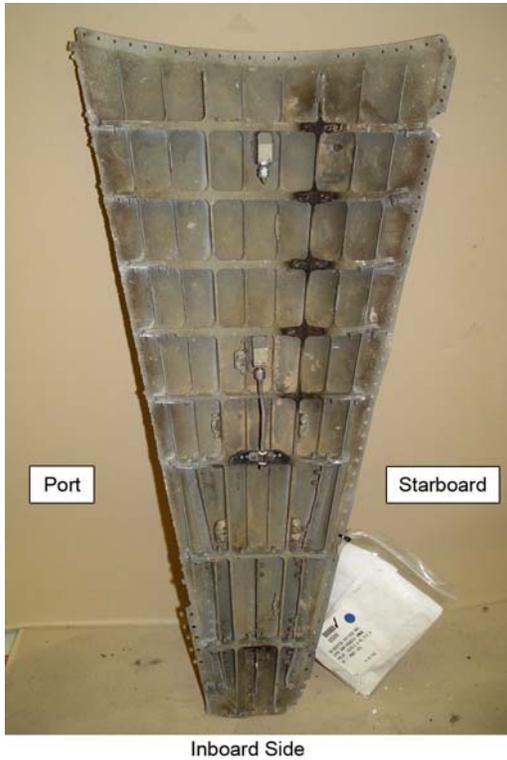
**Figure 2.4-39. Low-heat damage on the forward fuselage arrowhead panel, facing out, Columbia Reconstruction Database debris item no. 65049.**

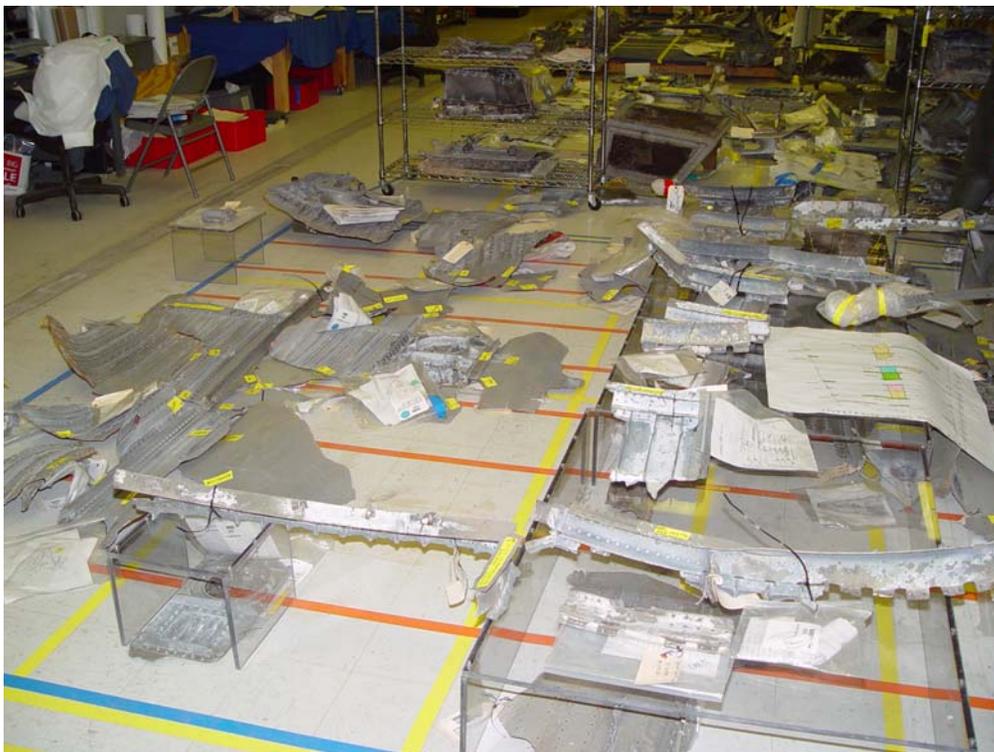
**Figure 2.4-40. Lower forward fuselage skin and frame debris.**

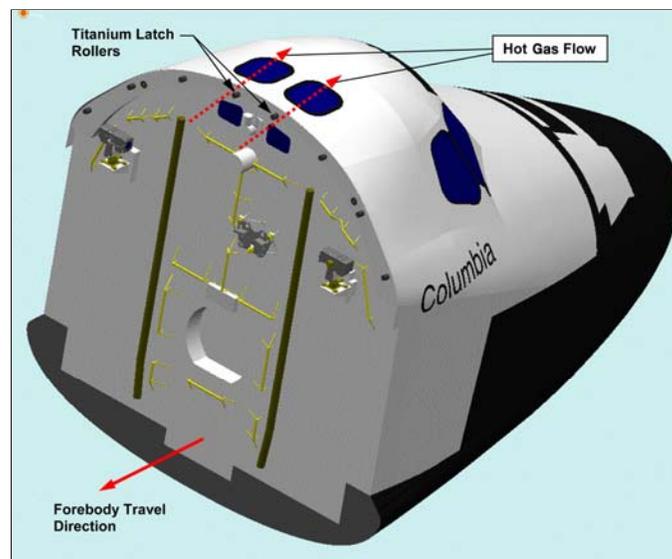
Figure 2.4-64. Titanium deposit on windows indicates forebody traveled backwards.

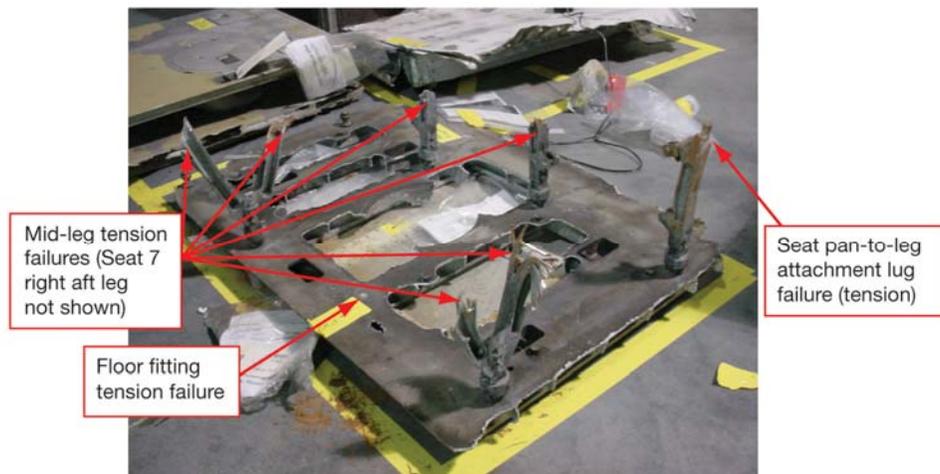
Figure 3.1-14. Recovered lithium hydroxide door with seats 6 and 7 legs attached.

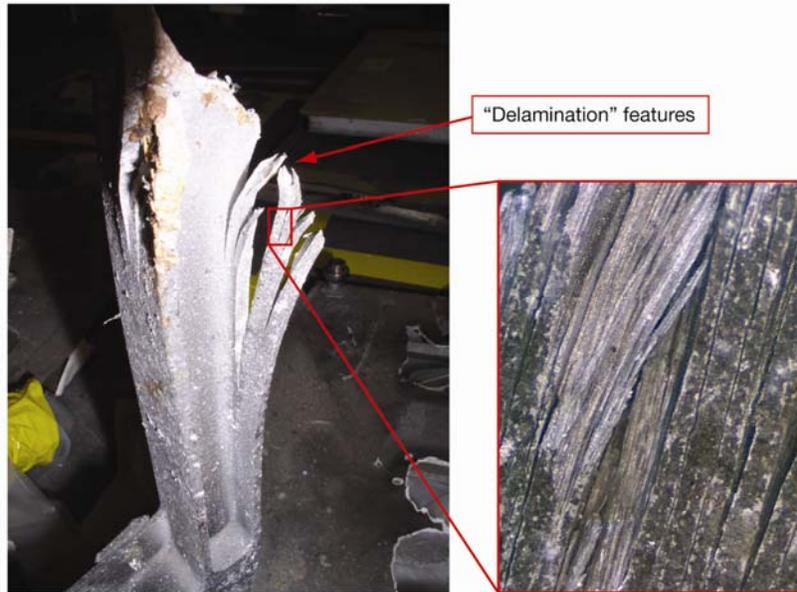
Figure 3.1-16. Example of a “broom-straw” fracture on a Columbia seat leg.

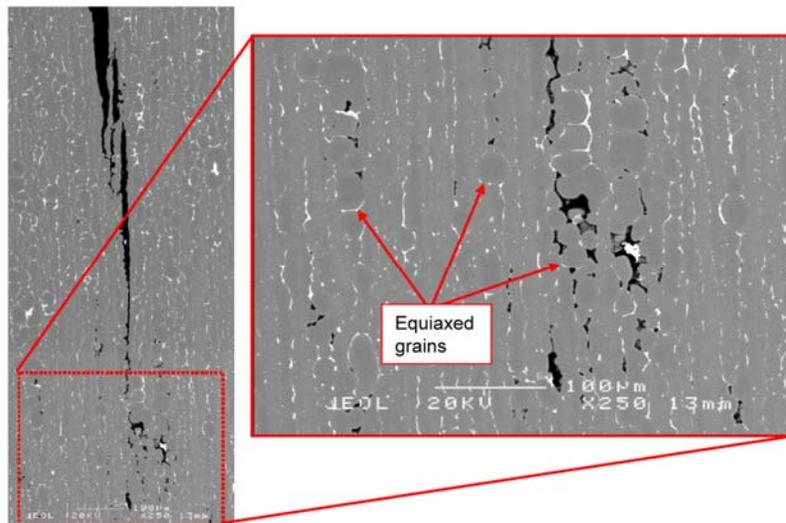
Figure 3.1-17. Scanning electron microscope image of broom-straw fracture surface cross sections.

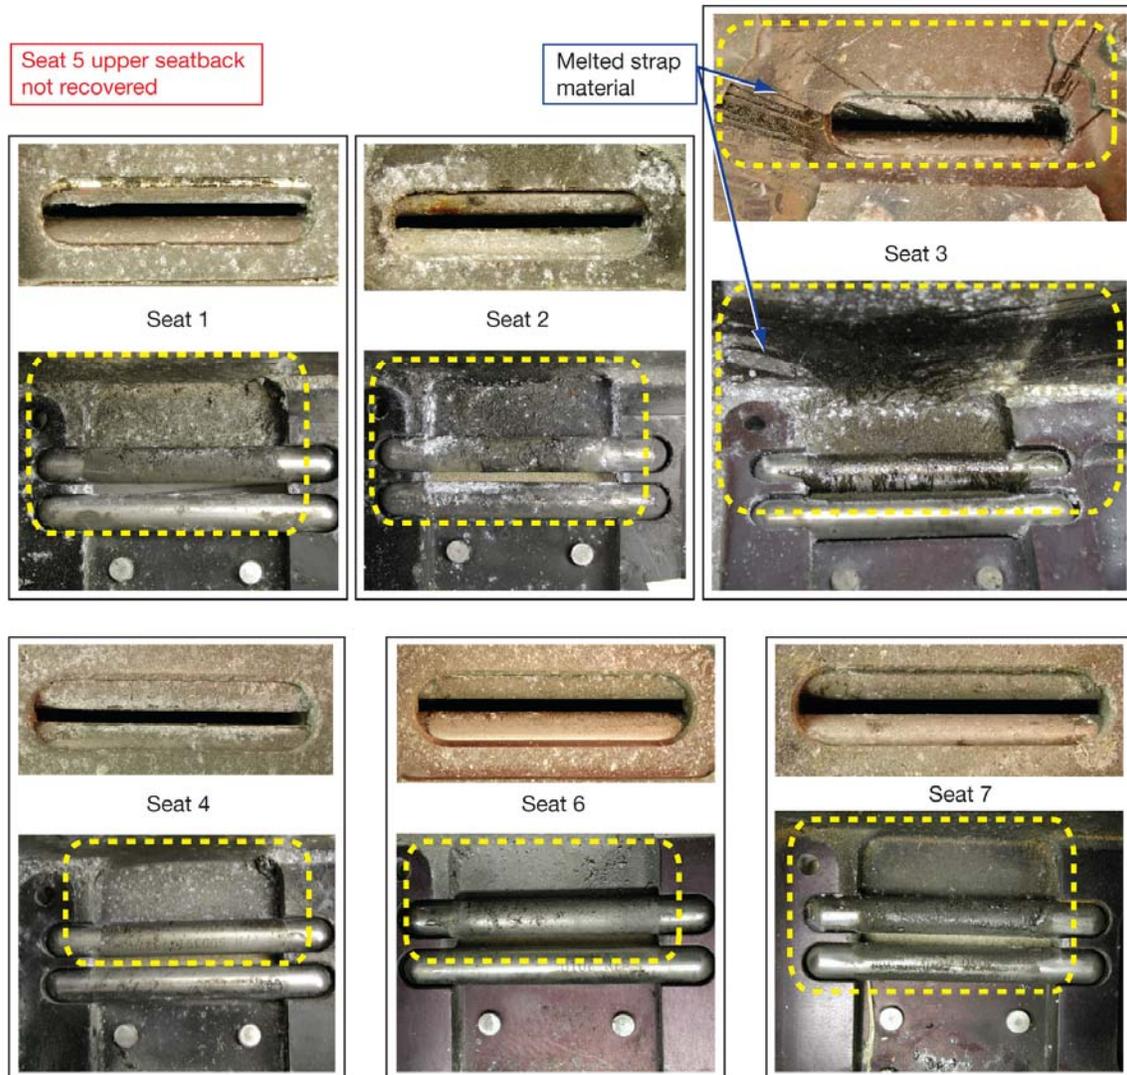
**Figure 3.1-22. Upper seatback inertial reel strap pass-through slots – external (top)/internal (bottom); melted strap material areas outlined in yellow.**

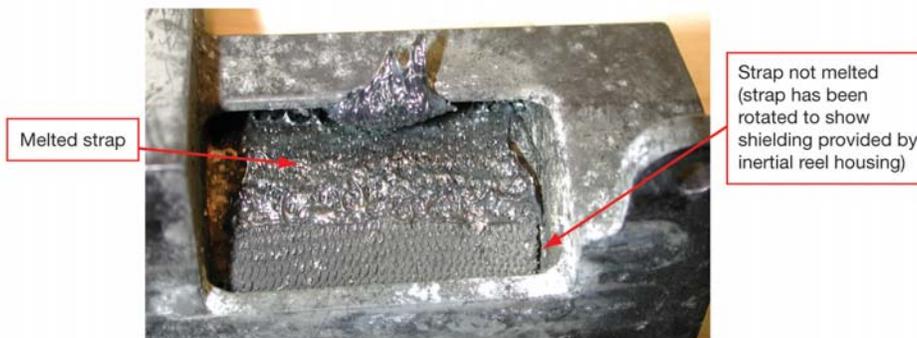
Figure 3.1-24. *Close-up of strap melt pattern.*

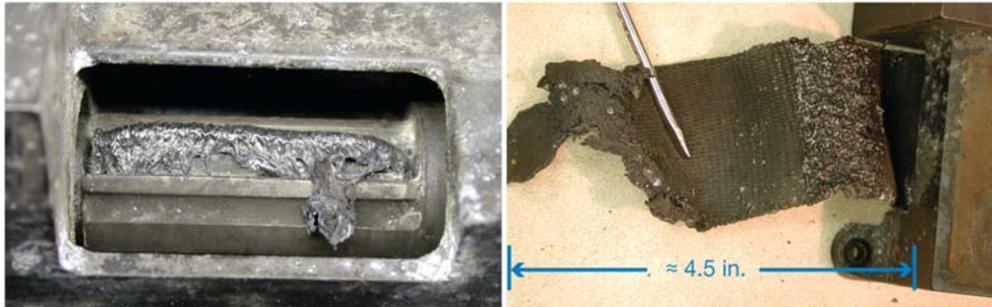
Figure 3.1-26. Seat strap failures: seat 1 (left) and seat 2 (right).

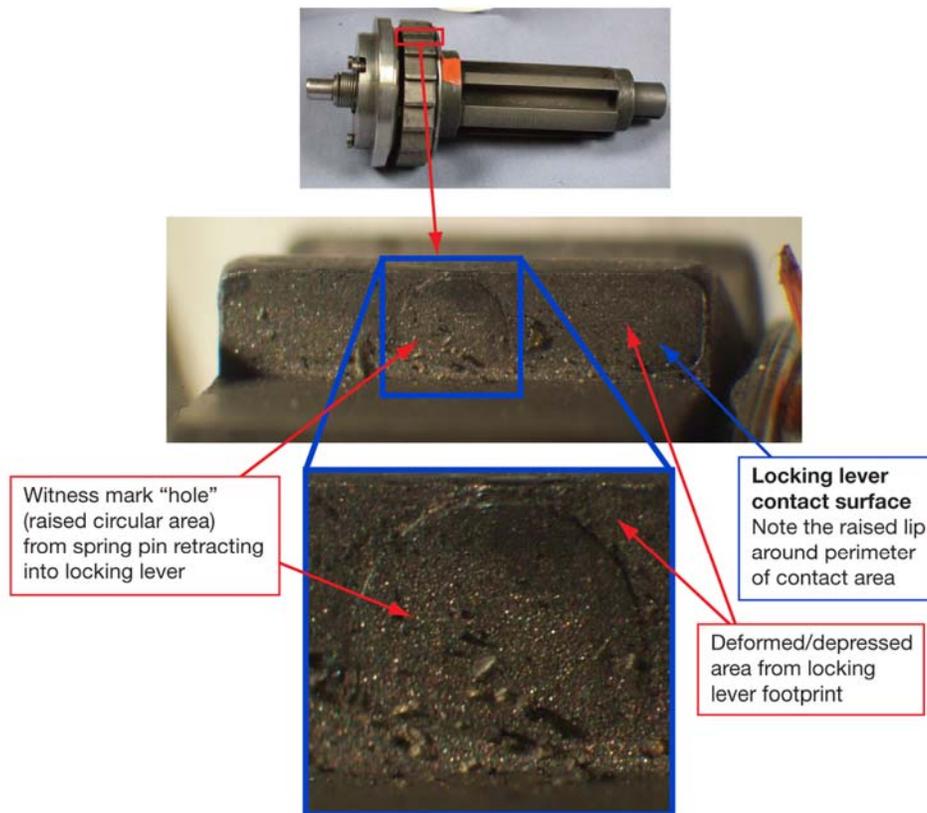
**Figure 3.1-33. Inertial reel locking gear witness mark.**

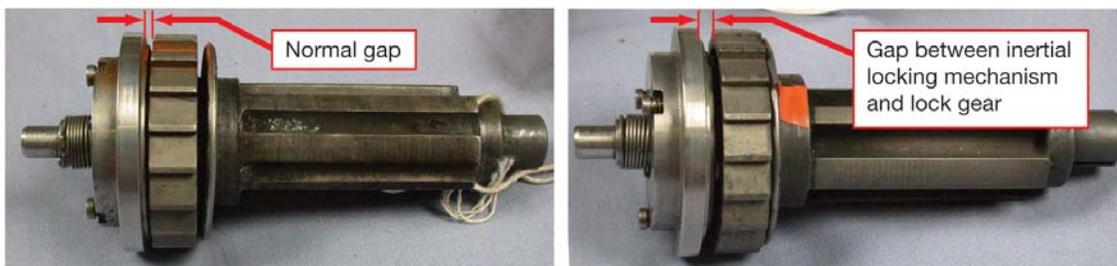
Figure 3.1-35. Separation gap on the seat 4 inertial reel.
