Chapter 2 – Vehicle Failure Assessment

This section discusses the trajectory, dynamic attitude, and thermal analyses of the *Columbia* accident performed in support of the Spacecraft Crew Survival Integration Investigation Team (SCSIIT). The motion analyses provided information about the loads experienced by the crew and the vehicle through the evolving conditions. Because the thermal environment for atmospheric entry is highly dependent on the aerodynamic properties of an object as well as the aerodynamic conditions such as altitude and velocity, the aerodynamic analyses also provided reference data for thermal analyses. The purpose of the thermal analyses was to aid in understanding the probable failure sequence by comparing the physical condition of certain key items of debris with predicted entry heating.

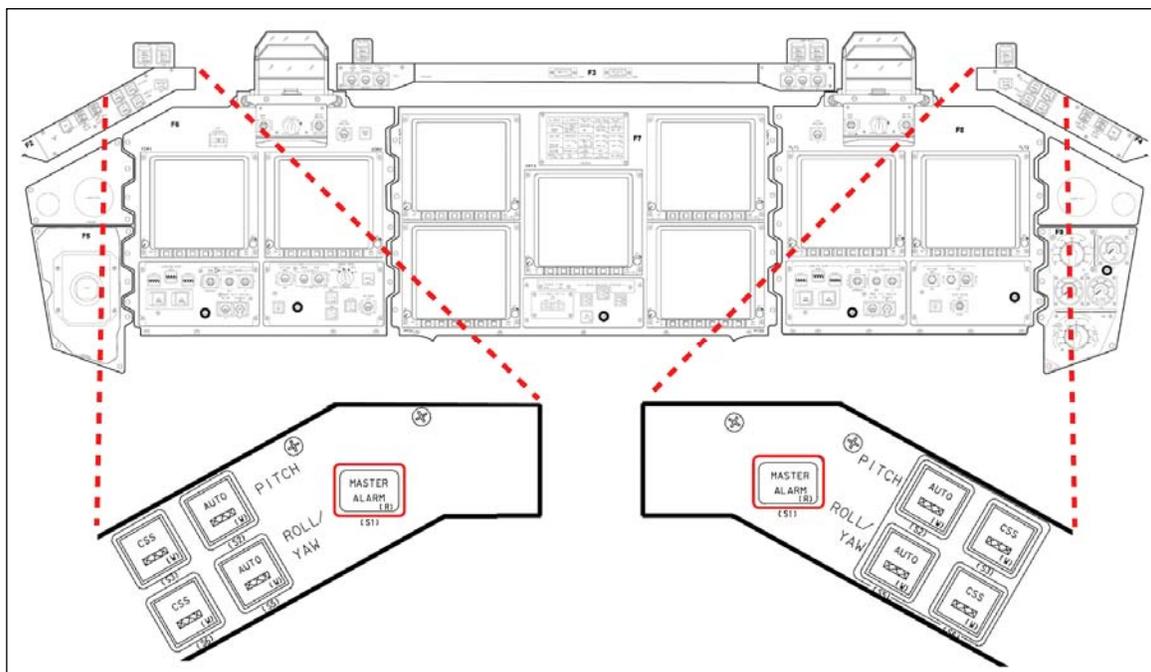
Master Alarm. ¹⁹ The Master Alarm associated with the FCS Channel 4 fault message would have been annunciated to the crew (figure 1.2-39).

Figure 1.2-39. Location of the master alarm light. [Adapted from the Space Shuttle Systems Handbook]

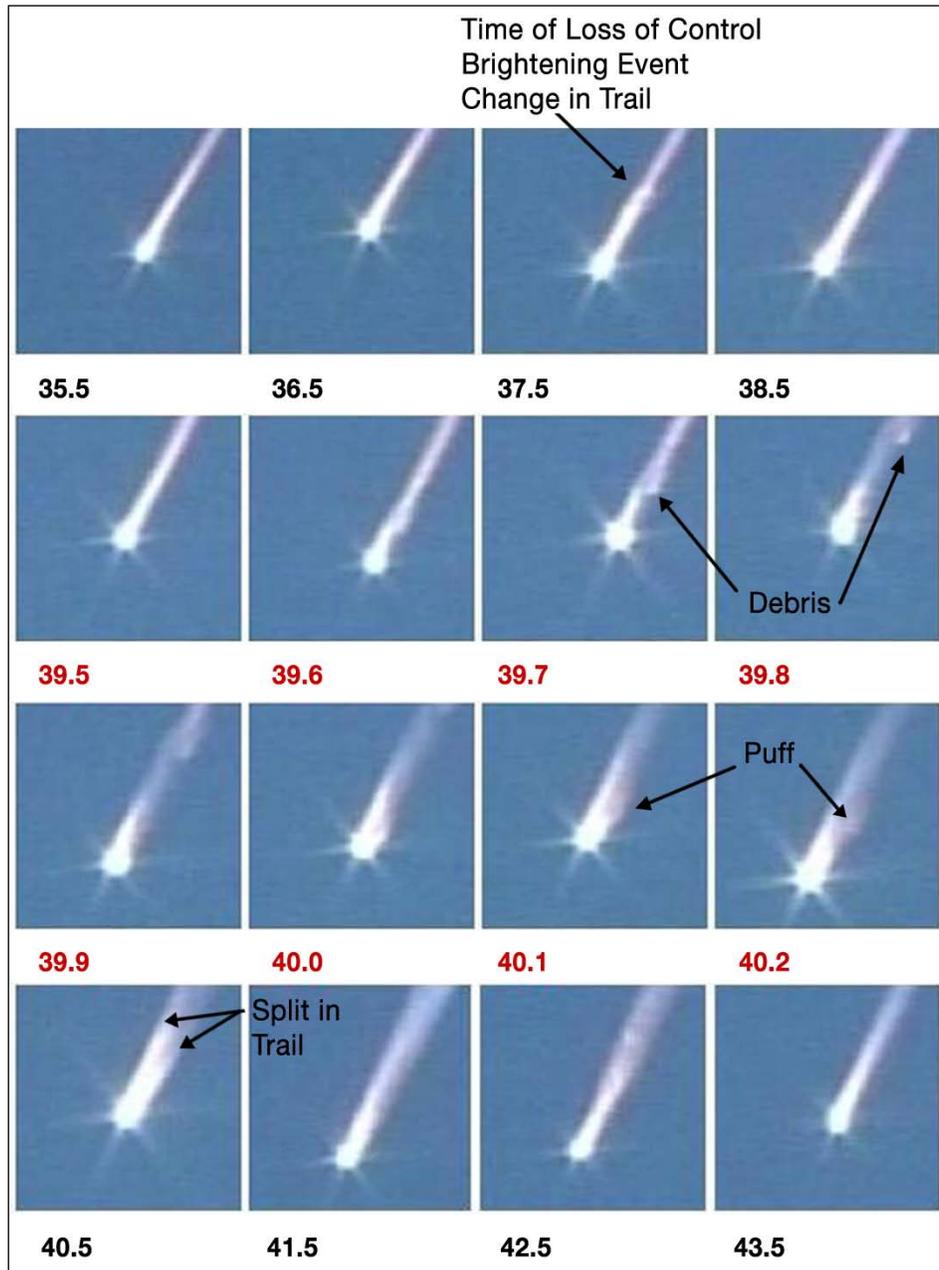
Figure 1.2-41. Video frame captures from ground-based video, beginning at GMT 13:59:35.5 (EI+926.5) and ending at GMT 13:59:43.5 (EI+937.5). The numbers below each frame indicate the seconds after GMT 13:59:00. The frames in the first and last rows are 1 second apart. The frames in the second and third rows are 0.1 second apart.

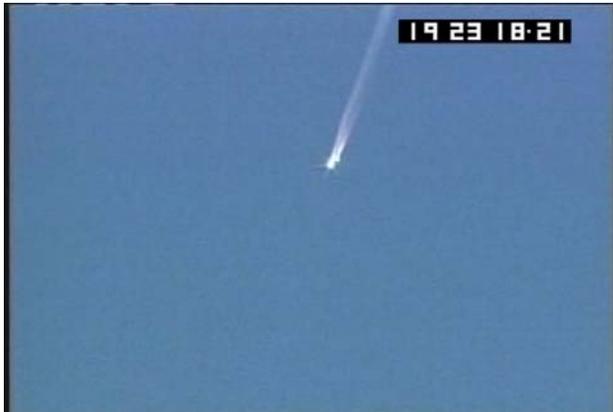
Debris D (possible Left OMS Pod). Video analysis identifies this as the earliest time at which Debris D is observed. Debris D was identified as possibly being the left OMS pod. (figure 1.2-42).</p>

Figure 1.2-42. Debris D is depicted in this frame.

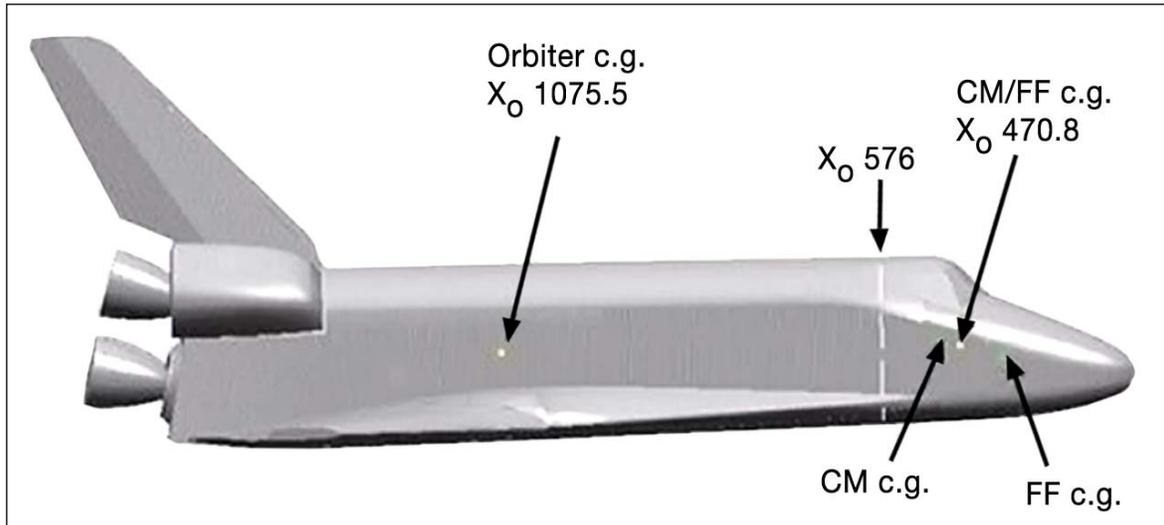
Prior to the CE, the crew was experiencing rotational loads with the center of rotation located aft of the crew module at the center of mass of the orbiter. As a result of the crew module and forward fuselage separating from the rest of the orbiter, the rotational arm decreased (figure 1.2-45).

Figure 1.2-45. X-axis center-of-gravity locations for the intact orbiter, the crew module, the forward fuselage, and the forebody (crew module plus forward fuselage). The X_o 576 is the aft bulkhead of the crew module.

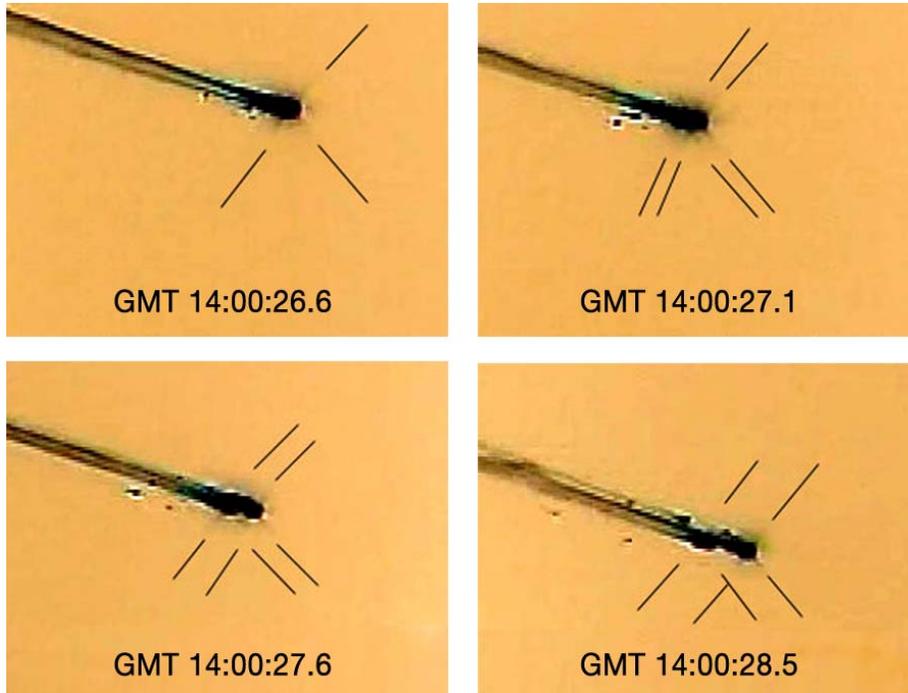
First visual indication that the orbiter had broken into multiple pieces (figure 1.2-46).

Figure 1.2-46. Color-inverted video images of the start of the double star event, GMT 14:00:26.6 (EI+977.6). Black lines have been added to more clearly identify the two separate objects.

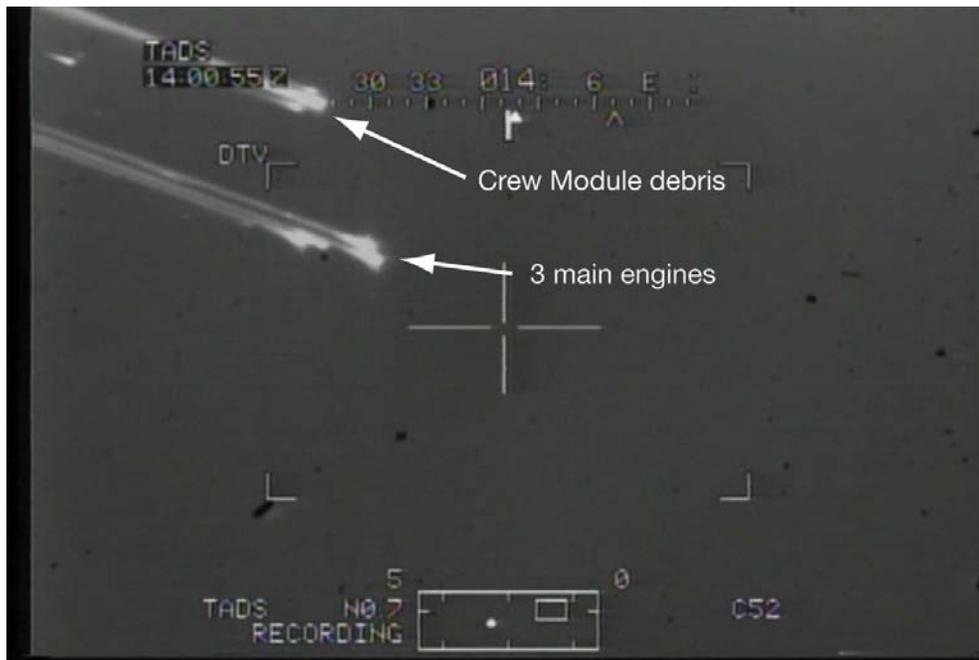
CREW MODULE CATASTROPHIC EVENT Begins. The CMCE is the initiation of a period of time during which the forebody was undergoing a major structural breakup. The breakup sequence progressed over several seconds and ends at approximately GMT 14:01:10 (EI+1021). Analysis of ground-based video of the event established the first detectable signs at GMT 14:00:53 (EI+1004). Based on engineering analysis, CMCE is thought to have started with the failure of the forward fuselage. Once the forward fuselage began to break away, the exposed crew module rapidly failed due to the combined effects of the high G-loads, aerodynamic forces, and thermal loads. The flight deck maintained structural integrity longer than the middeck (figure 1.2-47).
--------------------	--

Figure 1.2-47. Image from Apache³⁵ video showing crew module debris (top cluster) and the three main engines (cluster to left of cross hairs).

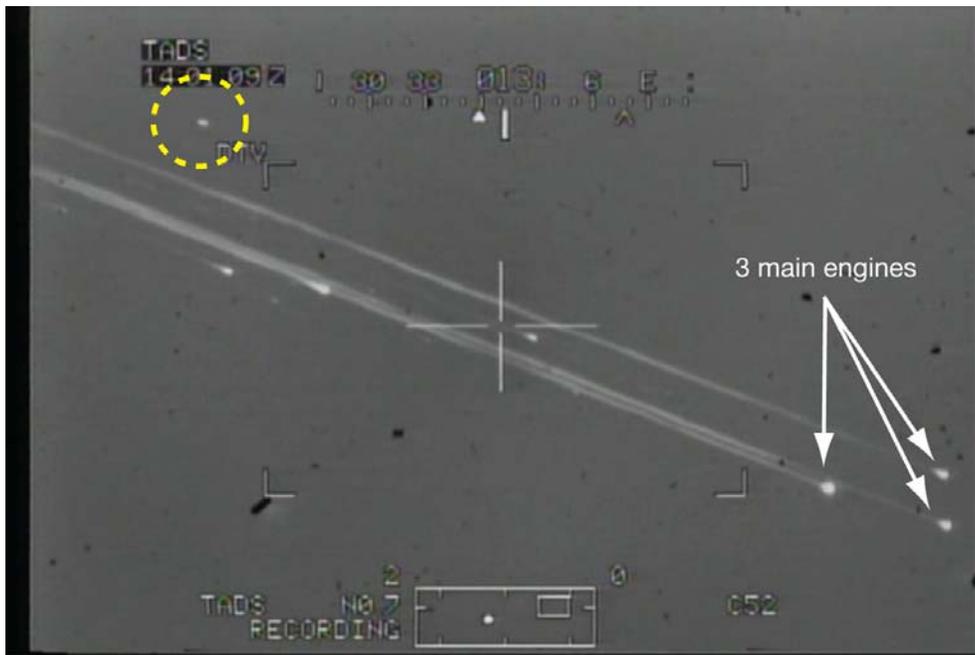
TD – Forward fuselage and crew module have fragmented into pieces too small to be detected on any of the ground-based videos (figure 1.2-48).
--------------------	--

Figure 1.2-48. Image is from the Apache video. Dotted circle indicates area where crew module debris is last visible. The three points in the lower right are the three main engines.

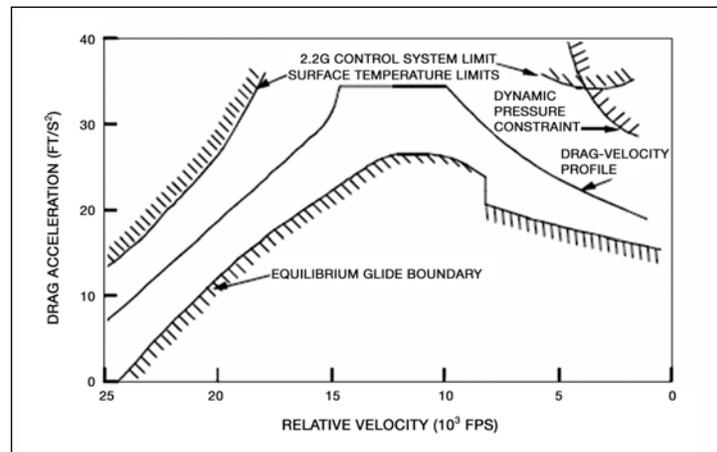
Figure 2.1-4. Entry guidance drag-velocity profile and limits.⁶

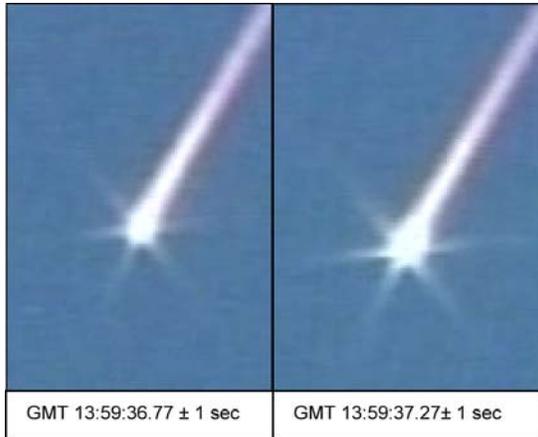
Significantly, ground-based video shows a marked change in the appearance of the orbiter’s trail at GMT 13:59:37 (immediately after the end of the first RGPC data set, RGPC-1) (figure 2.1-5). The width of the trail increases at this time, which likely indicates a change in the orbiter’s flight condition. In addition to the change in the width of the trail, the trail appears to pulse or “corkscrew” over a period of less than 1 second. It is possible that a large debris event (such as loss of a major portion of the wing) may have caused

Figure 2.1-5. Noticeable change in brightness at GMT 13:59:37±1 second.

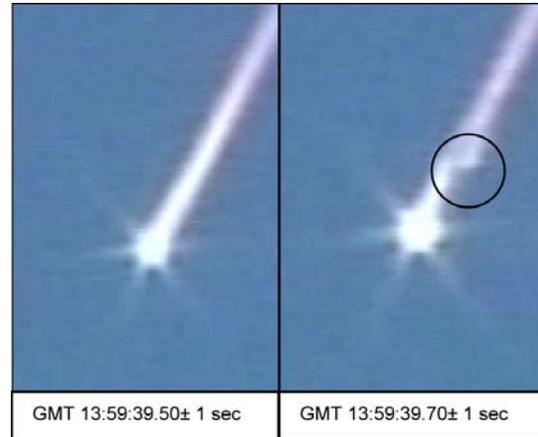
the LOC. However, the debris event closest to the LOS that was apparent in the video occurred 2 seconds, or more than 60 frames (figure 2.1-6), after the change in the trail's appearance. This suggests that it was subsequent to the LOC and was not the cause. Video time errors are up to 1 second, but the relative sequence of the events (brightening, followed by a debris event) is not changed.

Figure 2.1-6. Noticeable debris shedding event (circled at right) at GMT 13:59:39±1 second.

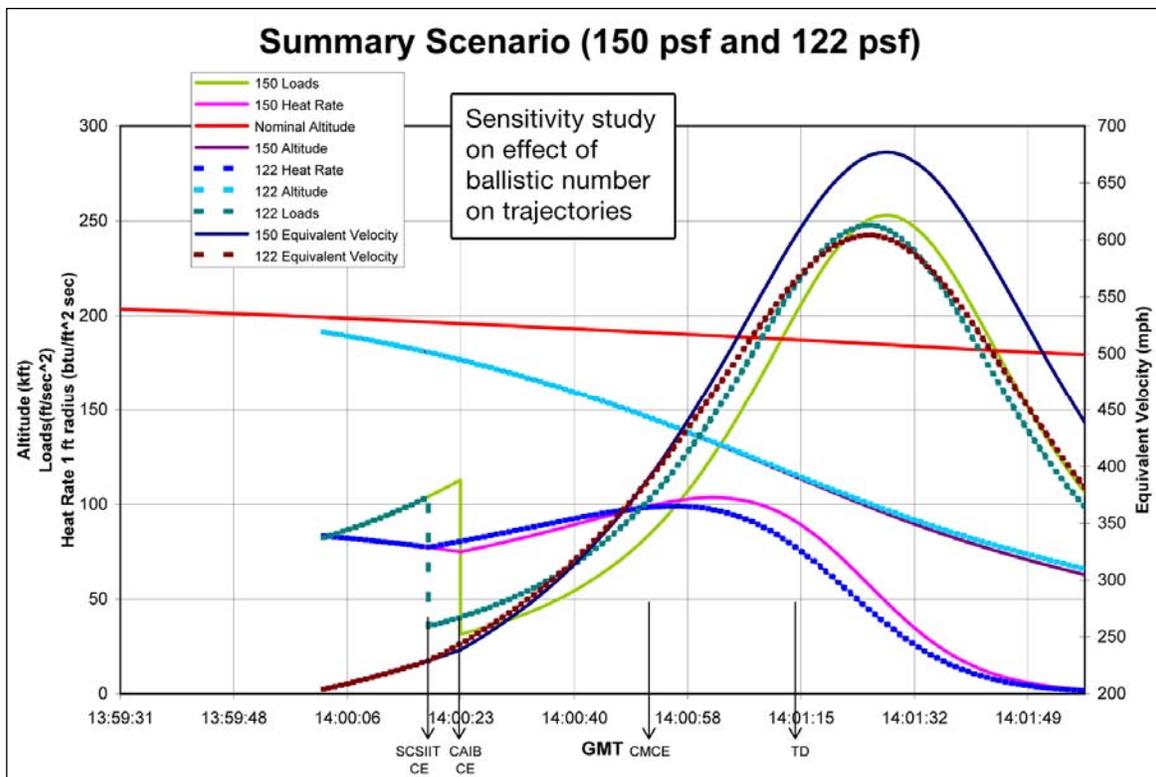
Figure 2.1-8. Comparison of 150-pounds-per-square-foot and 122-pounds-per-square-foot forebody projected trajectories.

Using more detailed information from ground-based video, the Image Science and Analysis Group (ISAG) determined that the orbiter breakup occurred at GMT 14:00:18.3.⁹ Later, higher-fidelity mass properties of the CM based on flight data were combined with a refined estimate of the geometry of the forebody to provide a more precise average ballistic number of 122 psf. Because ballistic analysis on many objects had already been conducted using the 150-psf reference trajectory, it was preferable not to change to the updated CE time and 122-psf reference trajectory for the additional ballistic analyses. A sensitivity study was conducted to determine how changing the reference trajectory average ballistic number from 150 psf to 122 psf would affect the release times. It was found that the release times only changed by 1 second. Since the overall error in ballistic release times was ± 5 seconds, this is not significant. Therefore, the original 150-psf forebody reference trajectory was used for the additional ballistic analyses. Figure 2.1-8 shows the two forebody reference trajectories. The dotted lines are the 122-psf trajectory parameters and the solid lines are the 150-psf trajectory parameters for an idealized forebody trajectory. The plot shows the differences in the CE times, loads, heat rates, altitudes, and equivalent velocity between the two trajectories. The trajectories were propagated out even past the CMCE, the time at which the forebody broke up, to enhance the evaluation of the differences.

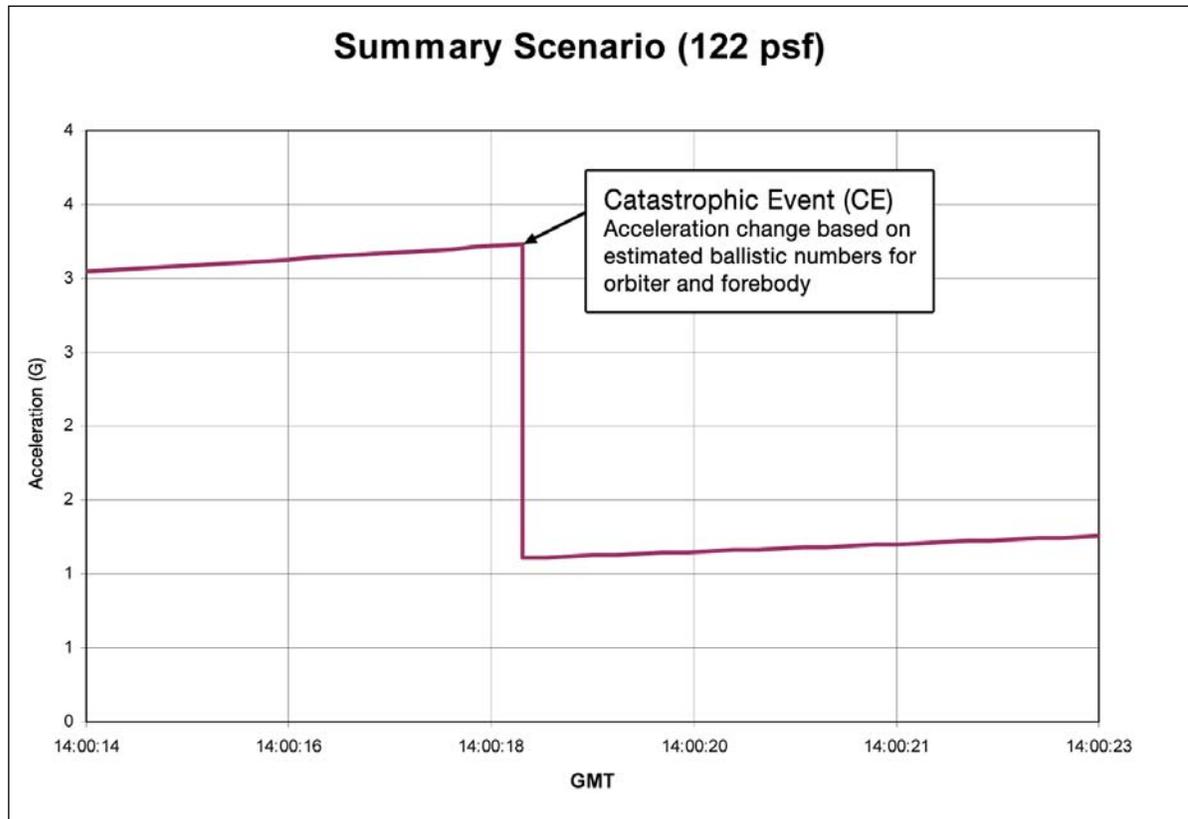
Figure 2.1-9. Estimated change in total G experienced by the forebody due to a change in ballistic number from the orbiter breakup.

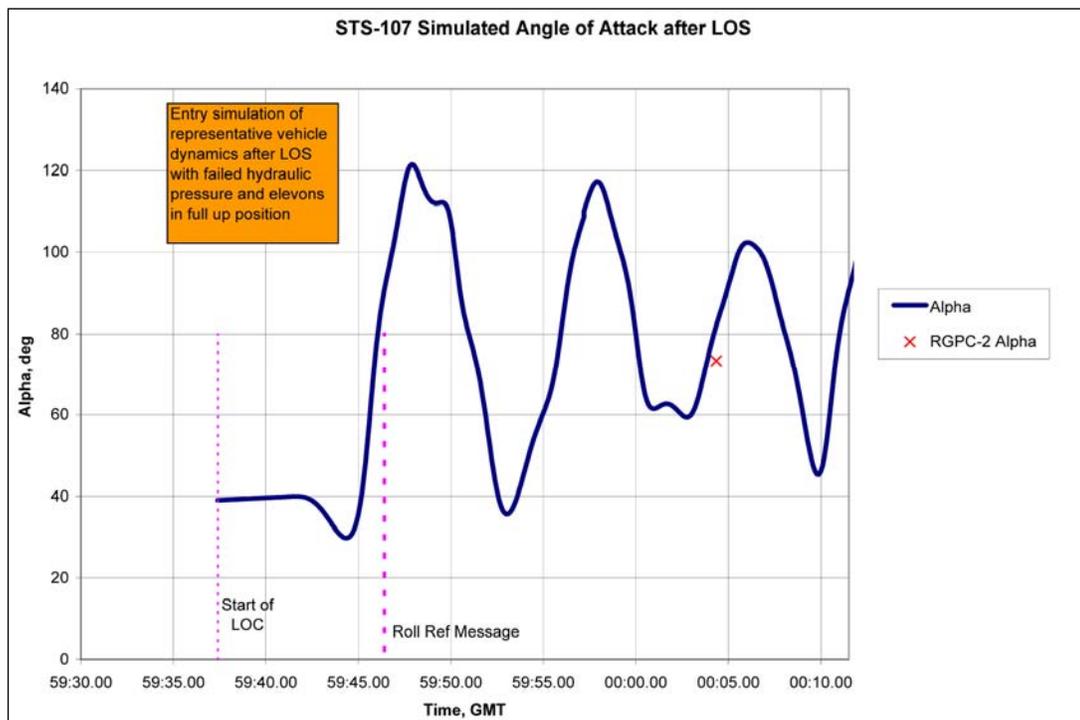
Figures 2.1-10 through 2.1-12 show the plots of the estimated orbiter angle of attack, roll angle, and sideslip angle from the start of the LOC period until the CE based on the simulation. The representative motion seen in these plots shows that the orbiter was oscillating around the velocity vector in all three axes.

Figure 2.1-10. STS-107 simulated angle of attack after loss of signal. Red data indicate alpha condition recorded in the reconstructed general purpose computer-2 data.

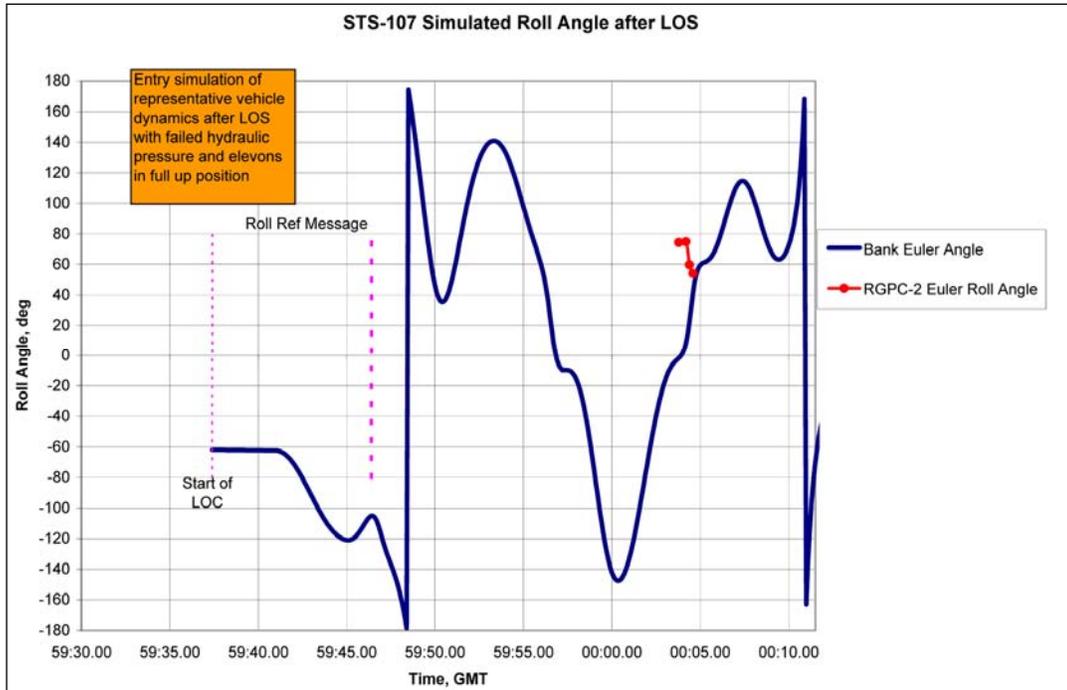
Figure 2.1-11. STS-107 simulated roll angle after loss of signal. Red data indicate roll conditions recorded in the reconstructed general purpose computer-2 data.

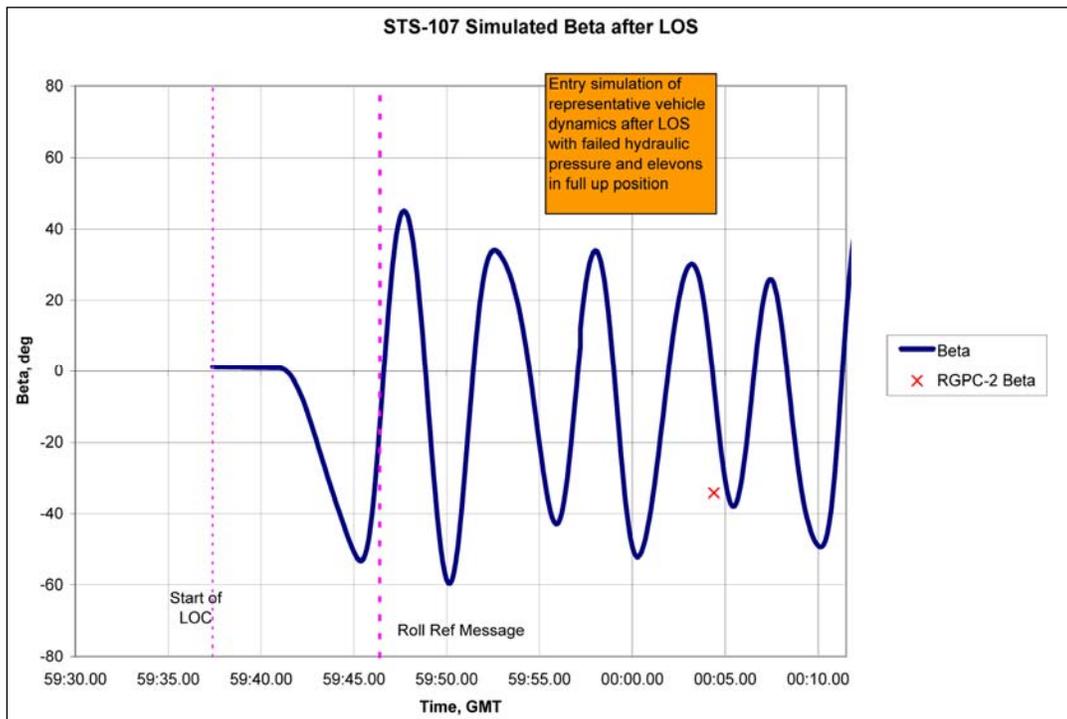
Figure 2.1-12. STS-107 simulated sideslip angle after loss of signal. Red data indicate beta condition recorded in the reconstructed general purpose computer-2 data.

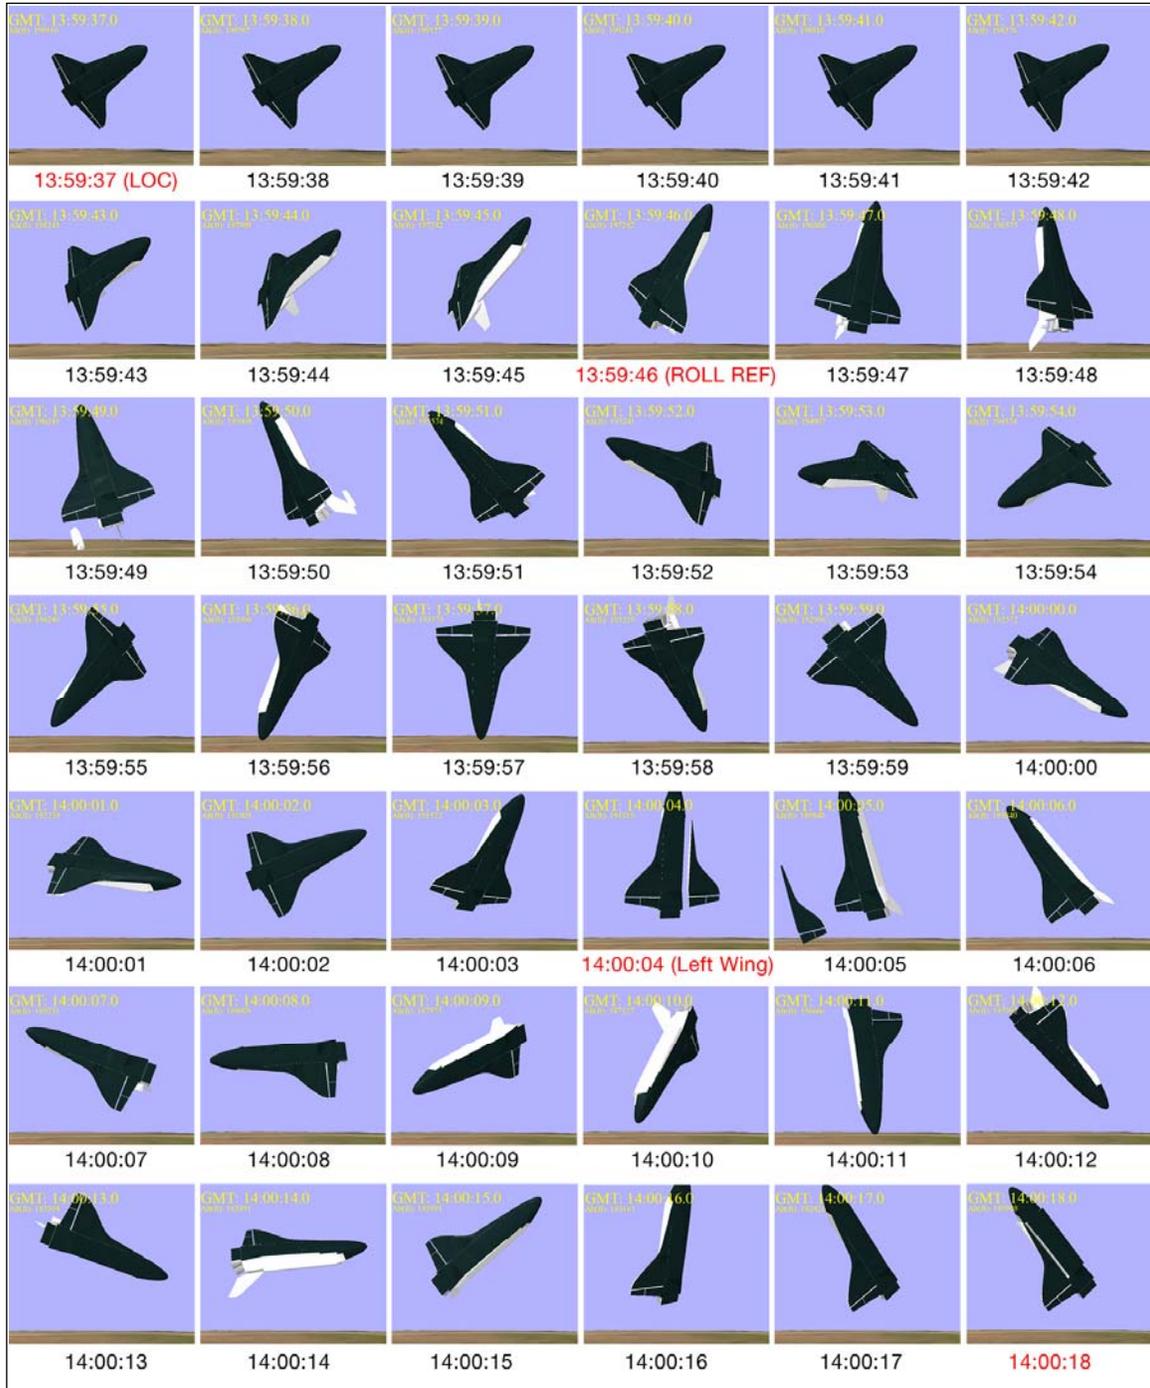
Figure 2.1-13 is a second-by-second graphical depiction of the simulated motion of the orbiter during this period. The sequence begins at the start of the LOC period (GMT 13:59:37) and ends at the CE (GMT 14:00:18). The view is from a point in front of the orbiter’s direction of travel, looking backward along the velocity vector. The snapshot for GMT 14:00:04 shows the left wing departing intact. In reality, the left wing did not come off all at one time but was shedding debris over a period of time.

Figure 2.1-13. Entry simulation snapshot sequence. Times are in Greenwich Mean Time.

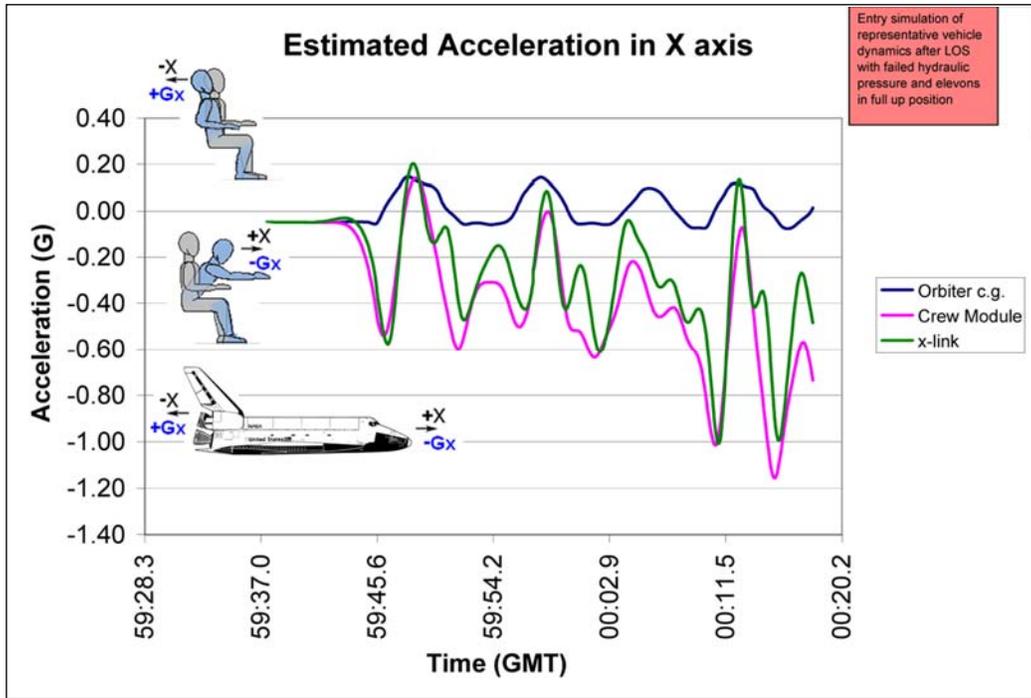
The accelerations are shown in figures 2.1-16 through 2.1-18. These figures show the accelerations due to rotational motion of the orbiter plus the translational accelerations due to atmospheric drag. There is one figure for each orbiter axis, and each figure shows the accelerations at the three different vehicle locations – at the orbiter center of mass, at the CM center of mass, and at the x-link location. Included in each figure is a pictorial that helps describe the effective motion of crew members that would result from these accelerations.

Figure 2.1-16. Estimated accelerations at the crew module in the X axis from the loss of signal to the Catastrophic Event.

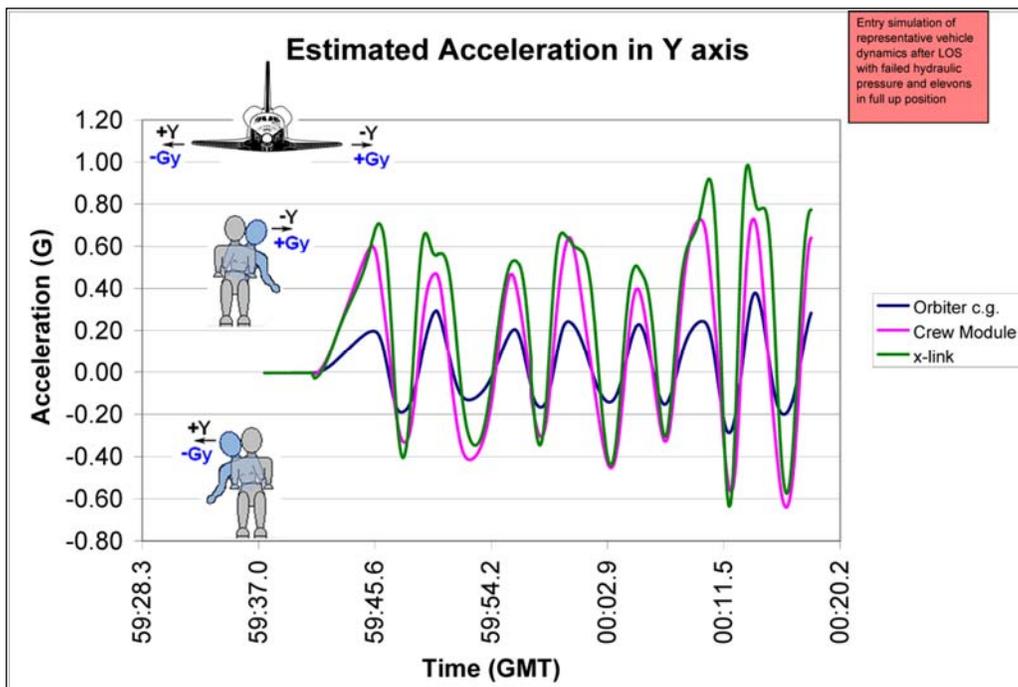
Figure 2.1-17. Estimated accelerations at the crew module in the Y axis from the loss of signal to the Catastrophic Event.

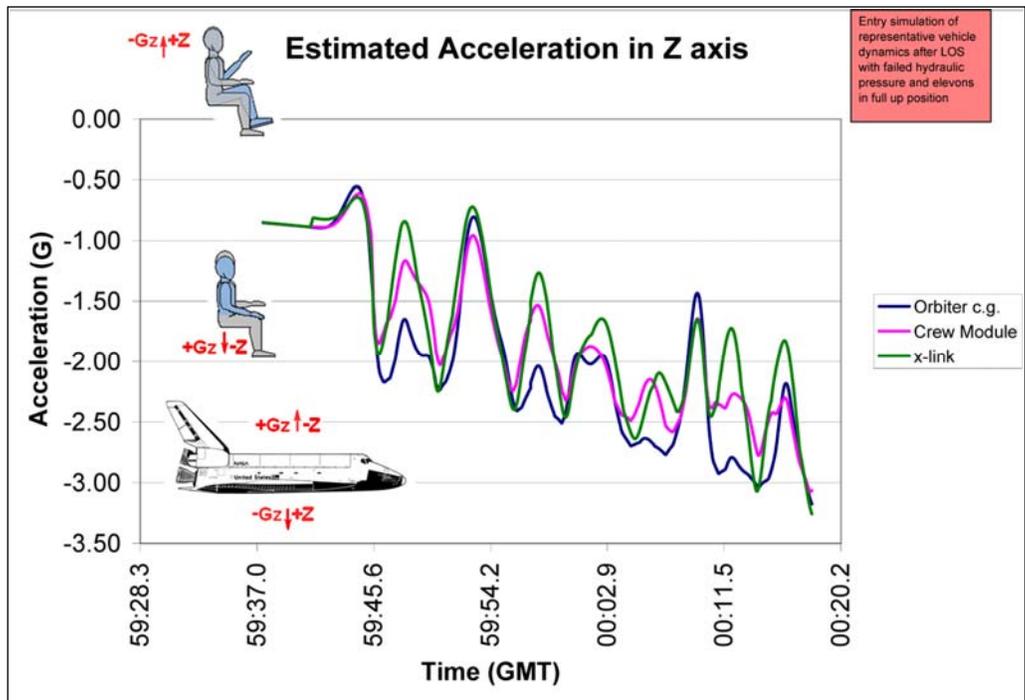
Figure 2.1-18. Estimated accelerations at the crew module in the orbiter Z axis from the loss of signal to the Catastrophic Event. [Note: Crew and orbiter Z axes have opposite convention]

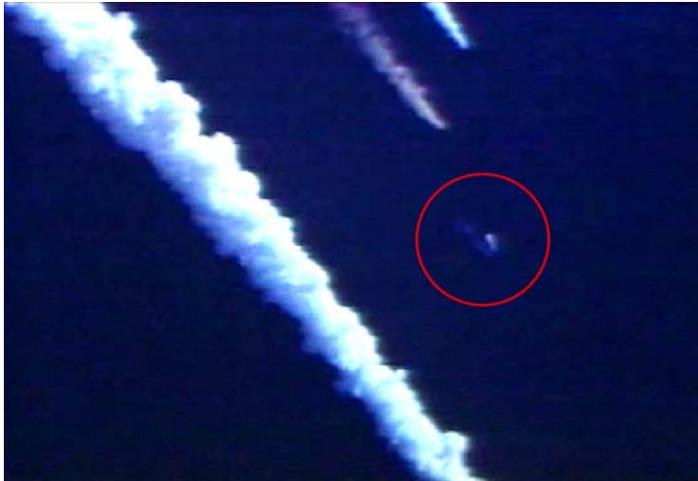
Figure 2.1-19. Video-capture showing Challenger crew module (circled in red) pointed nose into the direction of travel.

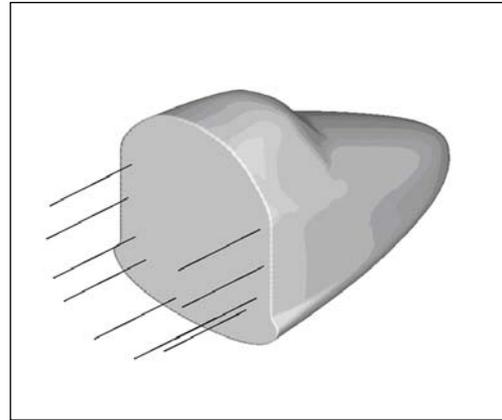
Figure 2.1-23. Modeled trailing wire configuration for forebody.

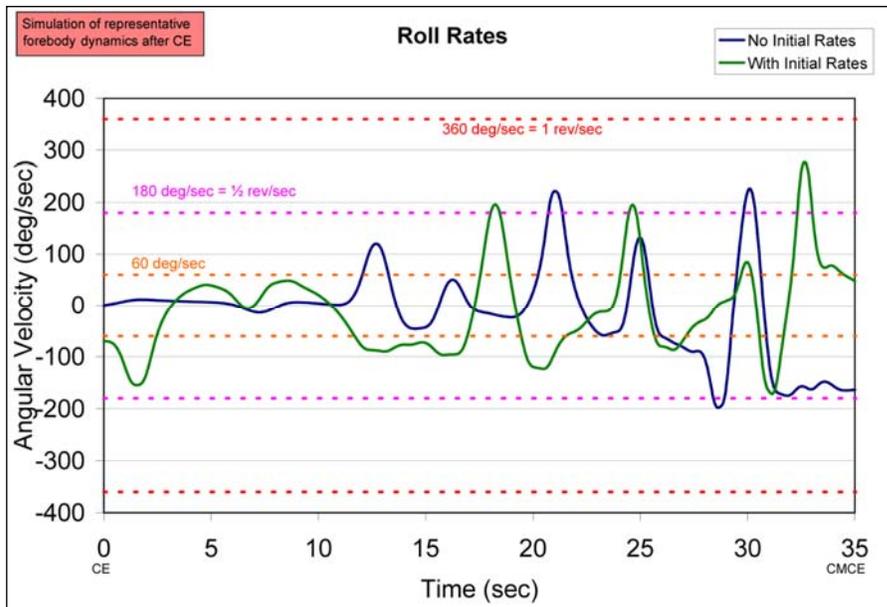
Figures 2.1-24 through 2.1-26 shows the forebody's angular velocity for each case.

Figure 2.1-24. Free-flying forebody roll rates, with and without initial rates.

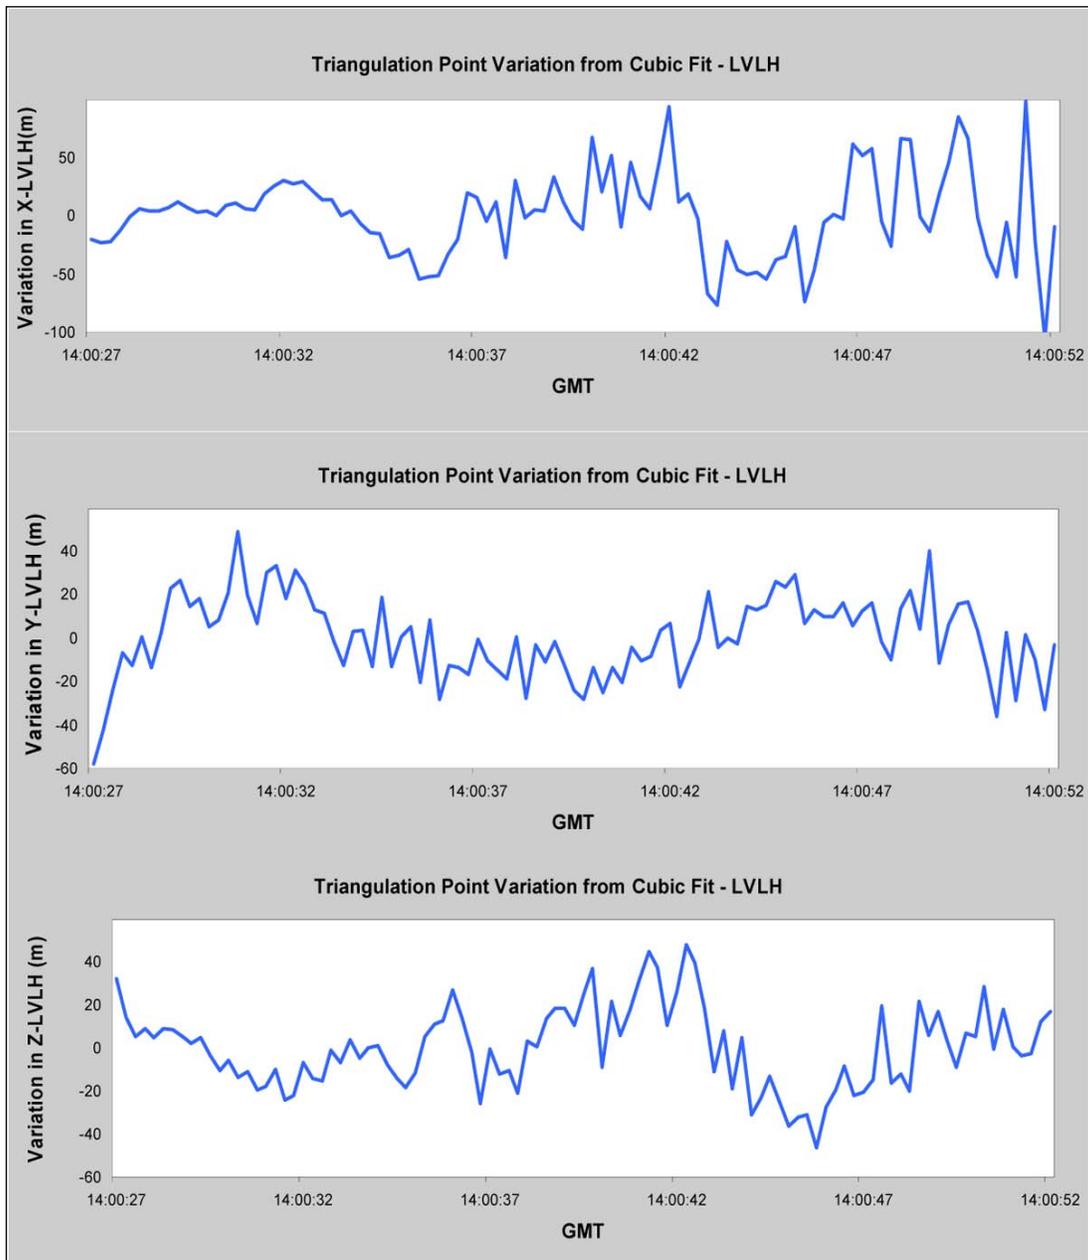
With these data, the relative motion in each axis were plotted (figure 2.1-29).

Figure 2.1-29. Relative motion between the forebody and the main engines.

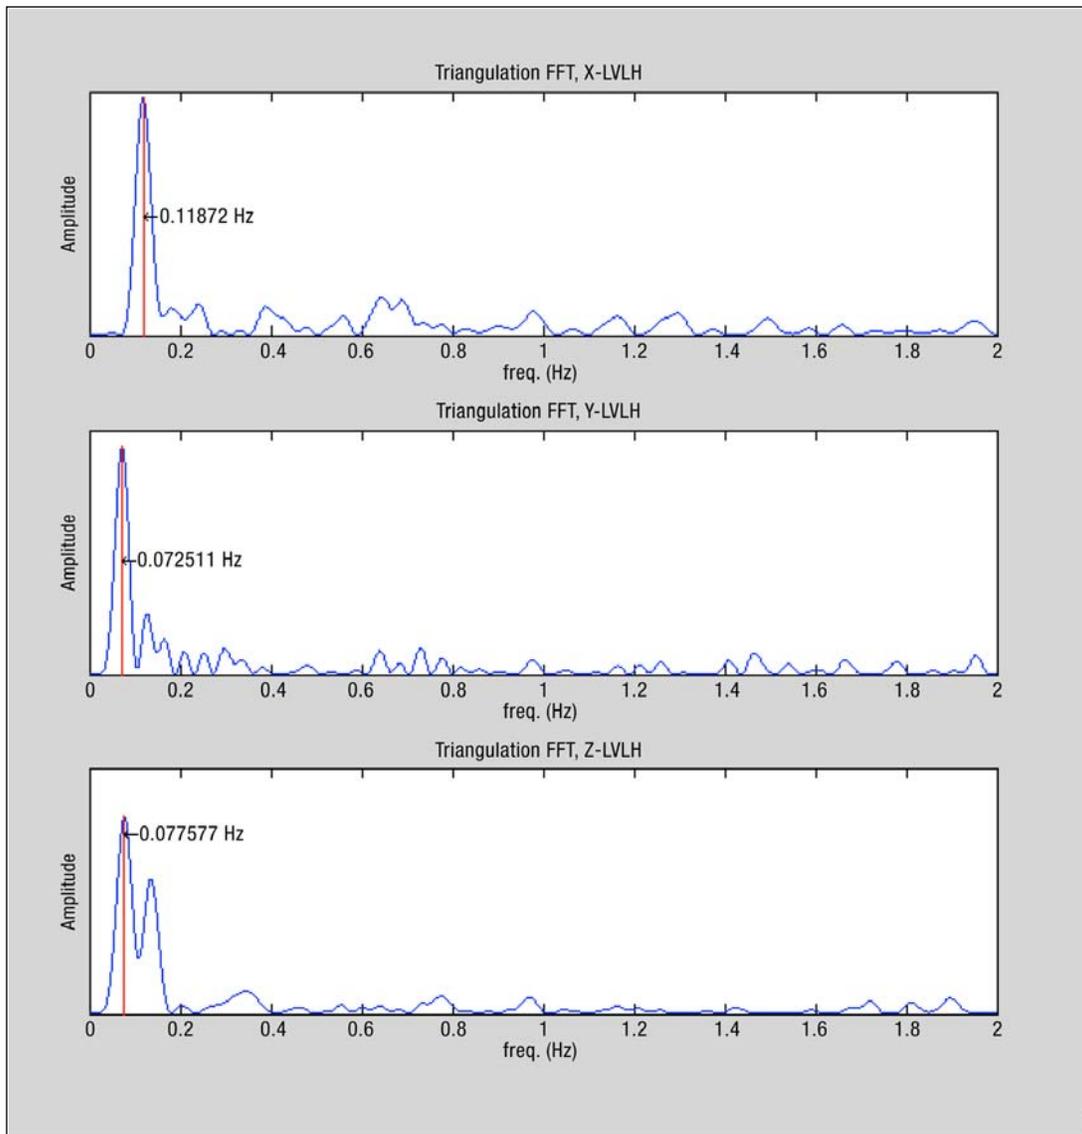
A Fast-Fourier Transform analysis was performed on the X-, Y-, and Z-axis data to look for frequency of motion. The frequency of the wobble motion was assumed to correlate to the rotation rate in that axis (figure 2.1-30).

Figure 2.1-30. Fast-Fourier transform of relative motion in X, Y, and Z axes in hertz.

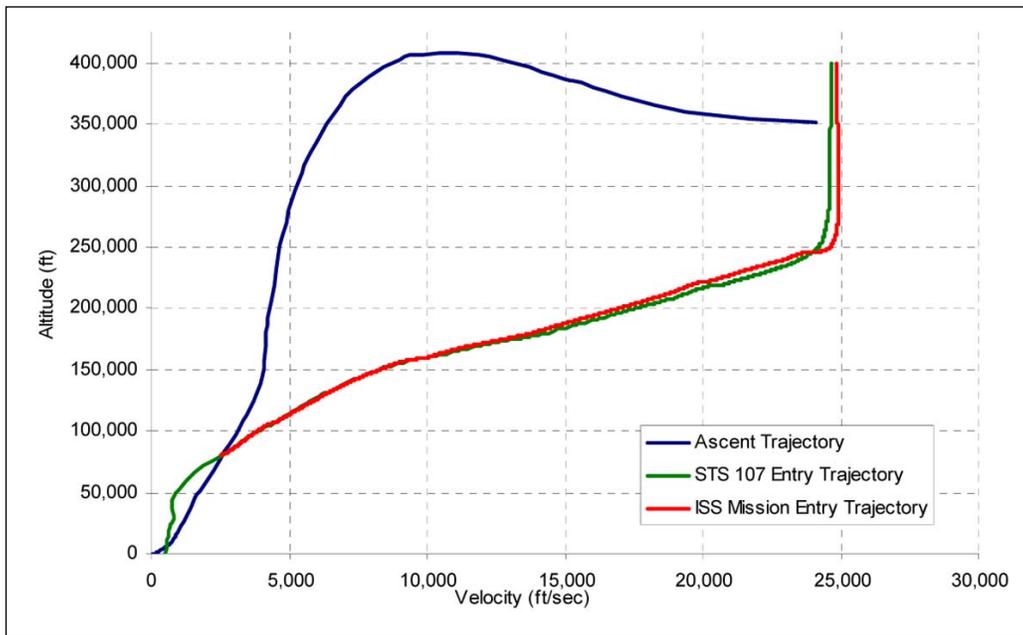
Figure 2.1-31. Altitude vs. velocity for selected trajectory profiles.

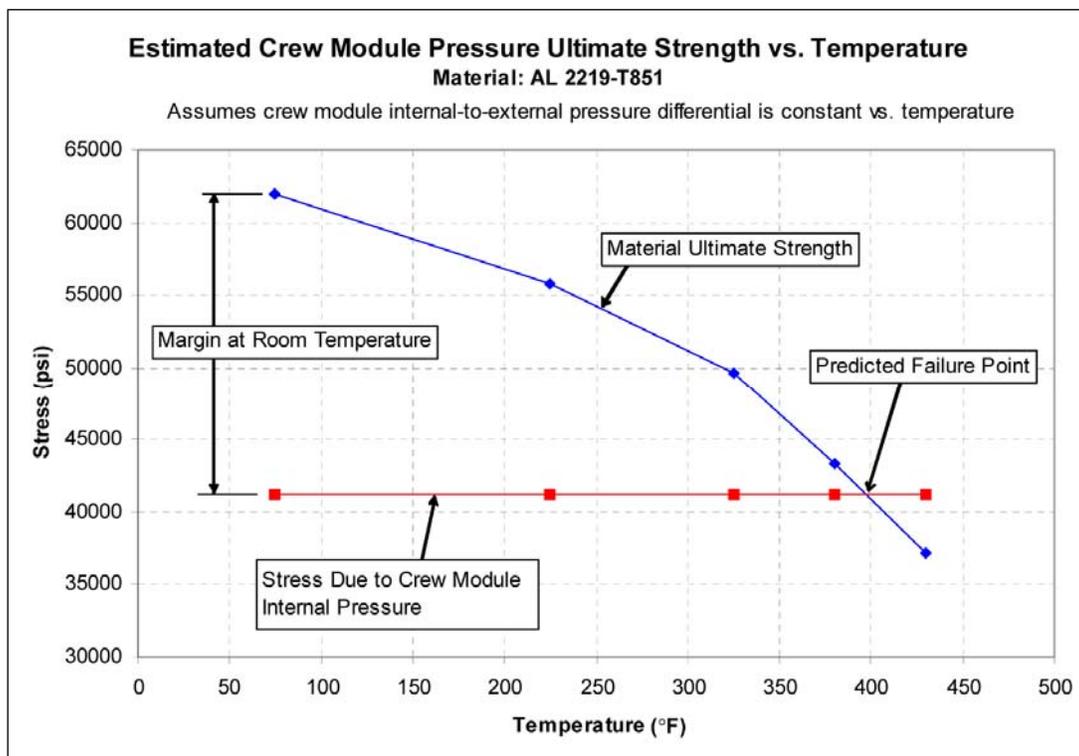
Figure 2.1-32. Crew module stress vs. temperature.

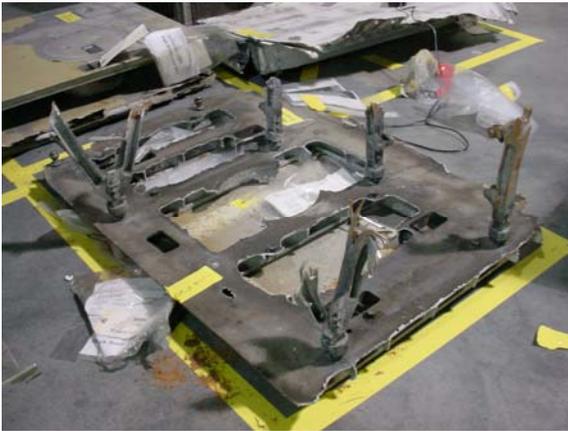
Figure 2.1-33. Recovered lithium hydroxide door with some seat legs still attached.

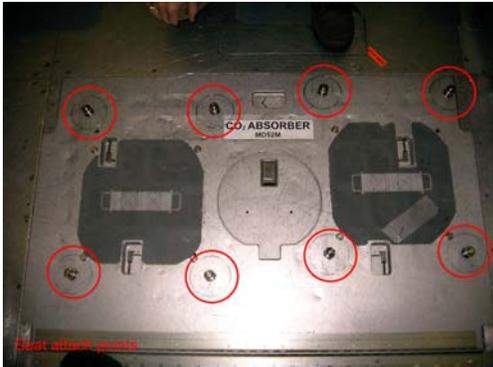
Figure 2.1-35. Upper surface of the lithium hydroxide door, facing the middeck (mockup).

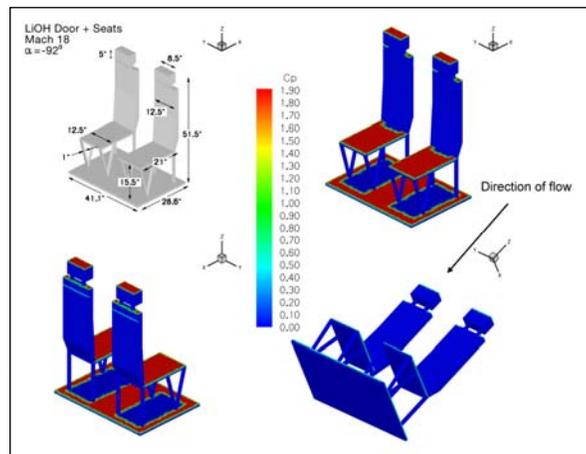
Figure 2.1-41. Pressure distribution of the lithium hydroxide door and seats at an angle of attack of -92 degrees. [Configuration 2]

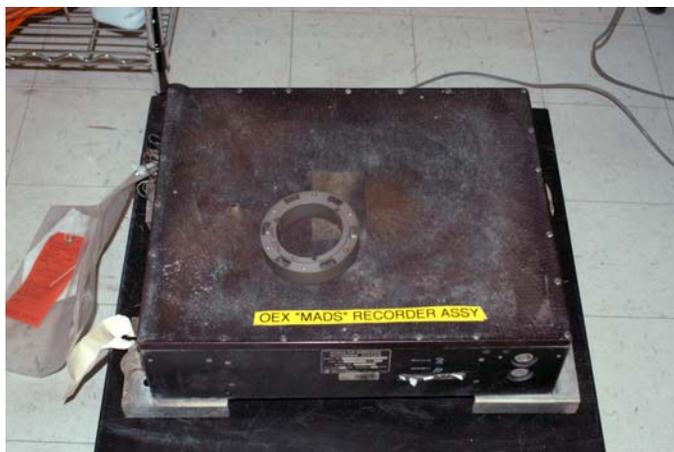
Figure 2.1-44. Recovered orbiter experiment recorder from STS-107. [Columbia Reconstruction Database, debris item no. 54057]

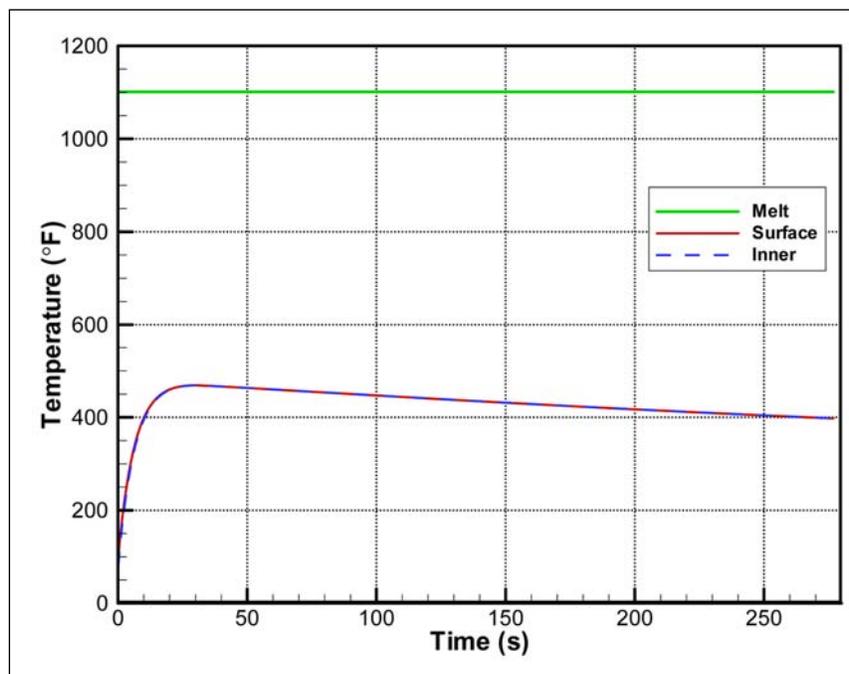
Figure 2.1-45. Temperature vs. time of the orbiter experiment recorder shell if released at GMT 14:01:02.
