Chapter 2 – Vehicle Failure Assessment

This section discusses the trajectory, dynamic attitude, and thermal analyses of the *Columbia* accident performed in support of the Spacecraft Crew Survival Integration Investigation Team (SCSIIT). The motion analyses provided information about the loads experienced by the crew and the vehicle through the evolving conditions. Because the thermal environment for atmospheric entry is highly dependent on the aerodynamic properties of an object as well as the aerodynamic conditions such as altitude and velocity, the aerodynamic analyses also provided reference data for thermal analyses. The purpose of the thermal analyses was to aid in understanding the probable failure sequence by comparing the physical condition of certain key items of debris with predicted entry heating.

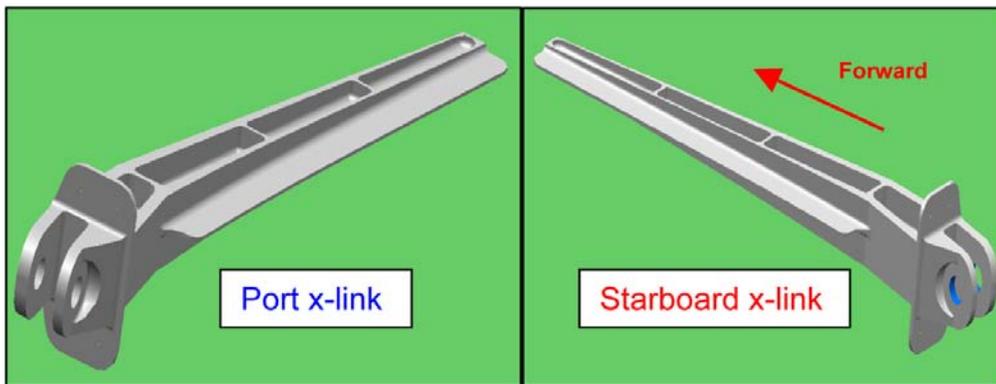
Figure 2.1-46. Drawings of pristine port and starboard x-links.

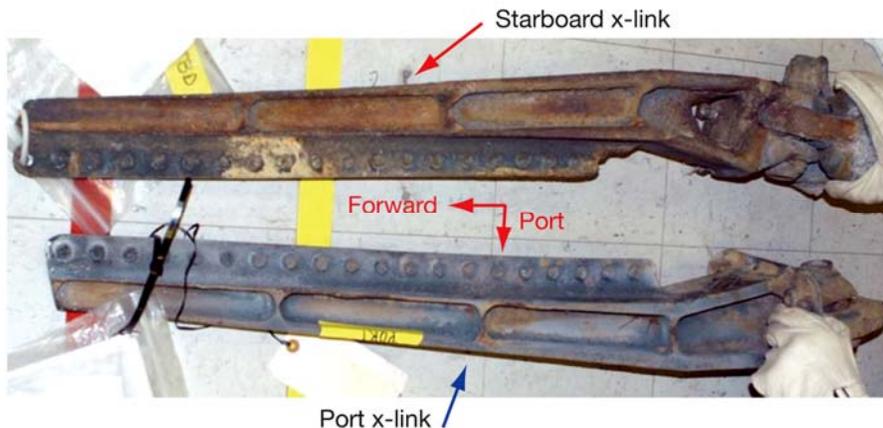
Finding. Thermal analyses predicted that entry aeroheating alone was insufficient by an order of magnitude to produce the observed thermal damage on the x-links. Therefore, the x-links must have experienced other heating mechanism(s) in addition to normal entry heating.

Figure 2.1-47. Comparison of port and starboard x-links recovered from Columbia. [Columbia Reconstruction Database, debris item no. 1678, and Columbia Reconstruction Database, debris item no. 1765]

Conclusion A13-2. The heating from a Type IV shock-shock impingement and titanium combustion (in some combination) likely resulted in the damage seen by the forward payload bay door rollers and the x-links.

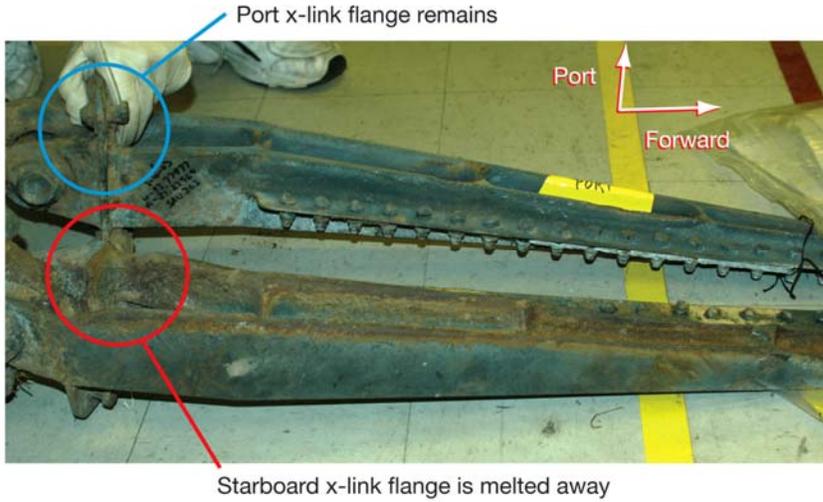
Figure 2.1-48. Comparison of port and starboard x-link flanges. [Columbia Reconstruction Database, debris item no. 1678 (top) and Columbia Reconstruction Database debris item no. 1765 (bottom)]

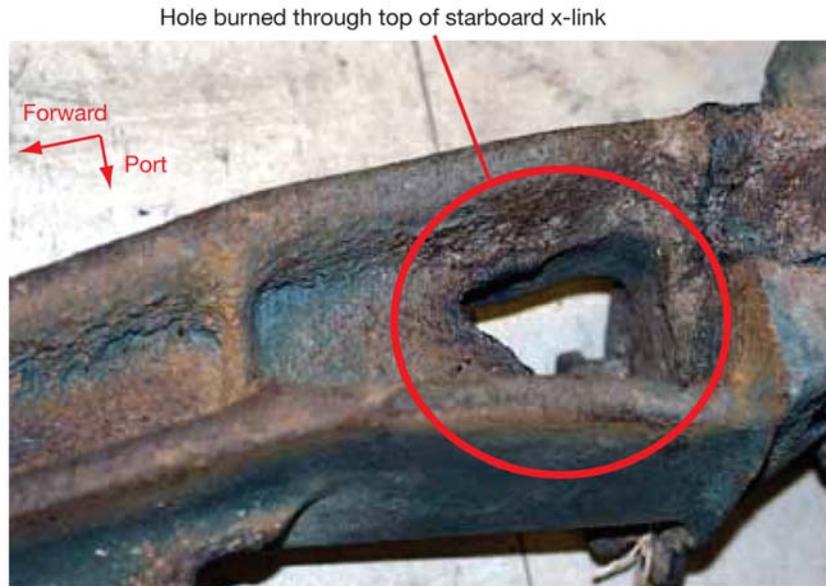
Figure 2.1-49. Close-up of the hole in the starboard x-link. [Columbia Reconstruction Database, debris item no. 1765]

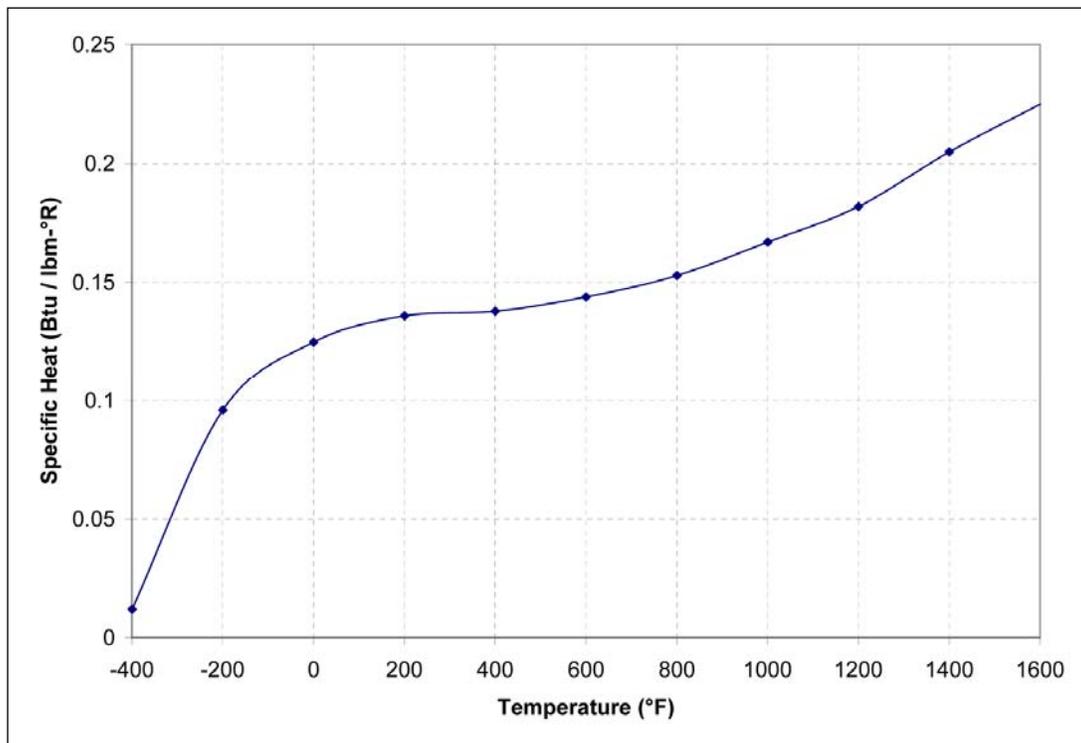
Figure 2.1-50. Specific heat of titanium vs. temperature.¹⁷

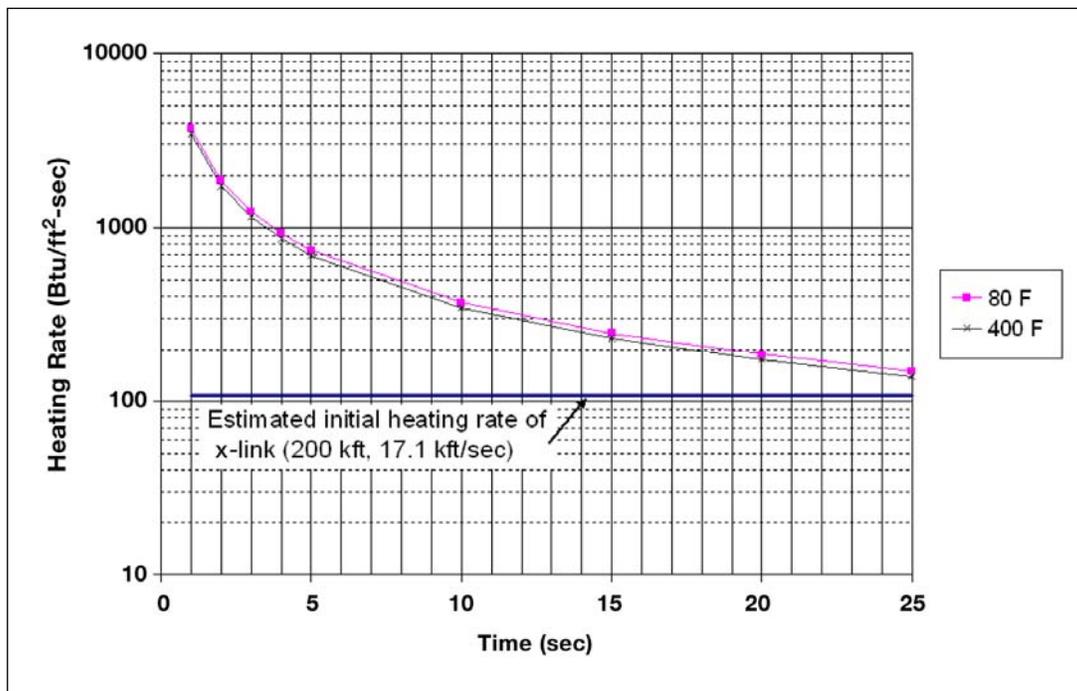
Figure 2.1-51. Heating rates required to ablate a titanium hole of 0.25 inch in depth.

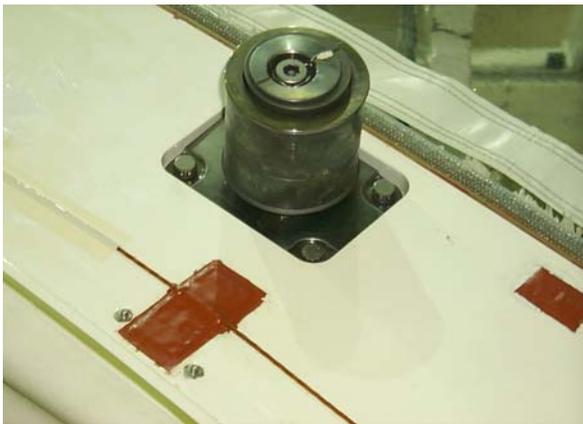
Figure 2.1-52. Payload bay door roller showing inner material and Inconel sleeve.

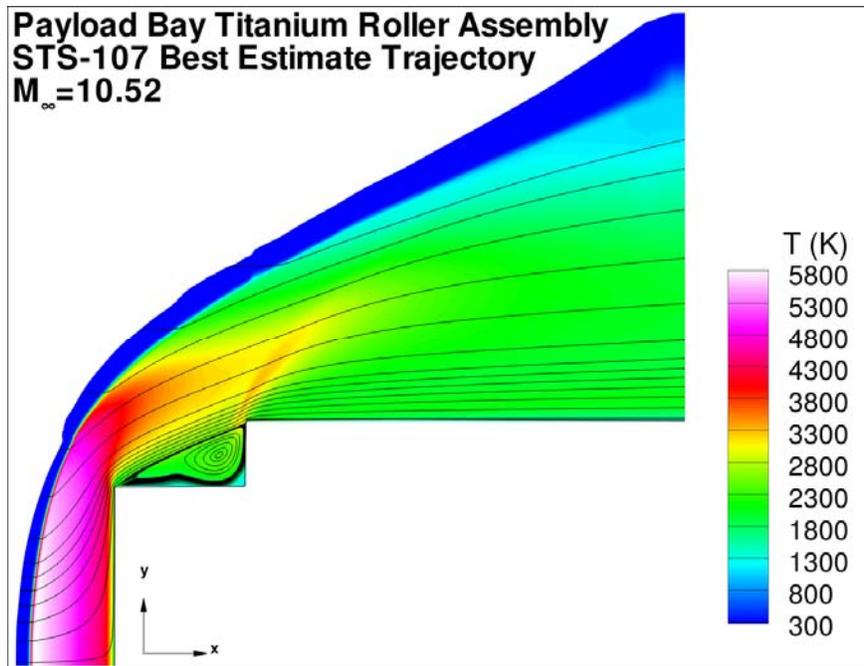
Figure 2.1-54. Computational fluid dynamics analysis of heating at the tip of the payload bay door roller for orthogonal geometry into the direction of travel at $M = 10.5$.

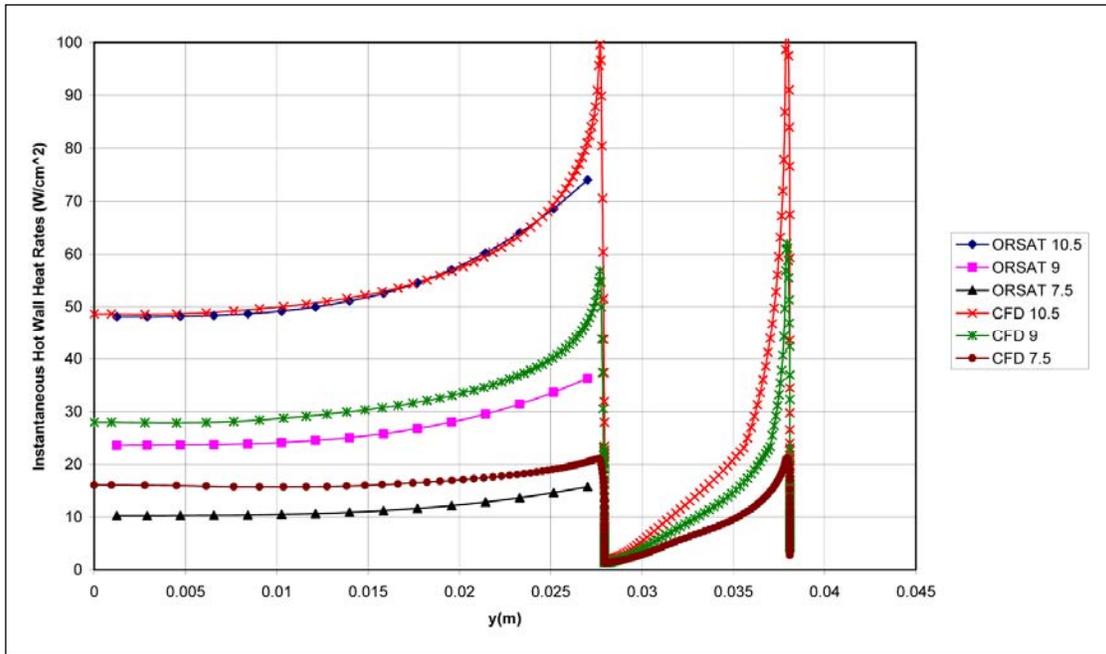
Figure 2.1-55. Comparison of the object reentry survival analysis tool and computational fluid dynamics heating rates for the front face of the payload bay roller for various Mach numbers. Y axis is radial distance from the center of the roller.

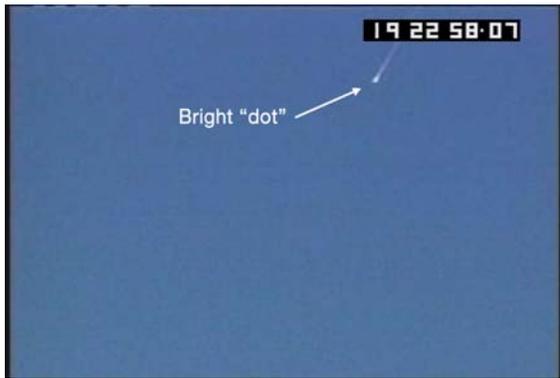
Figure 2.2-1. First frame of video of the Eastern timeline, GMT 13:59:32.5.

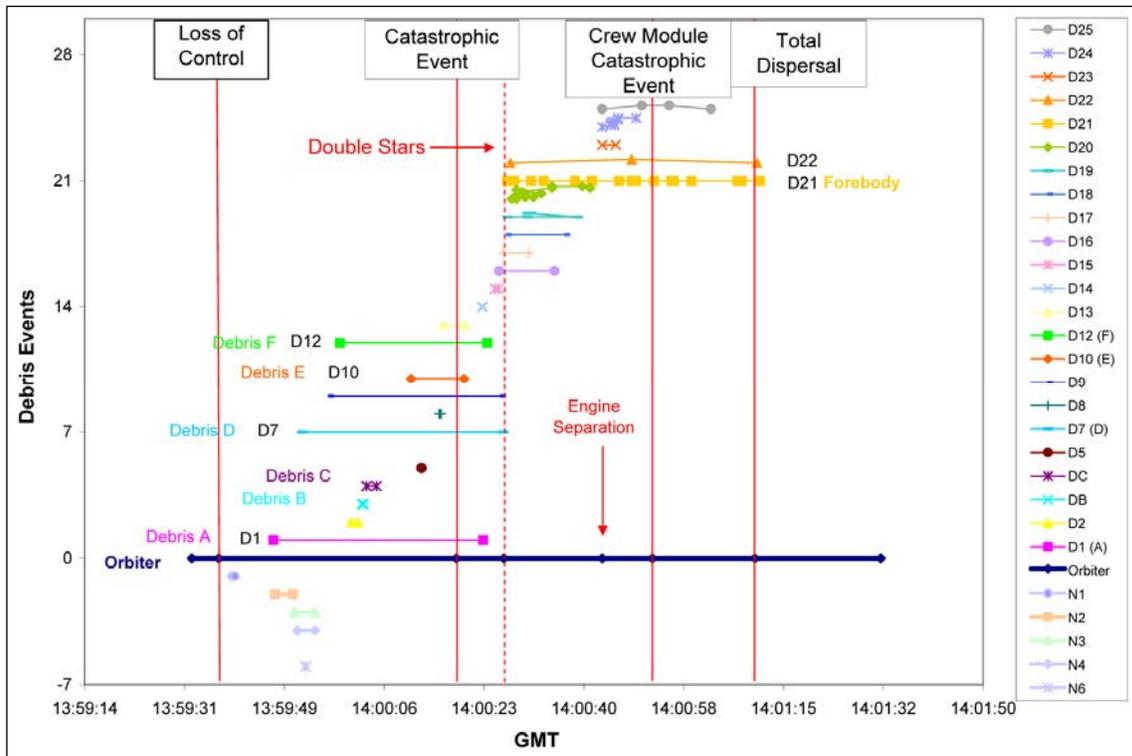
Figure 2.2-9. Debris tree.

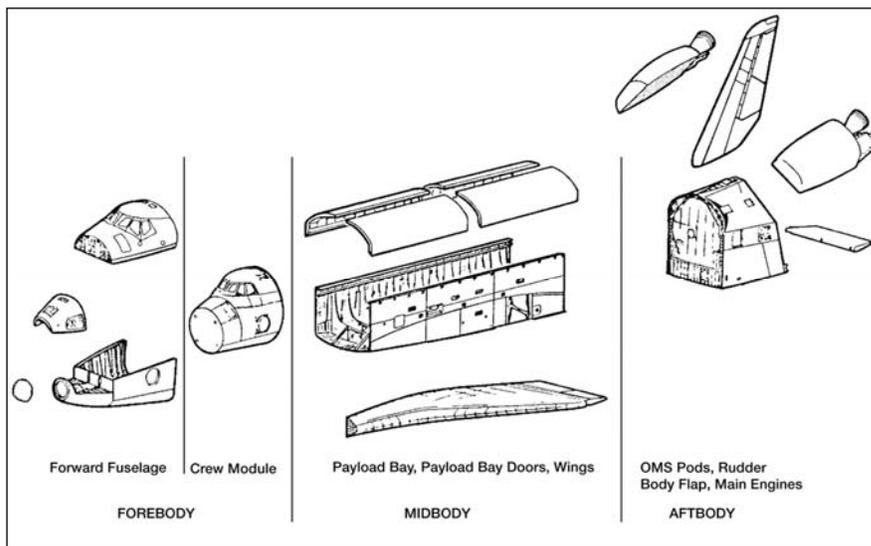
Figure 2.2-12. Depiction of the orbiter forebody, midbody, and aftbody elements.

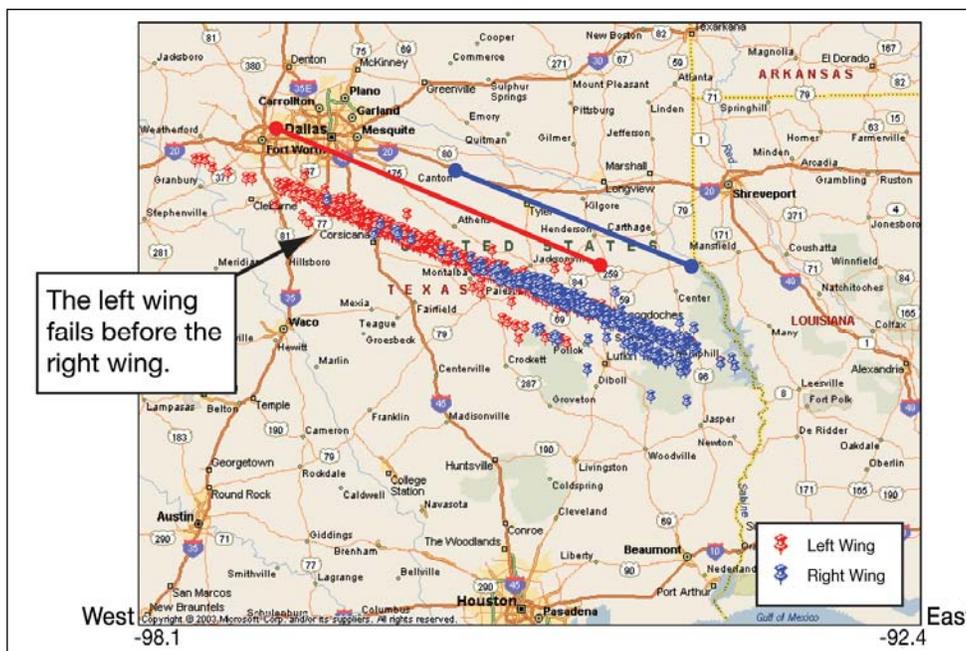
Figure 2.2-13. Debris field of the left and right wings.

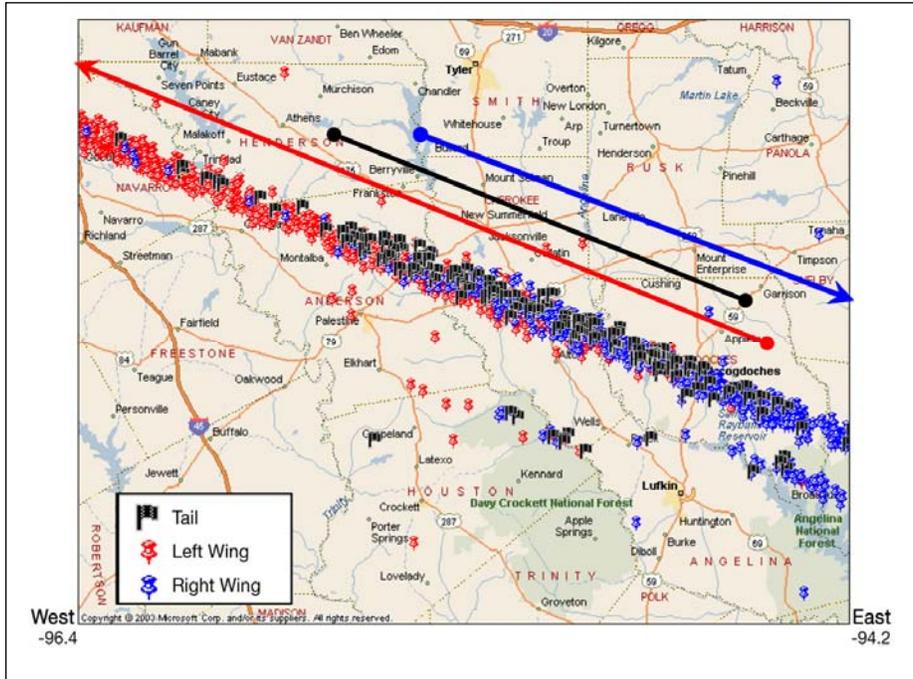
Figure 2.2-14. Partial debris field of the left wing, right wing, and tail.

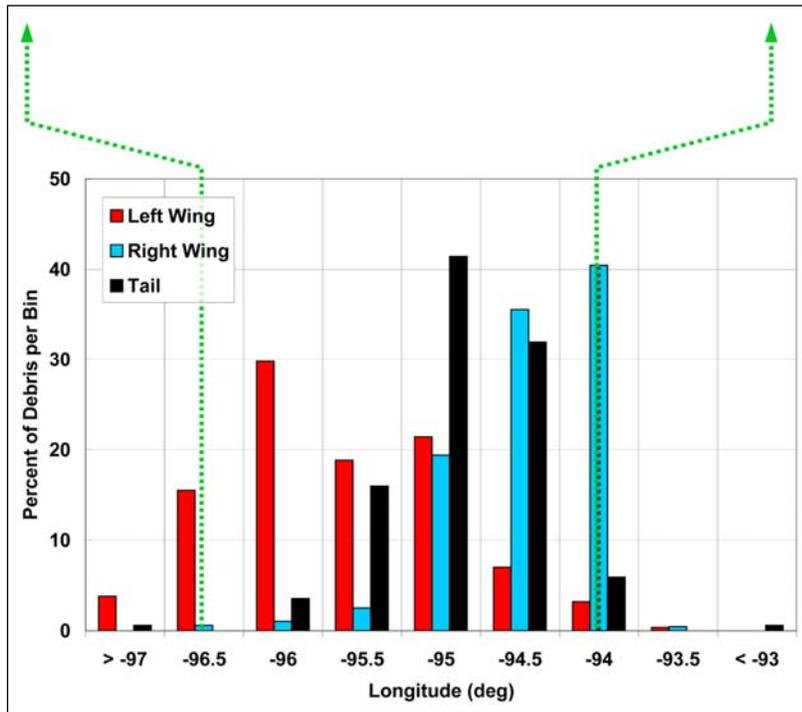
Figure 2.2-15. Histogram of the left wing, right wing, and tail debris. The green dotted lines are the projection onto the histogram of the longitude range shown in the map.

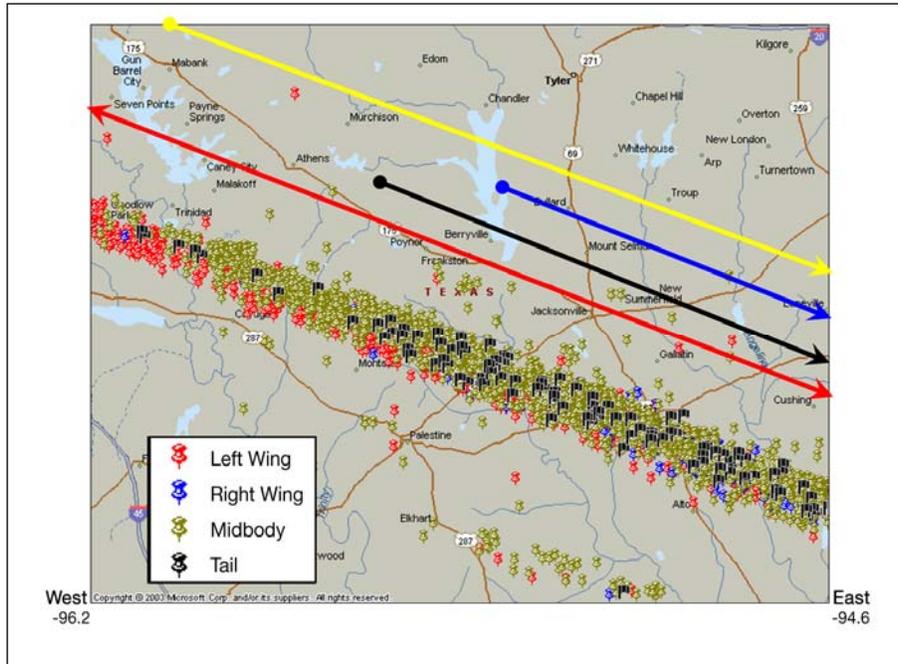
Figure 2.2-16. Partial debris field of the left wing, right wing, midbody, and tail.

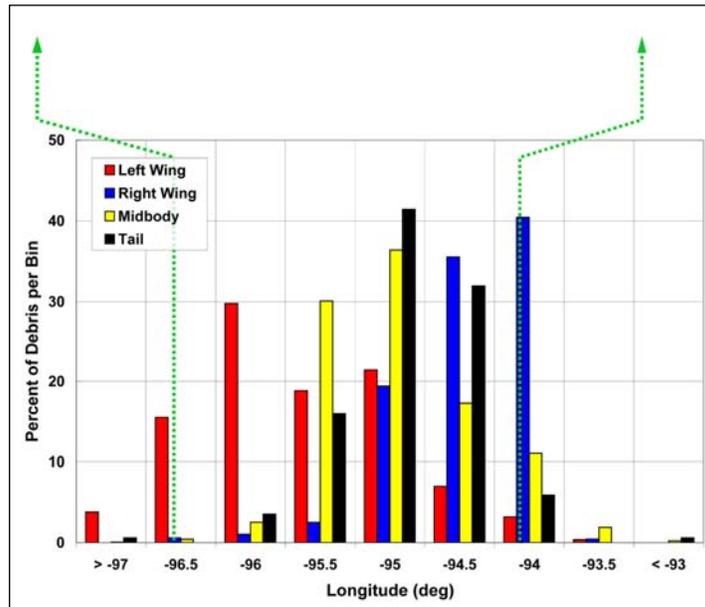
Figure 2.2-17. Histogram of the percentage of debris found vs. longitude for the left wing, right wing, midbody, and tail. The green dotted lines are the projection onto the histogram of the longitude range shown in the map.

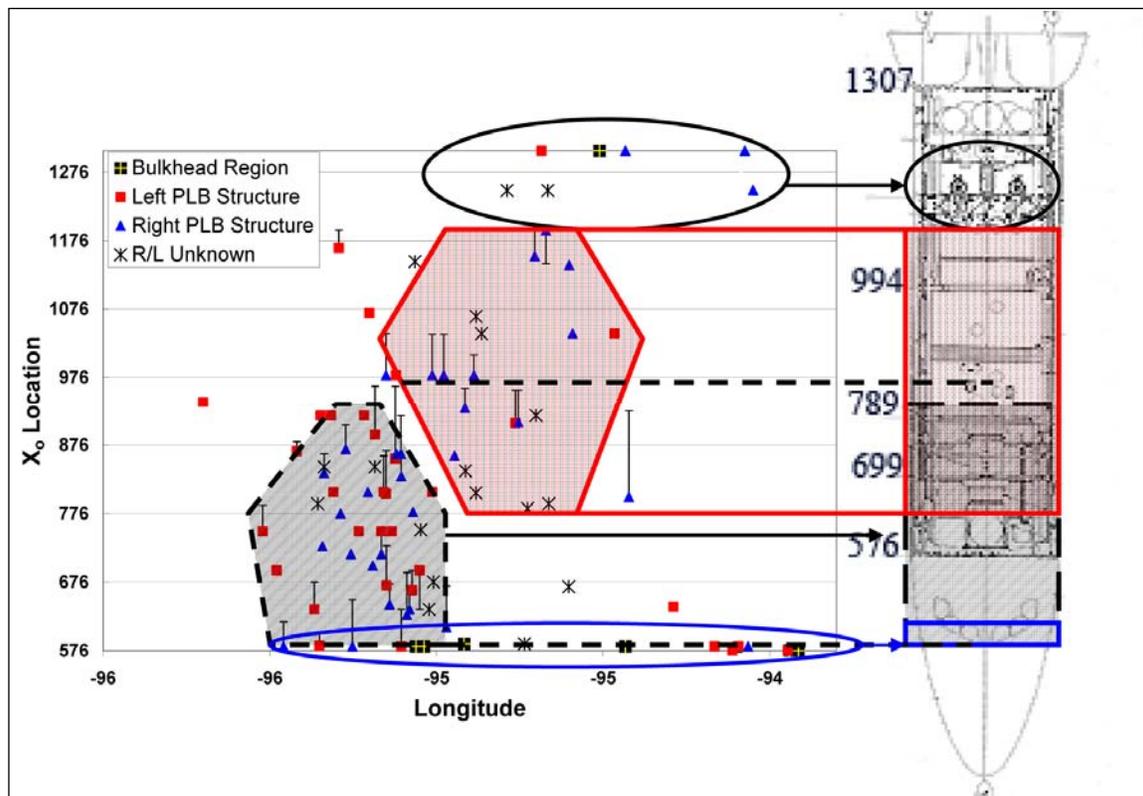
Figure 2.2-18. Longitude vs. the X_o origin of the structural debris of the mid fuselage. To the right is a drawing of the mid fuselage with key X_o positions marked.

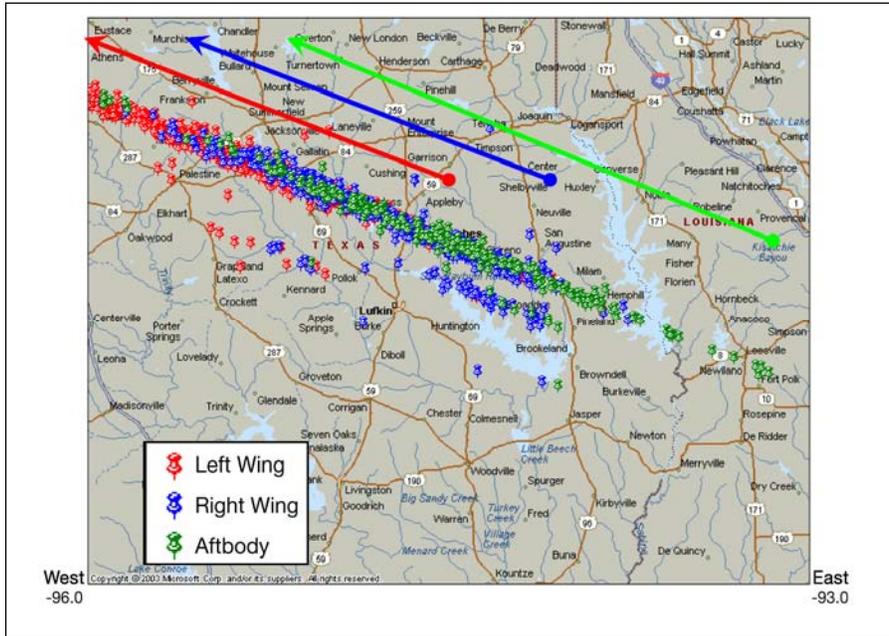
Figure 2.2-19. Partial debris field of the left wing, right wing, and aftbody.

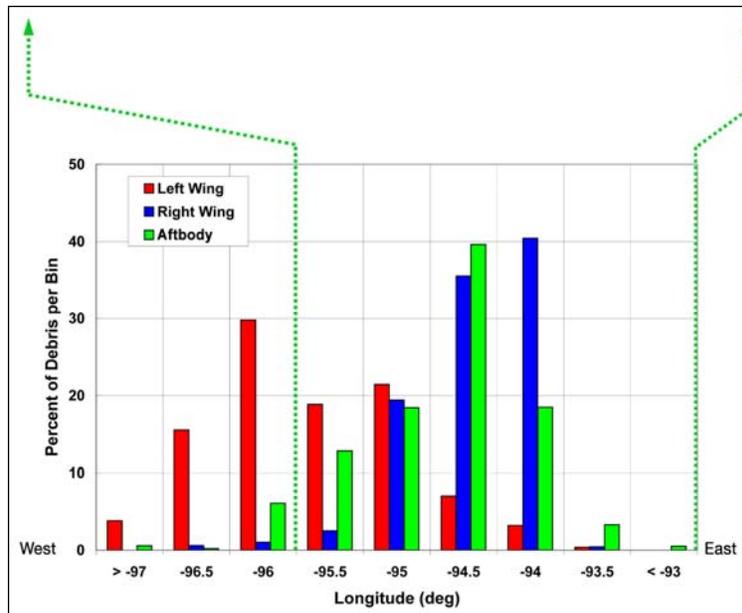
Figure 2.2-20. Histogram of debris of the wings and aftbody (including orbiter main engines). The green dotted lines are the projection onto the histogram of the longitude range shown in the map.

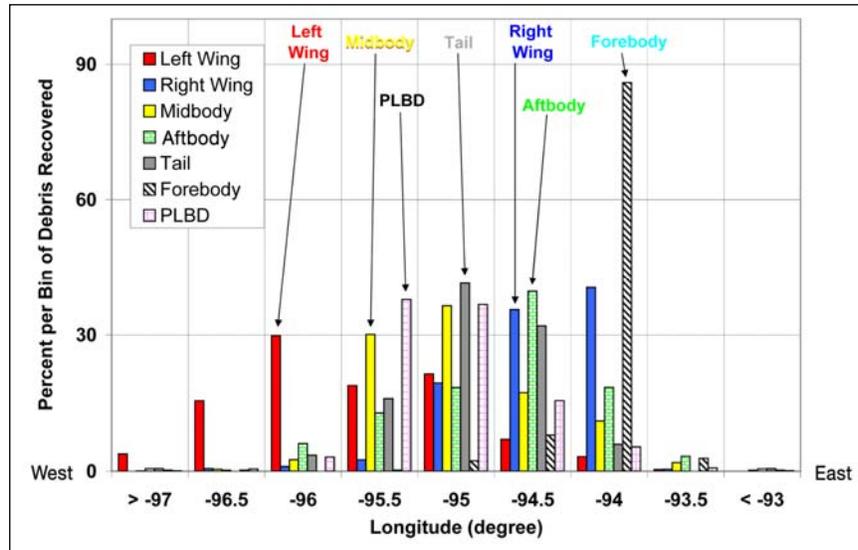
Figure 2.2-21. Histogram of the relative order of the major debris groups recovered.

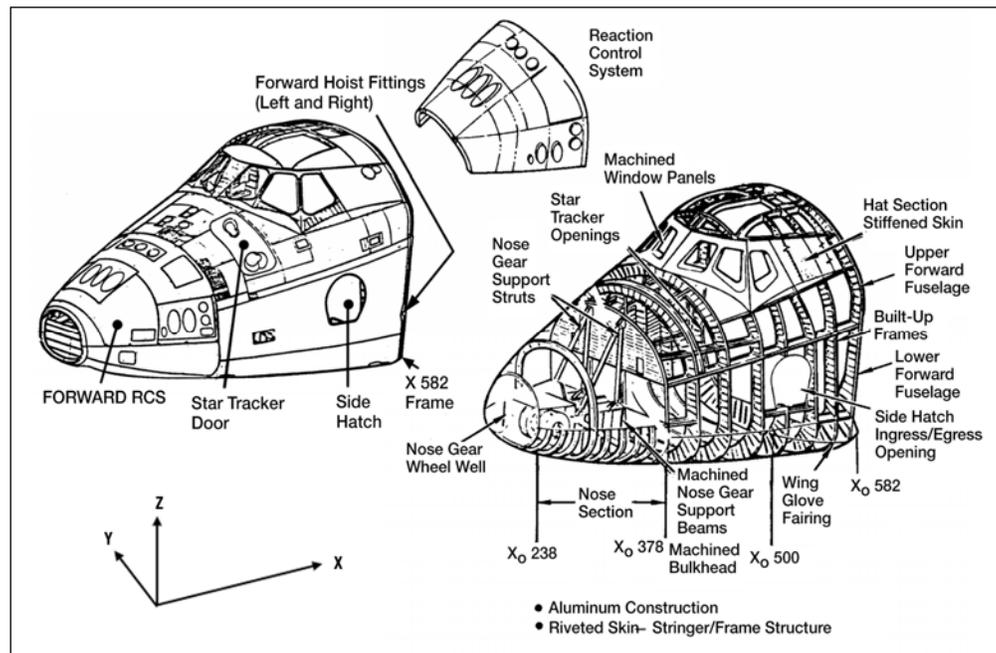
Figure 2.2-22. Forward fuselage structure.

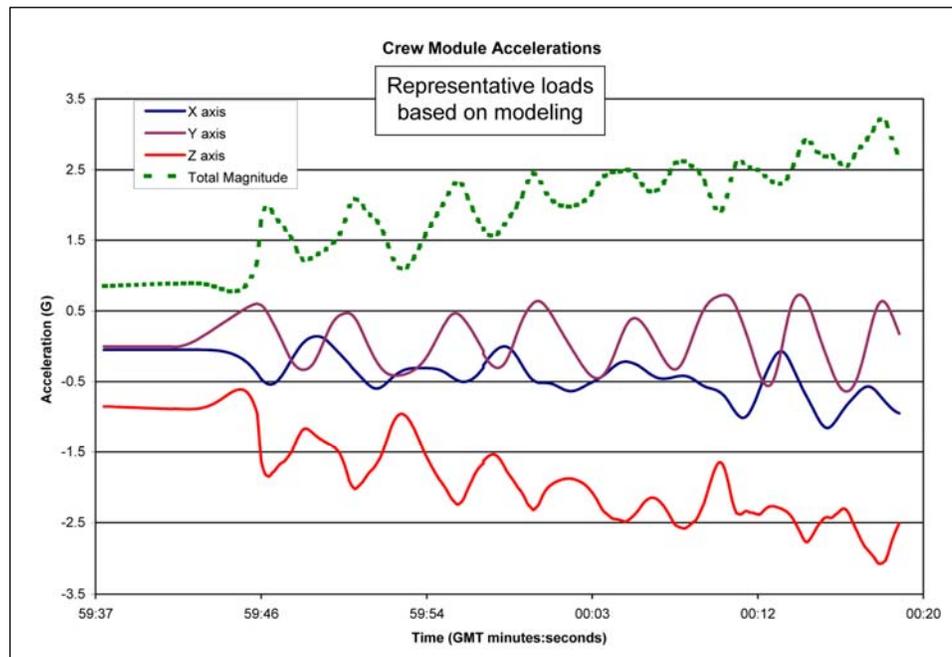
Figure 2.2-26. Resultant acceleration (G) vs. time prior to the Catastrophic Event in the orbiter coordinate frame.

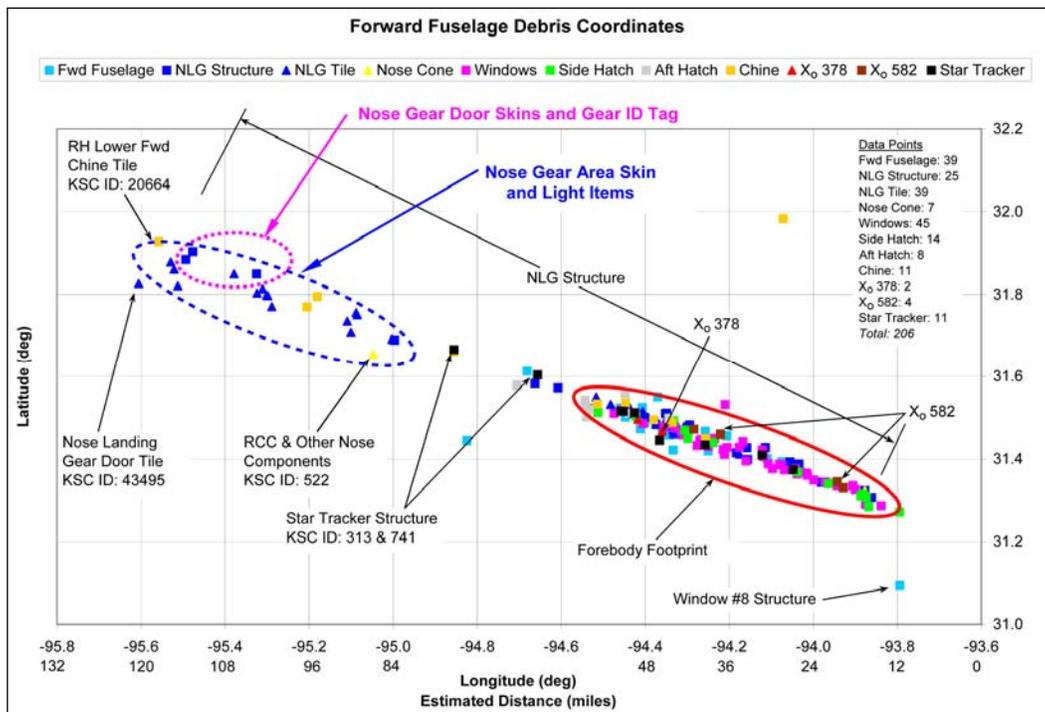
Figure 2.2-27. Forward fuselage debris field.

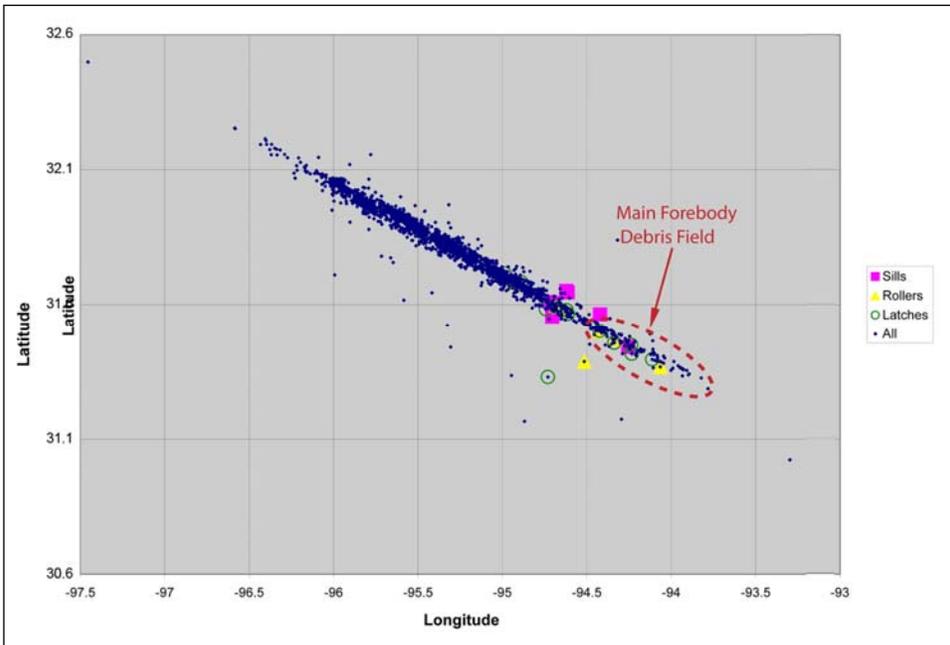
Figure 2.2-28. Payload bay door debris footprint relative to the main crew module debris field.

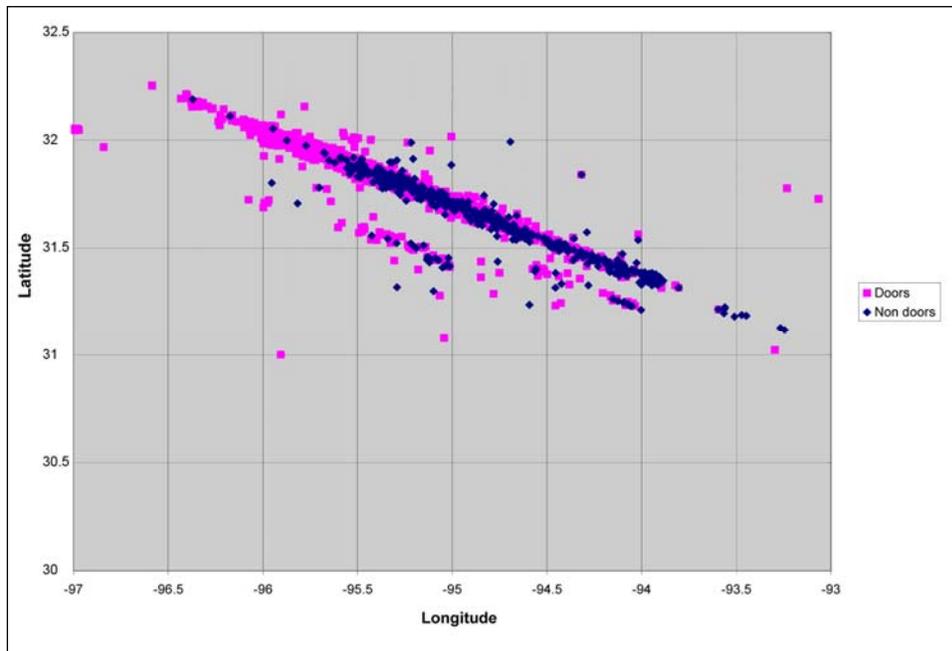
Figure 2.2-29. Payload bay door debris footprint relative to the payload bay structure.

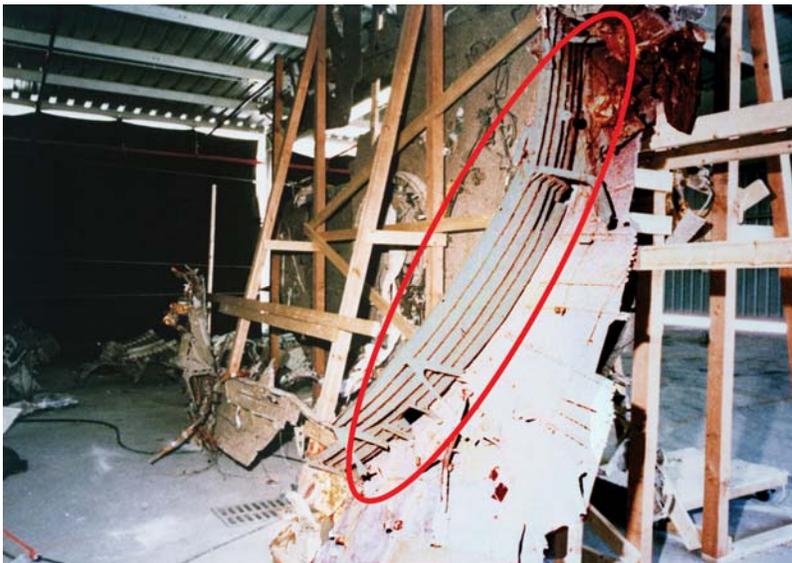
Figure 2.2-30. Recovered X_o 576 bulkhead of the *Challenger* crew module showing a portion of the X_o 582 ring frame bulkhead (circled in red).

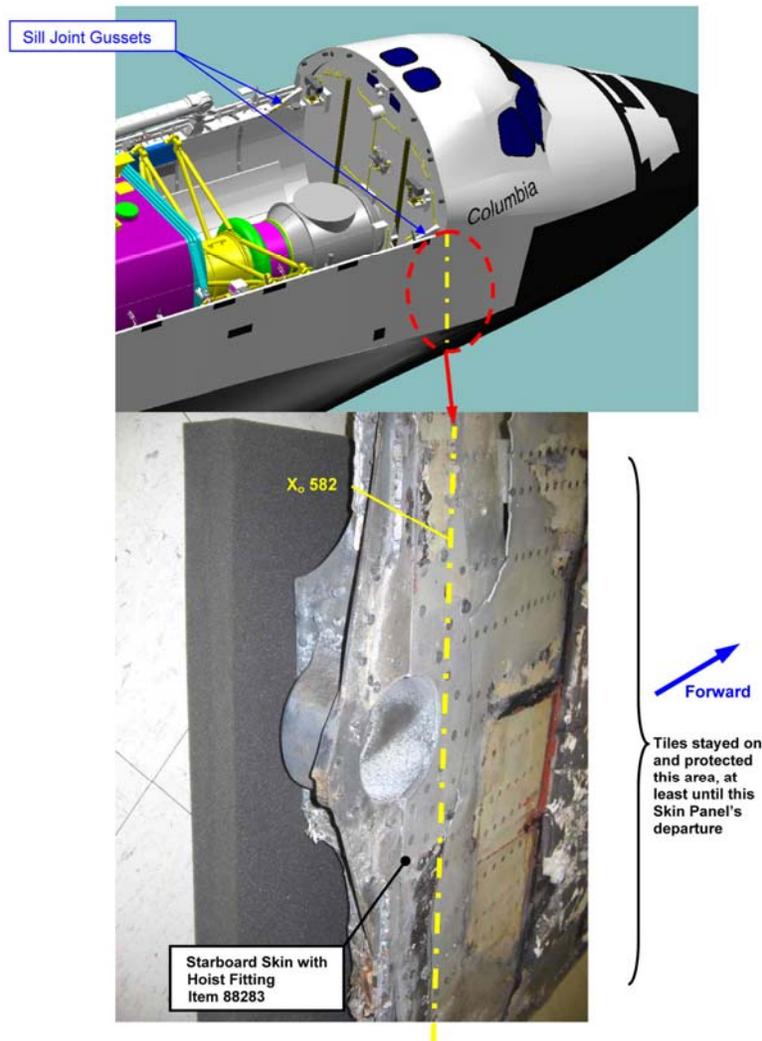
Figure 2.2-32. Forward fuselage skin still attached to the starboard hoist fitting.

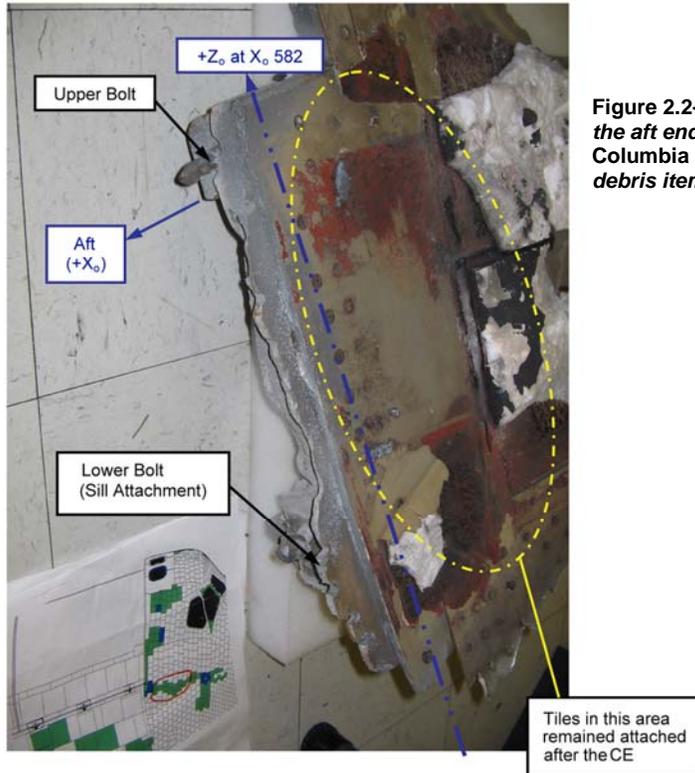
Figure 2.2-33. Thermal erosion on the aft end of the starboard-side skin, Columbia Reconstruction Database debris item no. 2436.

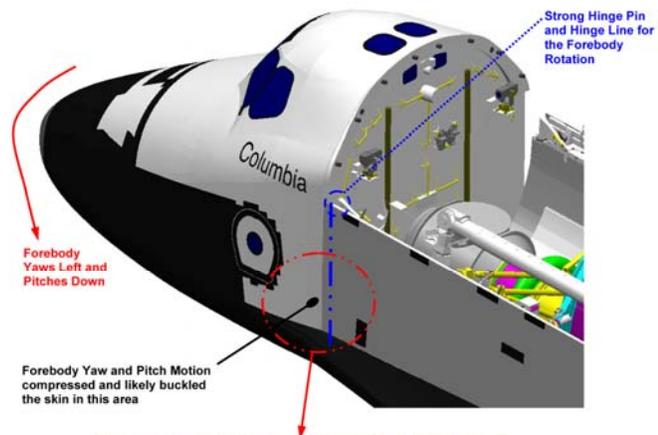
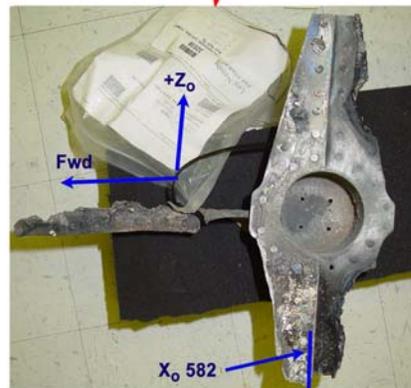
Figure 2.2-34. Forward port hoist fitting, Columbia Reconstruction Database debris item no. 32038.

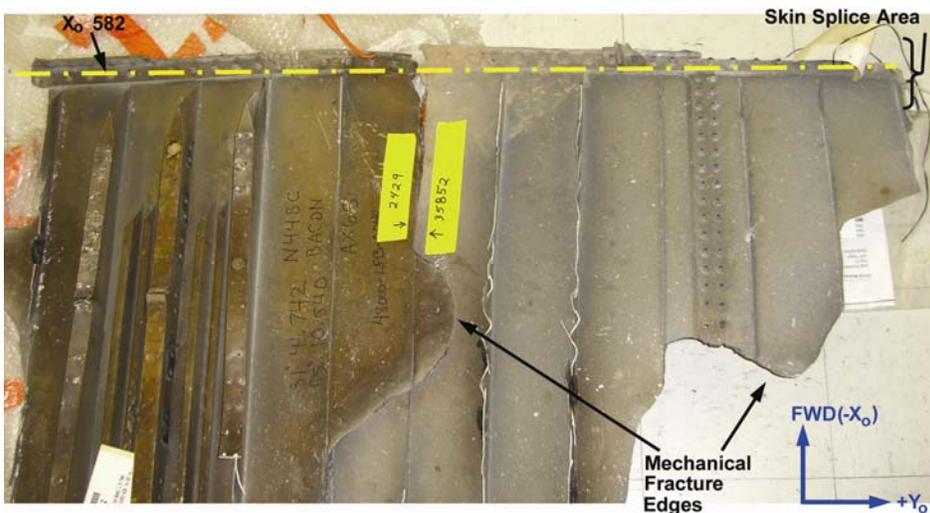
Figure 2.2-35. Bay 1 midbody bottom skin, Columbia Reconstruction Database debris item nos. 2429 and 33852.

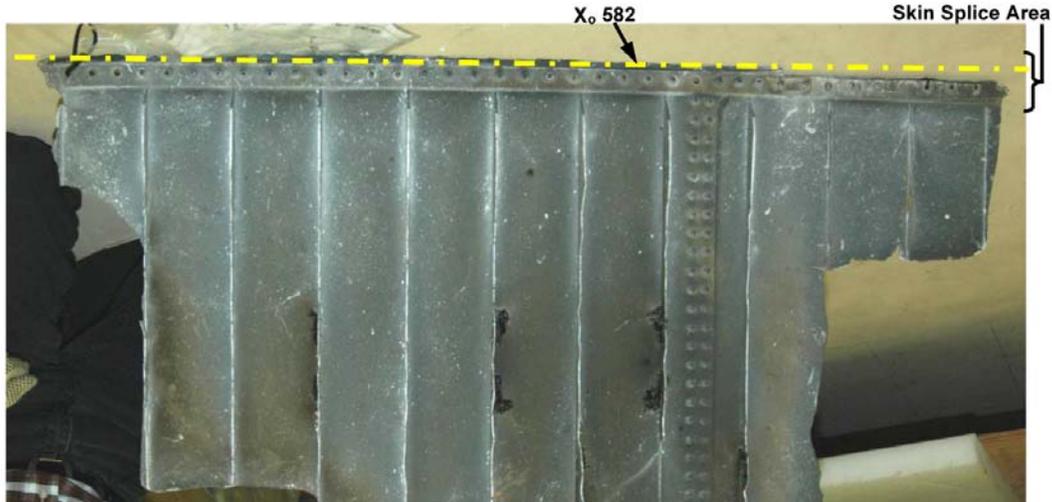
Figure 2.2-37. Bay 1 midbody skin, Columbia Reconstruction Database debris item no. 14908.

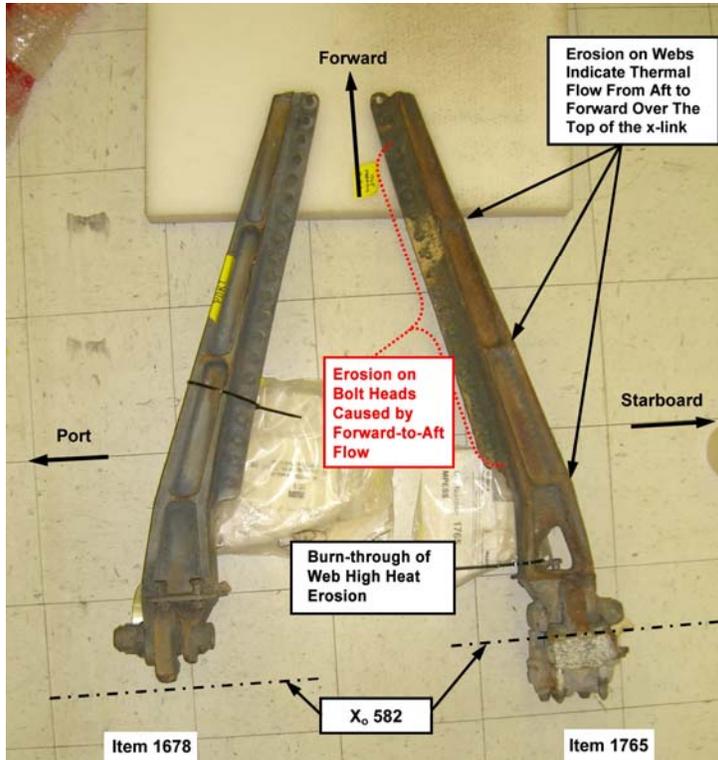
Figure 2.2-38. Port and starboard x-links.

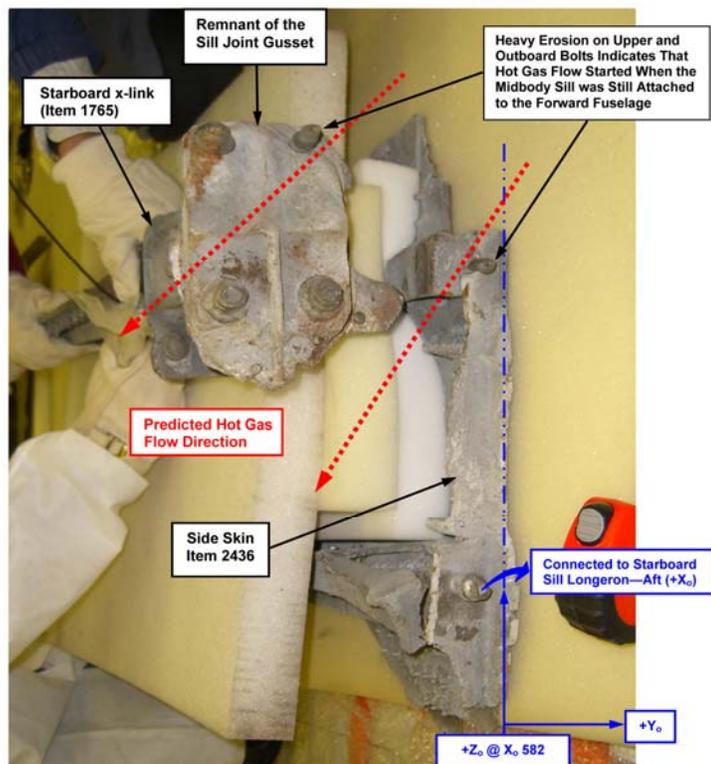
Figure 2.2-39. View looking forward at the starboard x-link and side skin.

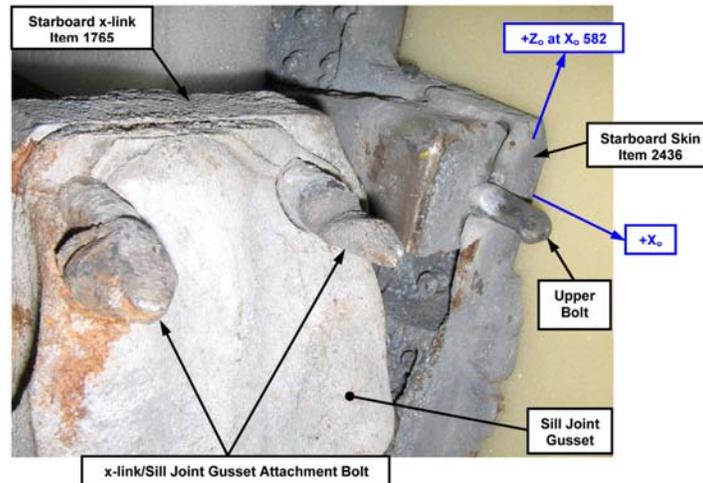
Figure 2.2-40. Detail of thermal erosion on the upper bolts at the starboard x-link and skin.

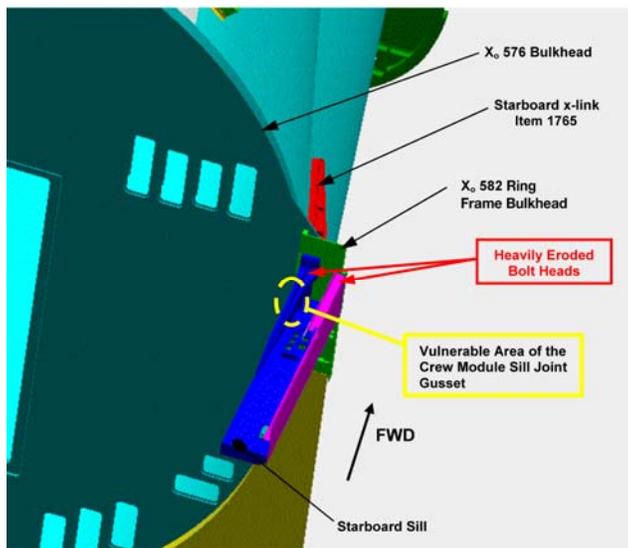
Figure 2.2-41. Weak links – sill joint gusset, starboard side.

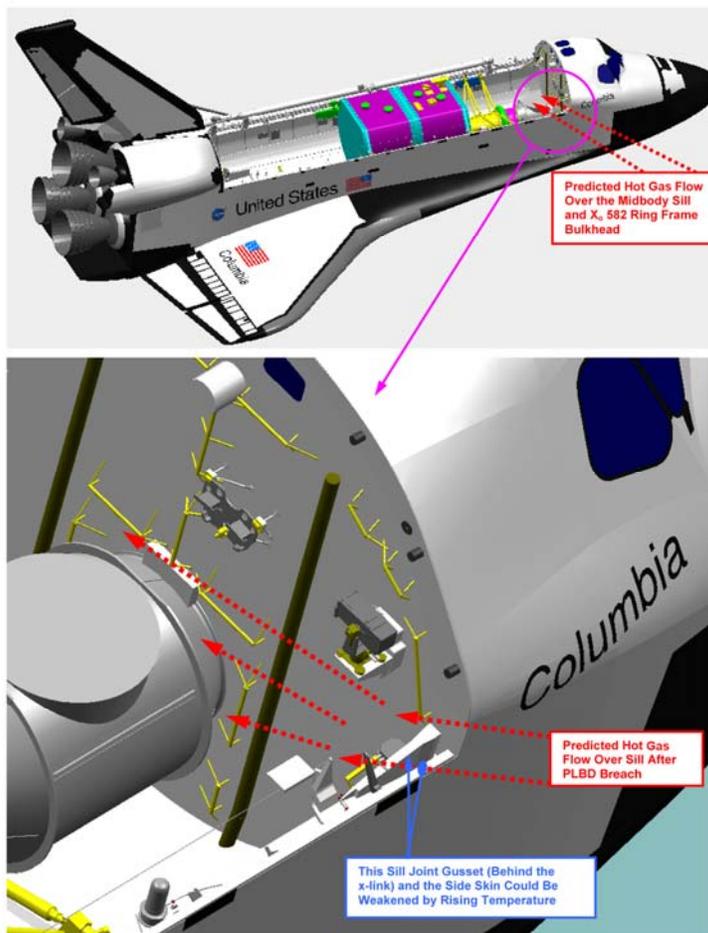
This thermal degradation could have occurred prior to the CE if the PLBDs departed or were compromised in that area (figure 2.2-43). Debris evidence shows that the starboard sill joint experienced more thermal damage than the port sill joint. This suggests the possibility that rising temperature on the starboard sill area weakened the sill joint until it failed mechanically. Although orbiter motion generally resulted in “belly-into-the-wind” orientation (see Section 2.1), with the large pitch and roll oscillations hot gas could flow beyond the belly of the orbiter, up and over the sill. However, hot gas exposure to the sill area could only be short and intermittent (<3 seconds at a time). Debris field and ballistic assessment of PLBD debris is inconclusive. However, a local failure or compromise on the starboard PLBD near the sill could have resulted in this scenario without evidence being apparent in these assessments.

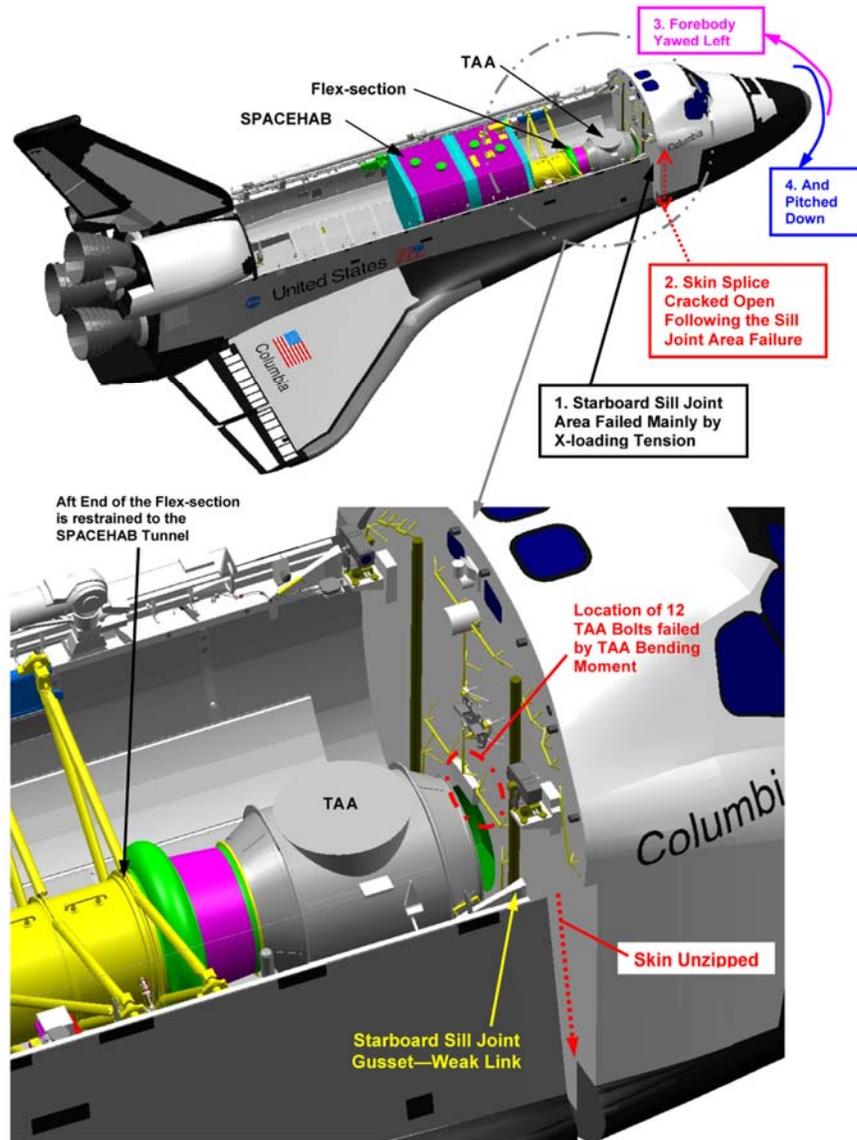
Figure 2.2-44. Forebody departed the midbody at the Catastrophic Event.
