Columbia Crew Survival Investigation Report

NASA/SP-2008-565

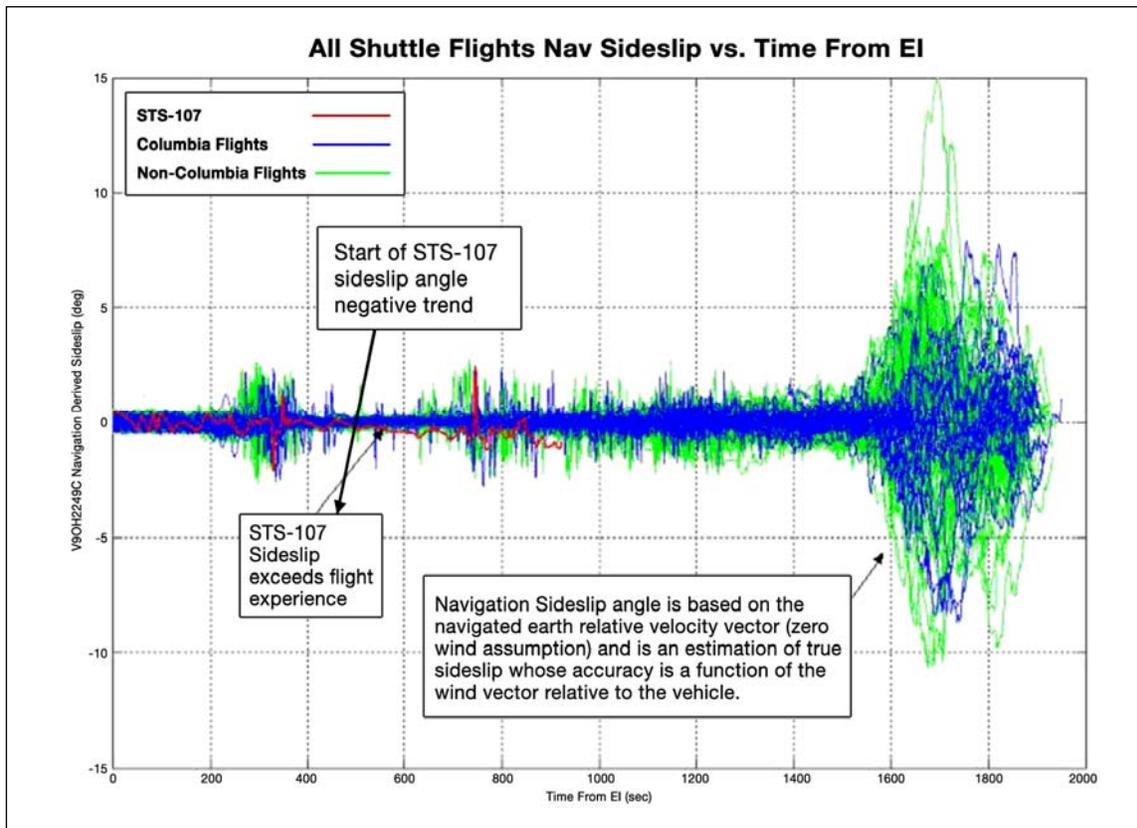
Figure 1.1-10. Negative trend starts at GMT 13:51:46 (EI+457) and exceeds flight experience at GMT 13:53:38 (EI+569).¹¹

At GMT 13:53:38 (EI+569), the sideslip angle (left yaw) exceeded all previous flight experience (figure 1.1-10).

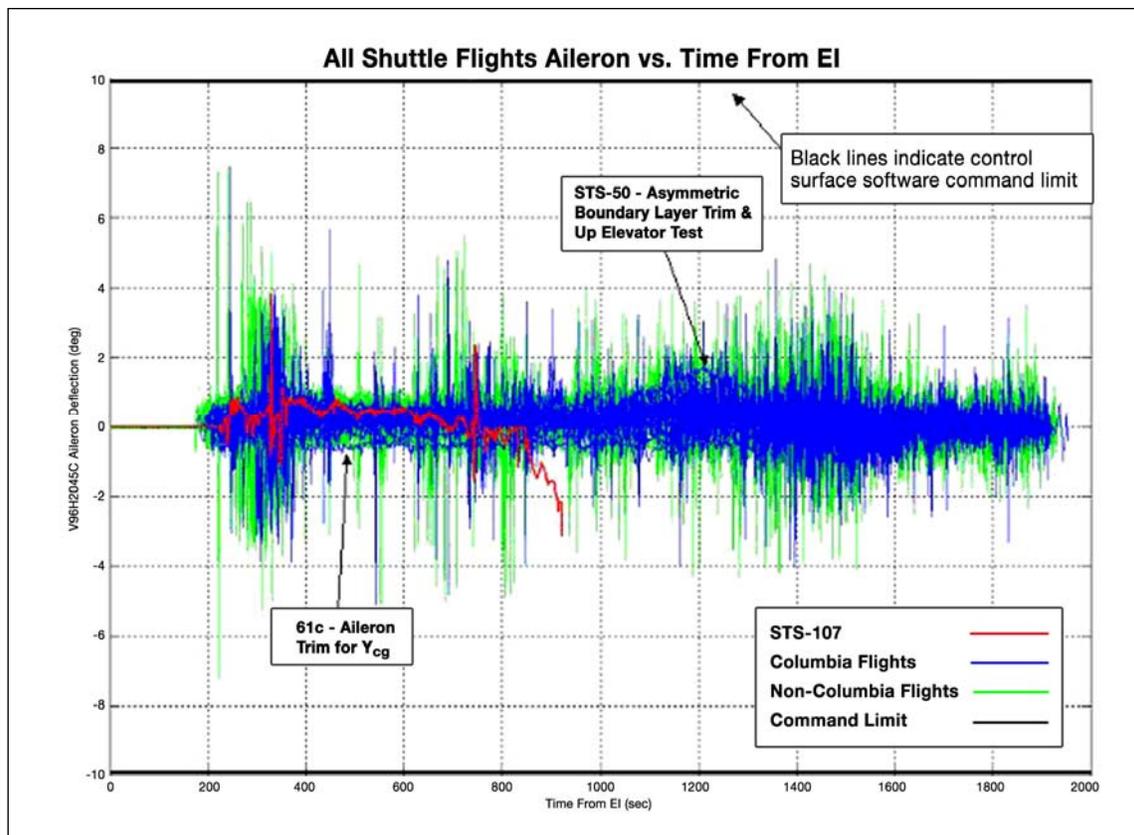
Figure 1.1-11. The sharp divergence from previous flight experience starts at approximately GMT 13:58:19 (EI+850).¹²

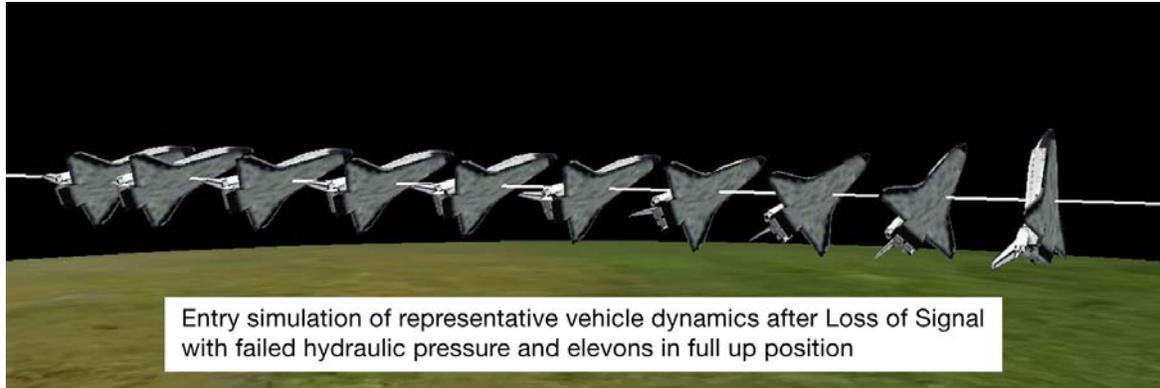
This section discusses key events that affected the crew from LOS at GMT 13:59:32 (EI+923) to the CE, which began at 14:00:18 (EI+969) (figure 1.1-19). During this period of time at about GMT 13:59:37 (EI+928), loss of control (LOC) of *Columbia* occurred. LOC marks the beginning of the transition from controlled flight to an uncontrolled ballistic entry. This phase is 46 seconds long.

Figure 1.1-20. Sequence (1-second intervals) showing a simulation of orbiter loss of control pitch-up from GMT 13:59:37 (EI+928) to GMT 13:59:46 (EI+937). White line indicates vehicle trajectory relative to the ground.

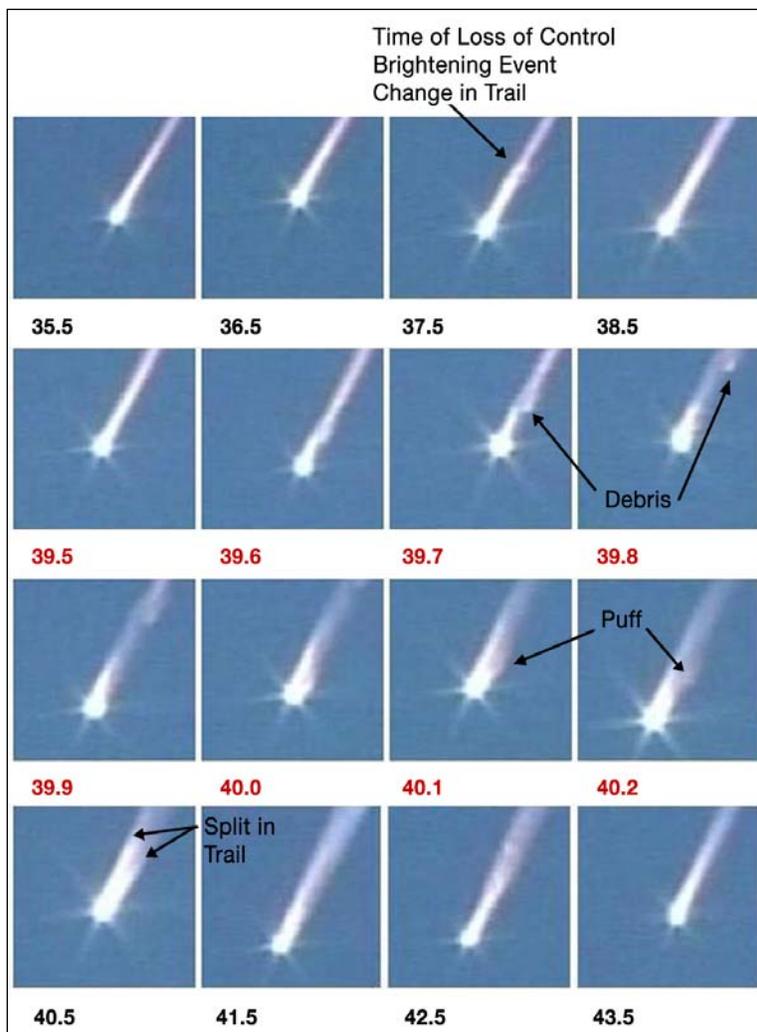
Figure 1.1-21. Video frame captures from ground-based video, beginning at GMT 13:59:35.5 (EI+926) and ending at GMT 13:59:43.5 (EI+937). The numbers below each frame indicate the seconds after GMT 13:59:00. The frames in the first and last rows are 1 second apart. The frames in the second and third rows are 0.1 second apart.

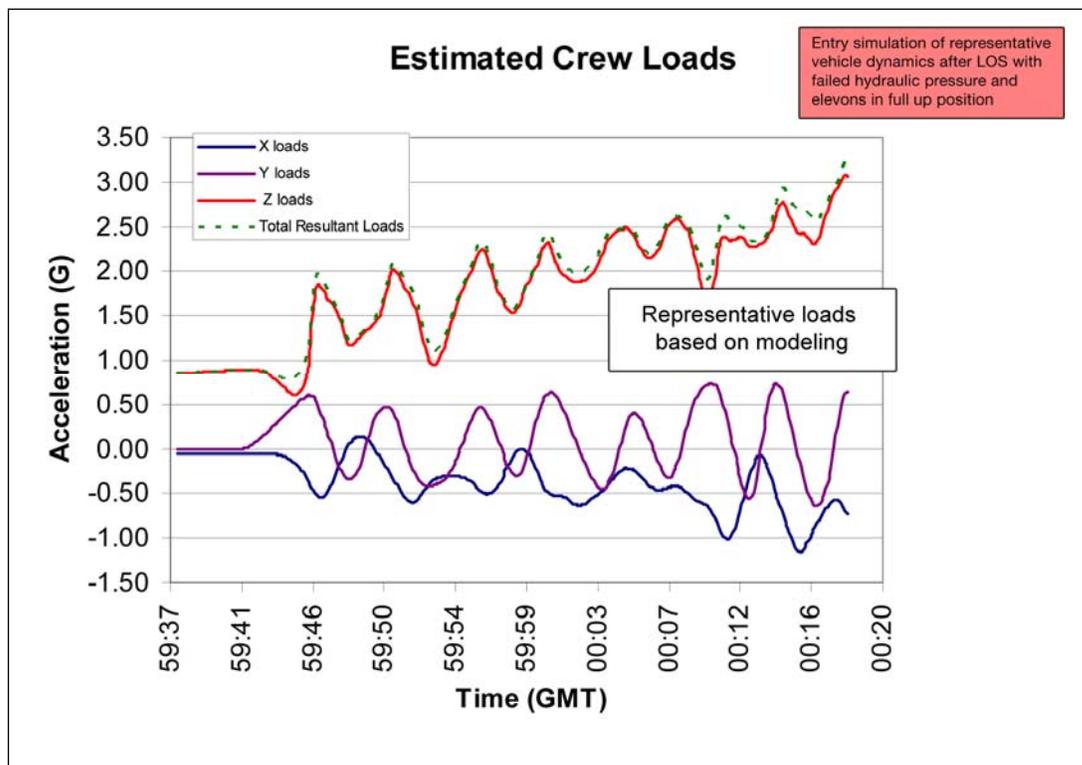
Results of a shuttle LOC simulation show that the motion of the orbiter in this timeframe is best described as a highly oscillatory slow (30 to 40 degrees per second) flat spin, with the orbiter's belly generally facing into the velocity vector. It is important to note that the velocity vector was still nearly parallel to the ground as the vehicle was moving along its trajectory in excess of Mach 15. The crew experienced a swaying motion to the left and right (Y-axis) combined with a pull forward (X-axis) away from the seatback. The Z-axis accelerations pushed the crew members down into their seats. These motions might induce nausea, dizziness, and disorientation in crew members, but they were not incapacitating. The total acceleration experienced by the crew increased from approximately 0.8 G at LOC to slightly more than 3 G by the CE (figure 1.1-22).

Figure 1.1-22. Resultant acceleration (G) vs. time prior to Catastrophic Event in the crew coordinate frame from the aerodynamic simulation model.

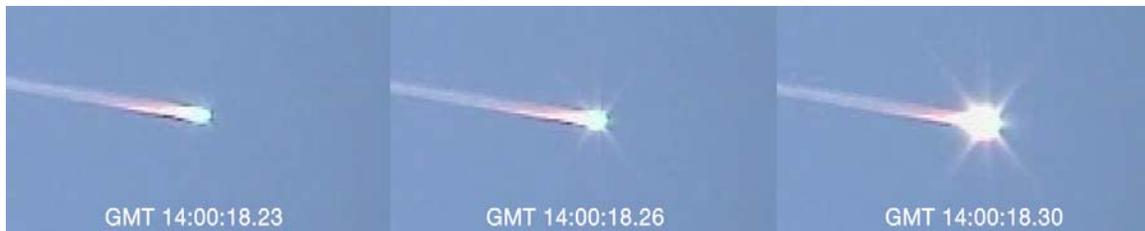
At GMT 14:00:18 (EI+969), video showed that a significant event (the CE) occurred to the orbiter (figure 1.1-24). The GPS Miniaturized Airborne Global Receiver (MAGR) experiment, which was located in the middeck and powered by a fuel cell in the payload bay, experienced a loss of power at the CE. Less than 1 second later, the MADS/OEX recorder, which was also located in the crew module and similarly powered from the payload bay, also experienced a total power loss. The conclusion was that the forward and midbody orbiter segments separated at the CE. The CE is actually the start of a period of several seconds in which the orbiter underwent a major structural breakup. At GMT 14:00:25 (EI+976), there were visual indications that the orbiter was in multiple pieces. Ballistics analysis and structural debris analysis supports this period as the breakup event.

Figure 1.1-24. The Catastrophic Event is depicted in these three frames of video that cover 0.1 second. There is no change in the magnification/zoom factor. The third frame represents GMT 14:00:18.3 (EI+969).

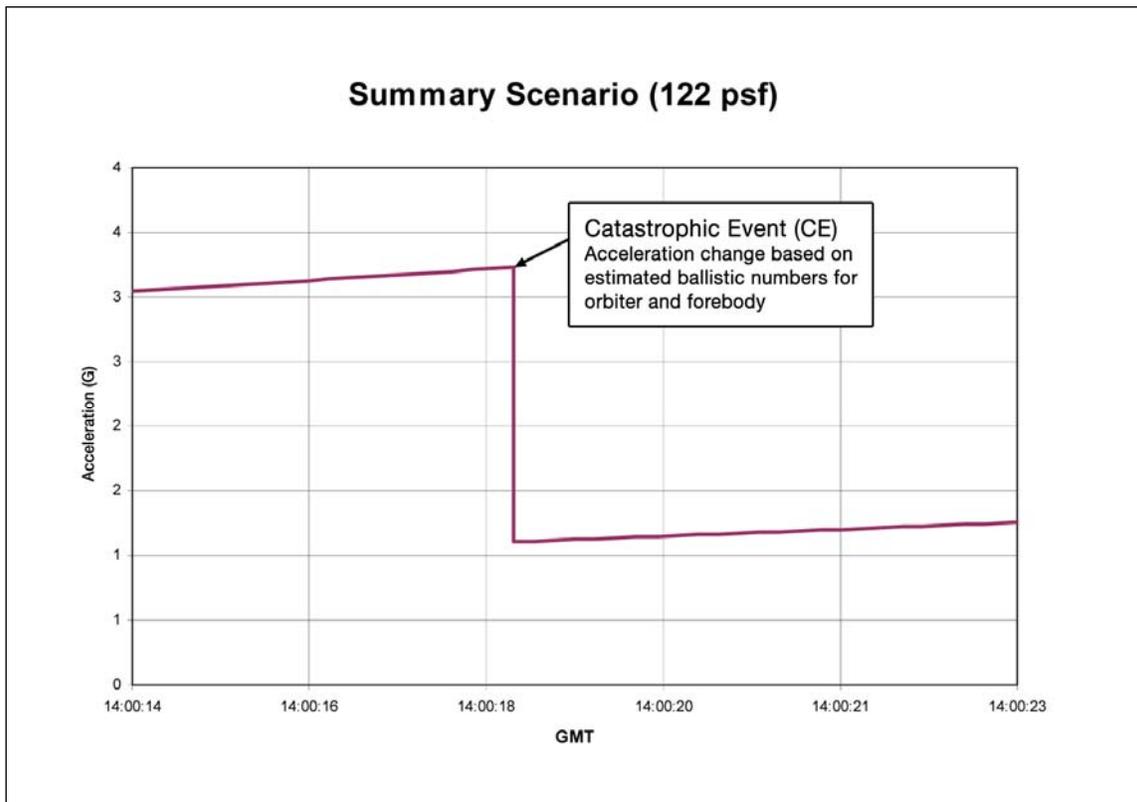
As the forebody broke free from the rest of the orbiter, its ballistic number underwent a sharp change from an average ballistic number of 41.7 pounds per square foot (psf) (out of control intact orbiter) to 122 psf (free-flying forebody). The aerodynamic drag of the forebody instantaneously decreased, resulting in a reduction in the translational deceleration from approximately 3.5 G to about 1 G (figure 1.1-27).

Figure 1.1-27. Estimated change in total G experienced by the forebody due to a change in ballistic number from the orbiter breakup.

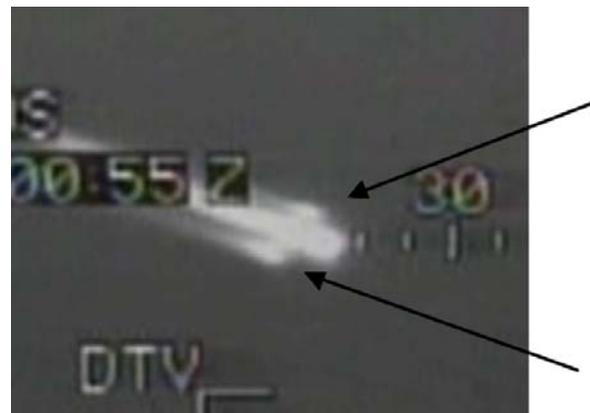
Figure 1.1-30. Video frame from the Apache video at GMT 14:00:55 (EI+1006) showing two similar luminosity objects separating from the forebody.

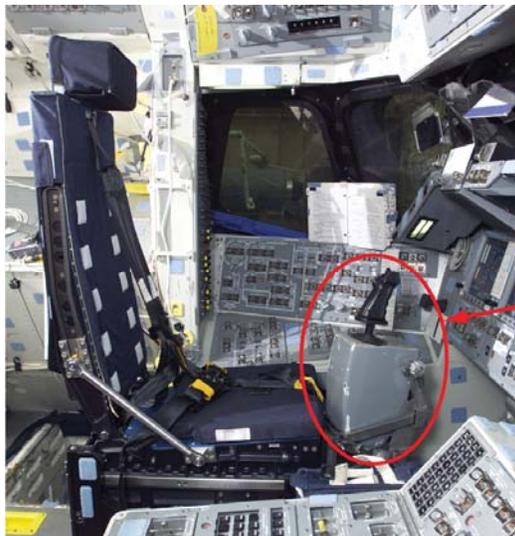
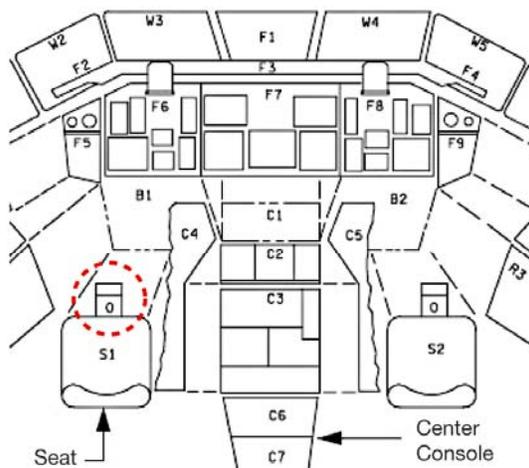
Between GMT 13:36:04 (EI-485) and GMT 13:36:06 (EI-483), the CDR/Seat 1 is performing entry preparation actions that lead to the RHC being bumped (figure 1.2-6).

Figure 1.2-6. Location of Commander’s seat and rotational hand controller. [Left picture from the Shuttle Training Simulator looking from starboard to port; right picture adapted from the Space Shuttle Systems Handbook looking from aft to forward]

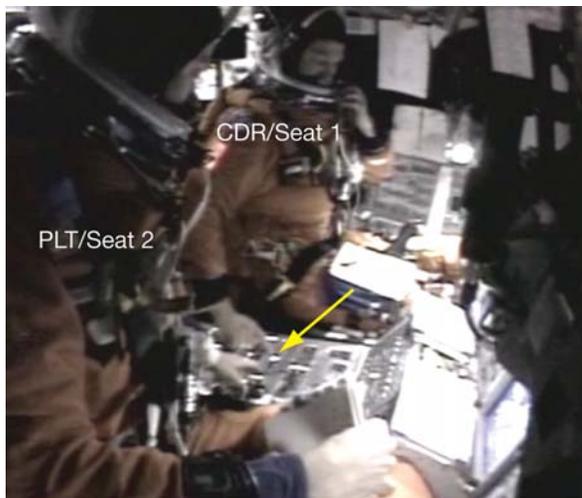
DAP DNMODE RHC. Primary Avionics Software System (PASS) DAP DOWNMODE RHC (time from telemetry analysis). The message indicates that the RHC movement in the previous event was sufficient to mode the DAP out of AUTO into Inertial mode. When this occurs, a “DAP DOWNMODE RHC” caution and warning message is displayed, the INRTL button on the C3 panel is illuminated (see arrow in figure 1.2-7), and a tone, which can be heard in the recovered video tape, is annunciated (figure 1.2-7).

Figure 1.2-7. Digital autopilot button on the C3 panel is illuminated.

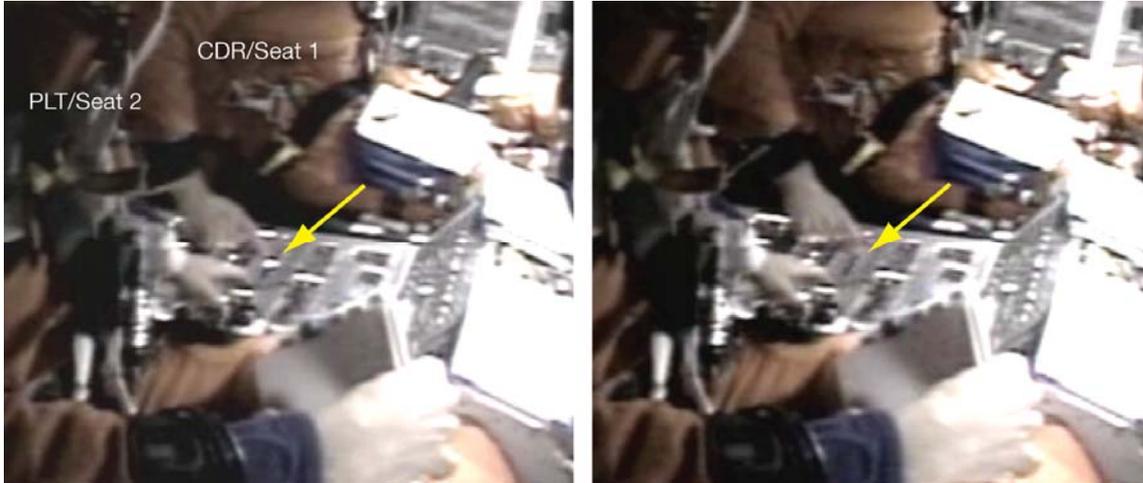
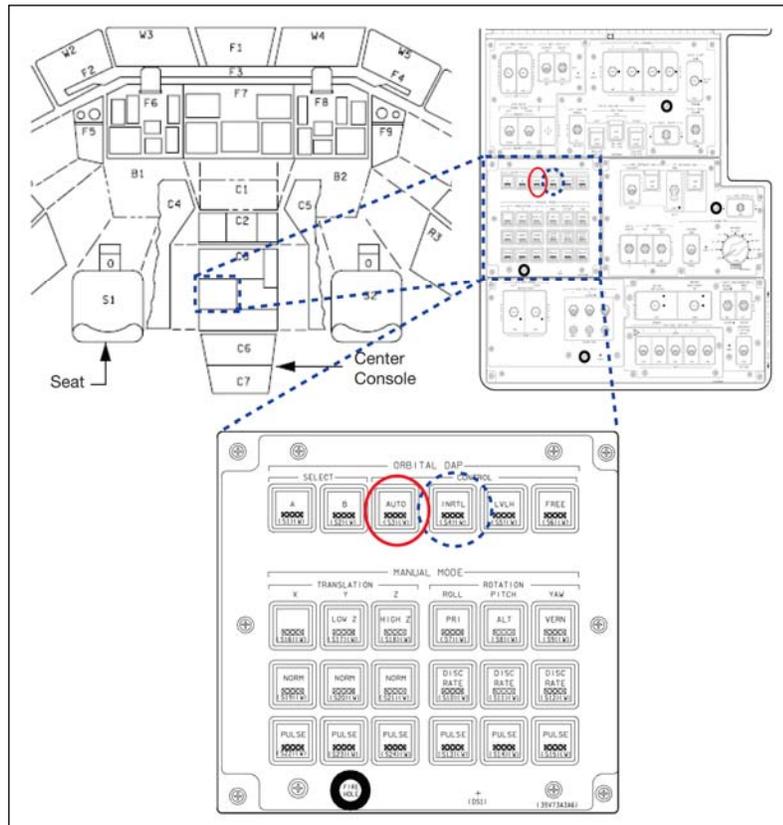
CDR/Seat 1 responds to the DAP DOWNMODE RHC message by pressing the illuminated AUTO button on the C3 panel to restore the DAP to AUTO (figures 1.2-8 and 1.2-9).

Figure 1.2-8. Digital autopilot is no longer in AUTO, INRTL light is ON (left figure); Commander/Seat 1 restores digital autopilot to AUTO, INRTL light is OFF (right figure).

Figure 1.2-9. Location of the “INRTL” button (blue circle) that illuminated when the digital autopilot moded out of AUTO, and the “AUTO” button (red circle) that the Commander pressed to restore the digital autopilot to AUTO. [Adapted from the Space Shuttle Systems Handbook]

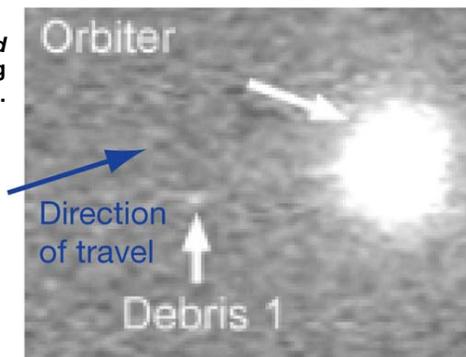
First Observed Incident of Debris Being Shed. This is most likely a piece of the left wing. Debris 1 is seen just aft of the orbiter envelope 1 second after a trail anomaly that consisted of a noticeably luminescent section of the plasma trail. There were no reported entry observations while Columbia was over the Pacific Ocean prior to GMT 13:53:15 (EI+546), so it is

not possible to know whether debris was being shed before this time. Image of Debris 1 is 0.6 second after first visual detection of it. Analysis indicates that the mass of the debris was probably less than 8 lbs. Neither the crew nor MCC personnel were aware of the shedding events (blue arrow shows direction of flight) (figure 1.2-24).

Figure 1.2-24. Video capture of the first observed incident of debris being shed. The orbiter is traveling from left to right in this image.

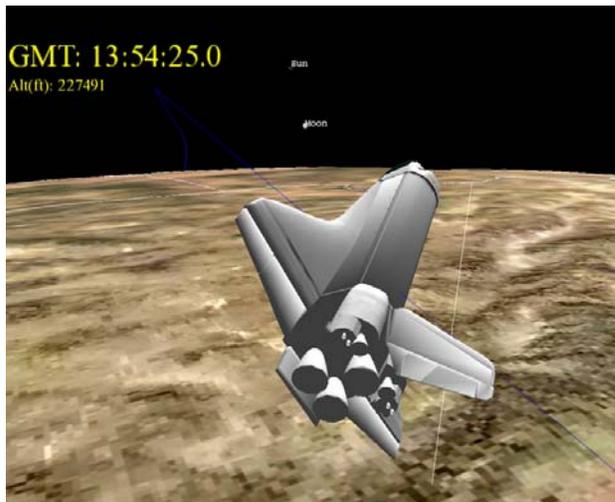
Columbia crosses the California-Nevada border. [Master Timeline, Rev. 15 Baseline] (figure 1.2-26).

Figure 1.2-26. Columbia crossing the California-Nevada border.

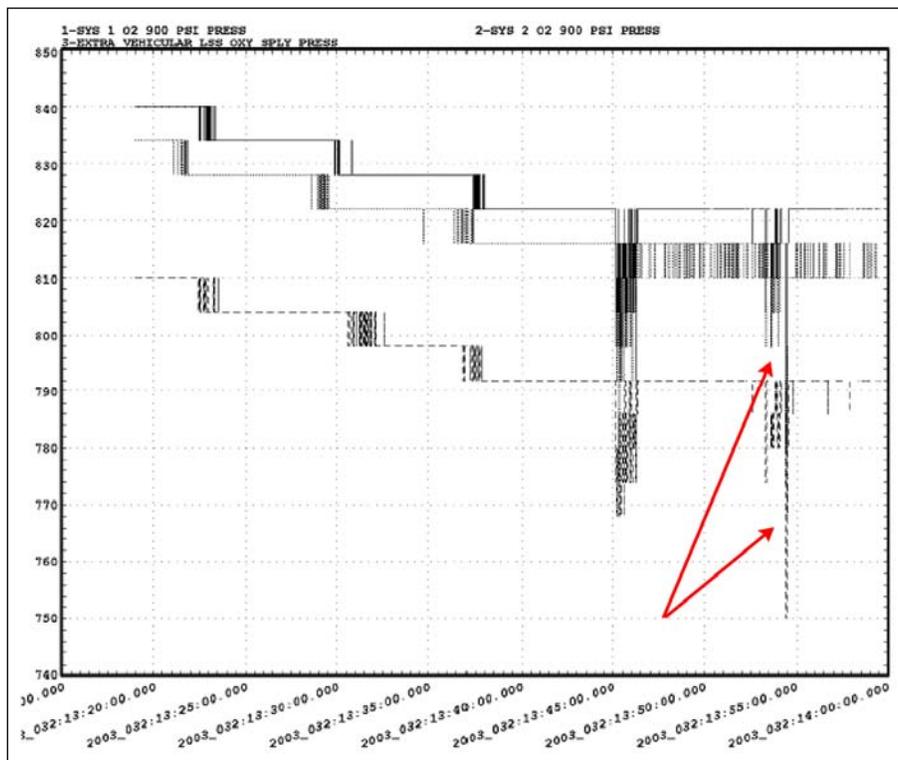
Indication of a second suit pressure check by three to five crew members (figure 1.2-27).

Figure 1.2-27. Plot of main oxygen supply pressure showing second series of suit pressure checks (red arrows).

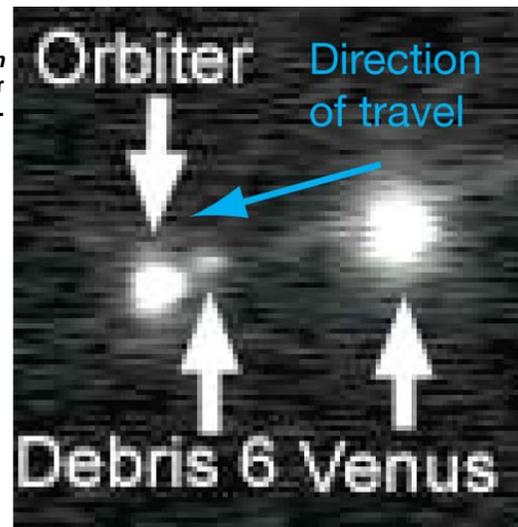
Debris 6 released. The brightest debris-shedding event occurring in this phase, Debris 6, is first visible on video at GMT 13:54:36 (EI+627) (figure 1.2-28). Ballistic estimates determined that the actual release time was 4 seconds earlier. Luminosity measurements and calculated rates of deceleration were used to determine that the mass was probably a few hundred pounds. ⁷ There were no data from sensors, instrumental indications, or apparent crew recognition of this debris loss.

Figure 1.2-28. The brightest debris event known to have occurred prior to loss of signal. The orbiter is traveling from right to left.

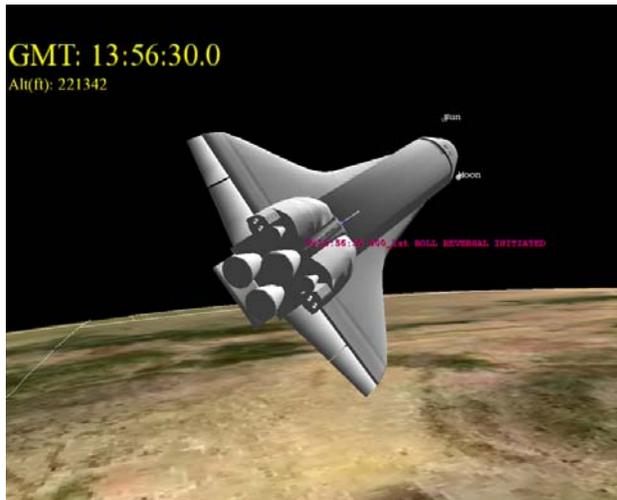
Figure 1.2-29. Attitude at the start of the roll reversal.

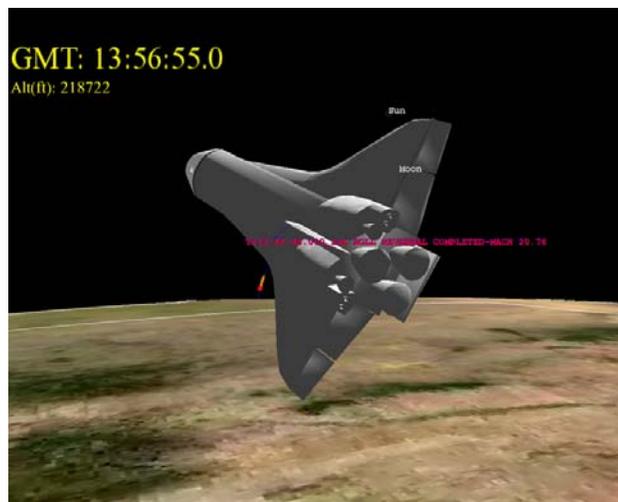
First Roll Reversal Completed. Left wing low (figure 1.2-30).

Figure 1.2-30. Attitude at the completion of the roll reversal.

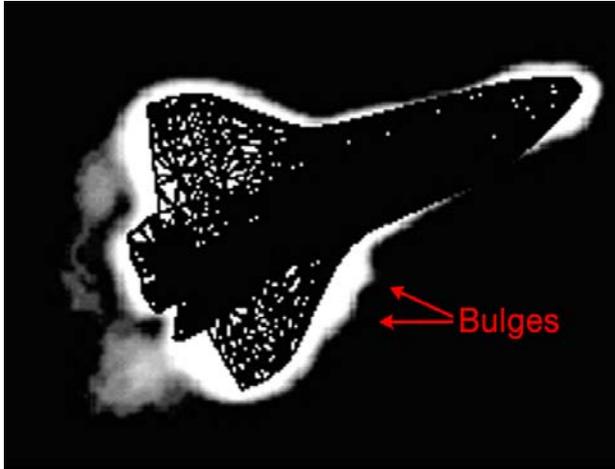
(as marked) at the left wing could not be explained by a nominal condition (figure 1.2-31).

Figure 1.2-31. *Infrared photograph of the shuttle during entry.*⁸

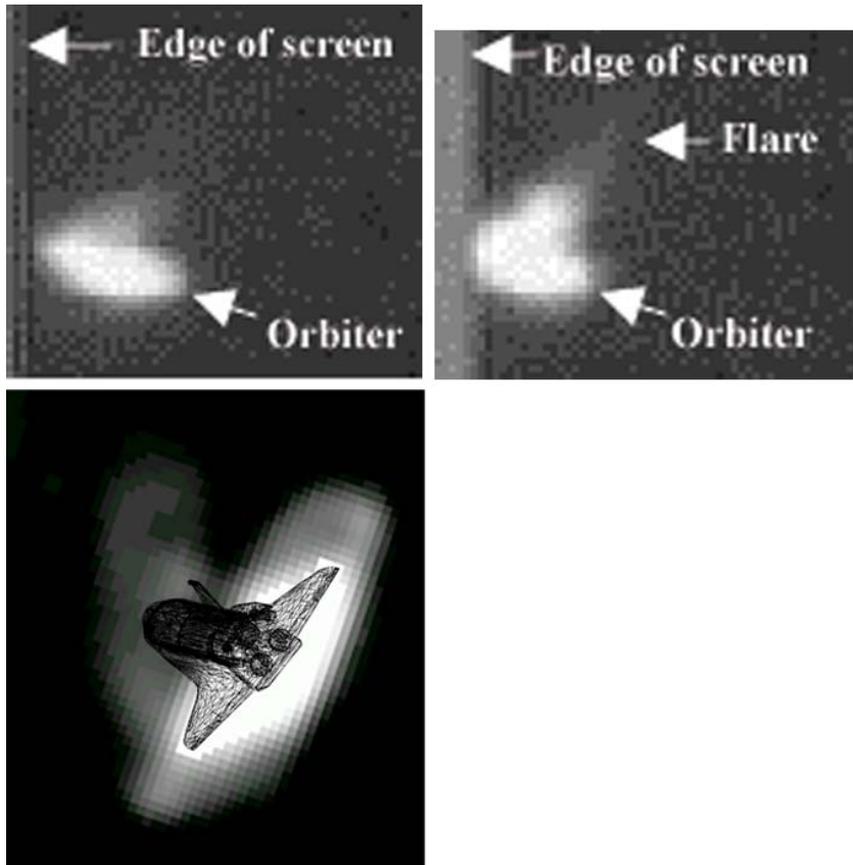
Flare 1 is an asymmetrical brightening of the orbiter shape at GMT 13:57:54.7 (EI+825) ±1 sec. This brightening was detected in images taken by a charge coupled device camera on a telescope, so its image is well magnified. Another brightening event was detected 6 seconds later (see GMT 13:58:00 (EI+831)). The two small images are the raw images from the data. The left image is interpreted to be the orbiter in a nominal condition. The image on the right is 0.4 second later. The larger image has been rotated to its correct viewing orientation and enhanced; a wireframe model of the orbiter at approximately the correct scale and orientation has been overlaid (figure 1.2-32).

Figure 1.2-32. Enhanced video captures showing the first observed flare in the trail.⁹

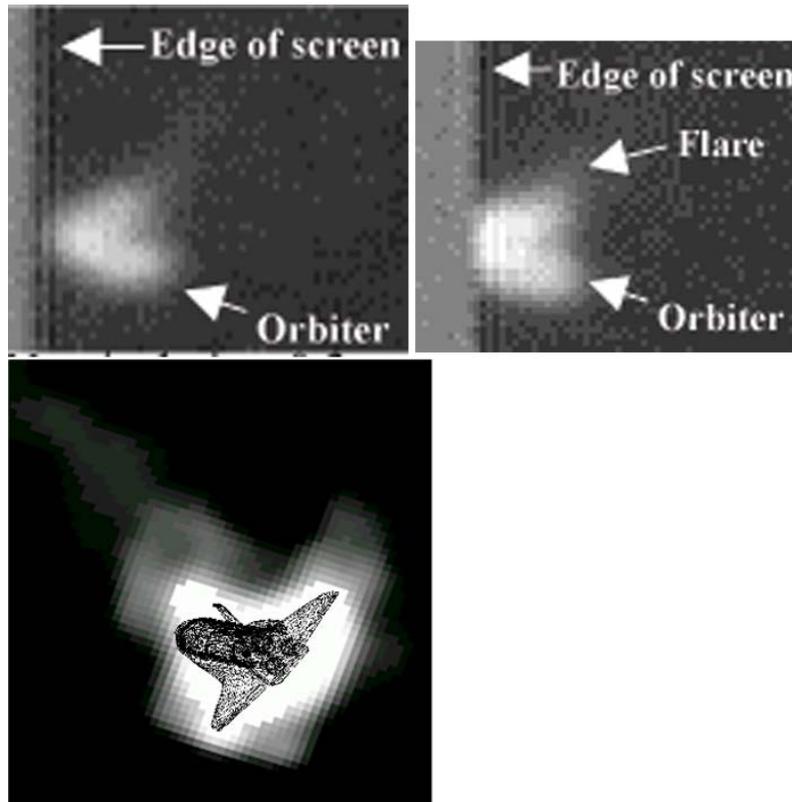
Figure 1.2-33. Enhanced video captures showing the second observed flare in the trail.

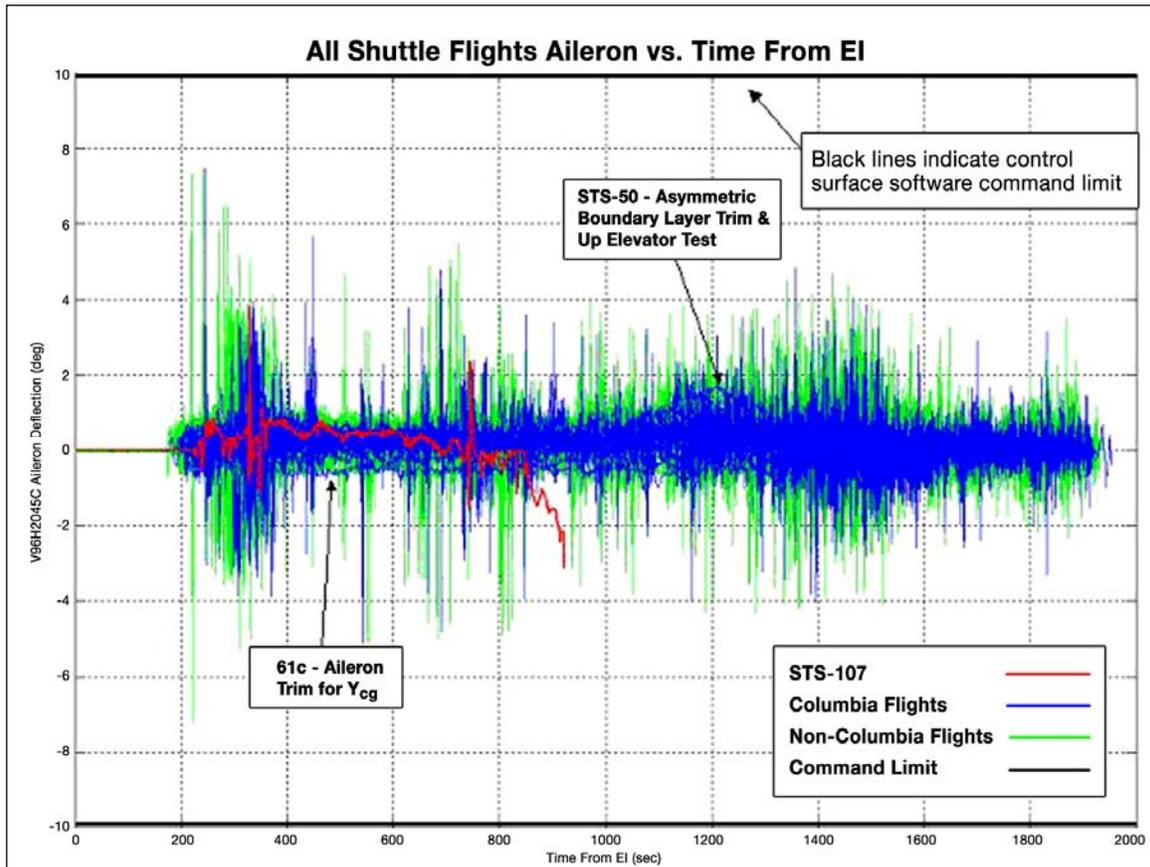
Start of “Sharp” Elevon Trim Increase. The FCS is now compensating for increasingly asymmetric aerodynamic loading and is commanding the elevon trim at a much higher than nominal rate. Time is uncertain (± 10 sec) (figure 1.2-34). [Master Timeline Rev. 15] </p>

Figure 1.2-34. The sharp divergence from previous flight experience starts at approximately GMT 13:58:19 (EI+850).¹⁰

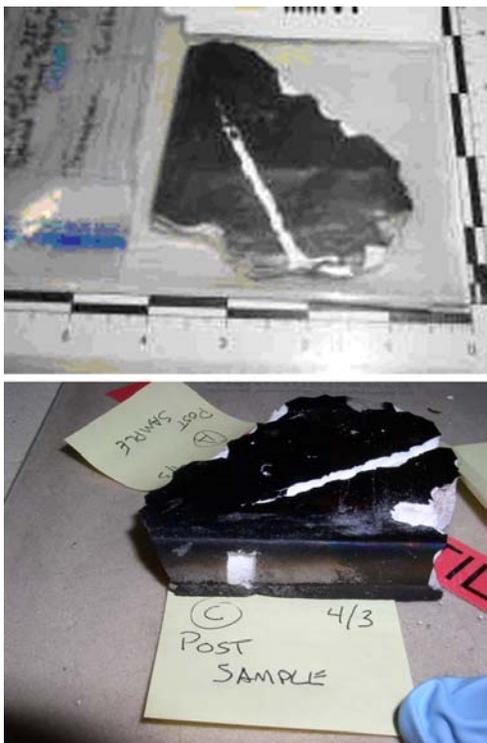
Figure 1.2-35. *The Littlefield tile.* [Picture from the Columbia Reconstruction Database, debris item no. 14768]

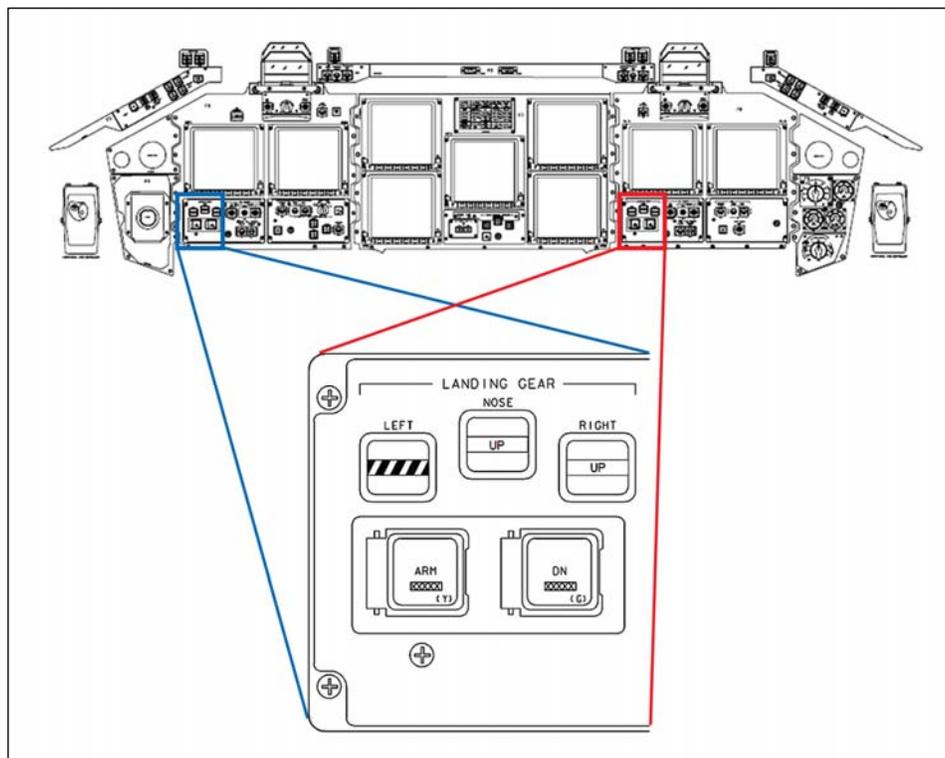
Figure 1.2-36. Landing gear indicator panel, identical on both sides of the flight deck forward display panels. Left indicator showing “barber pole” (indeterminate position). [Adapted from the Space Shuttle Systems Handbook]

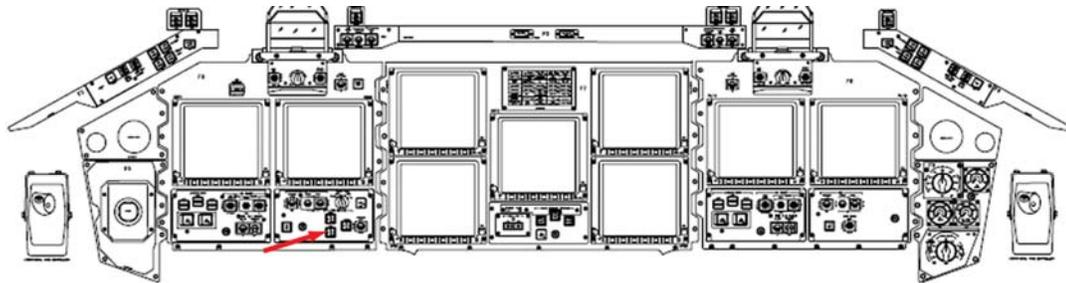
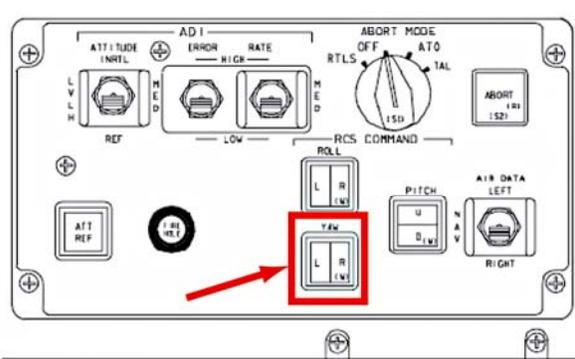
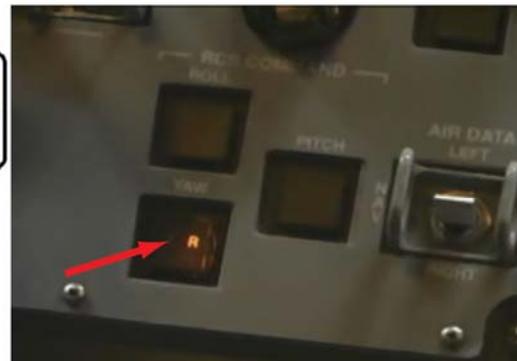
The only indication the crew would have that the jets were firing is from status lights on the F6 panel underneath the CDR2 display and the fuel quantity display on the overhead panel decrementing (figure 1.2-37).

Figure 1.2-37. Reaction Control System thruster status display. [Pictures [top and bottom left] adapted from the Space Shuttle Systems Handbook; picture (bottom right) from the Shuttle Engineering Simulator]

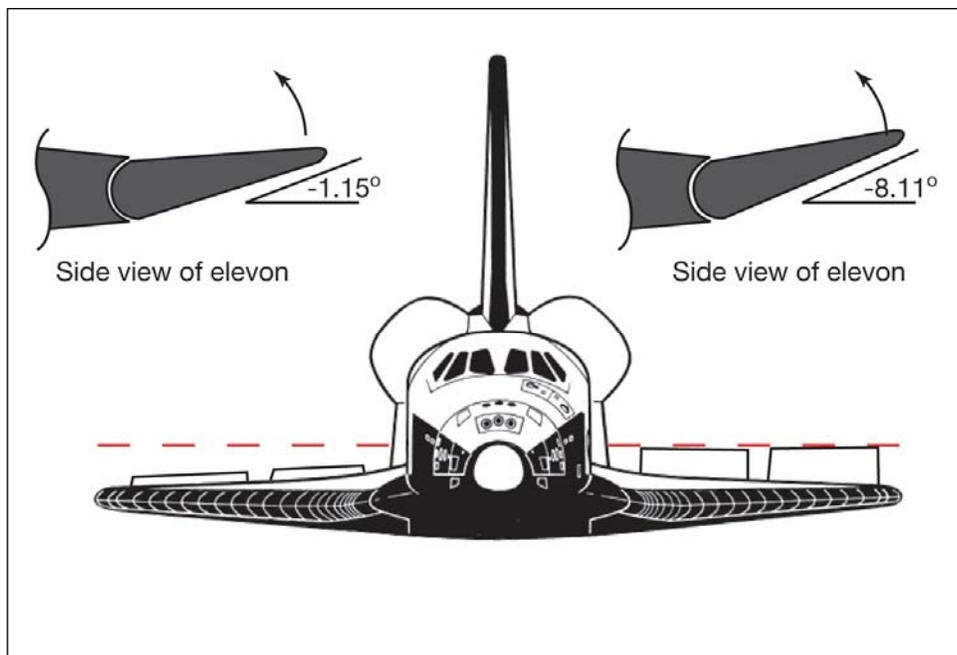
Last observed elevon deflections (figure 1.2-38):¹⁵

Left: -8.11 deg (deflected up)
 Right: -1.15 deg (deflected up)

Figure 1.2-38. Illustration of the last observed elevon deflections.
