**Port x-link assessment**

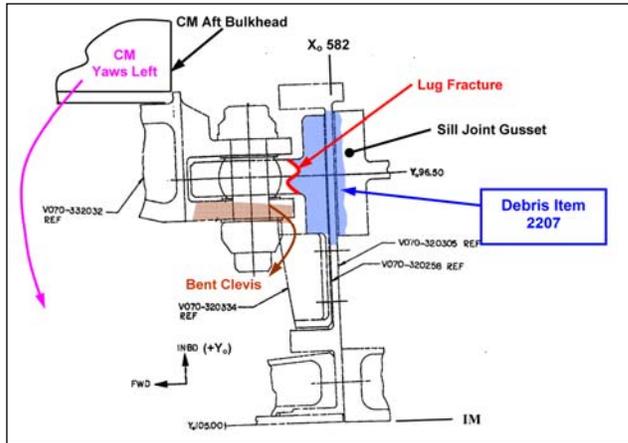
A portion of the X<sub>o</sub> 582 ring frame bulkhead and portside sill fitting, which has a lug that supports the port x-link, was recovered and inspected. The lug broke near its base mainly because of a bending load caused by the x-link and the forebody yawing to the left (figure 2.2-45). This yawing motion was identified by the yielding on the outboard flange of the clevis on the aft end of the port x-link (figure 2.2-46).

Figure 2.2-45. How the port x-link failed, cross-section view looking down.

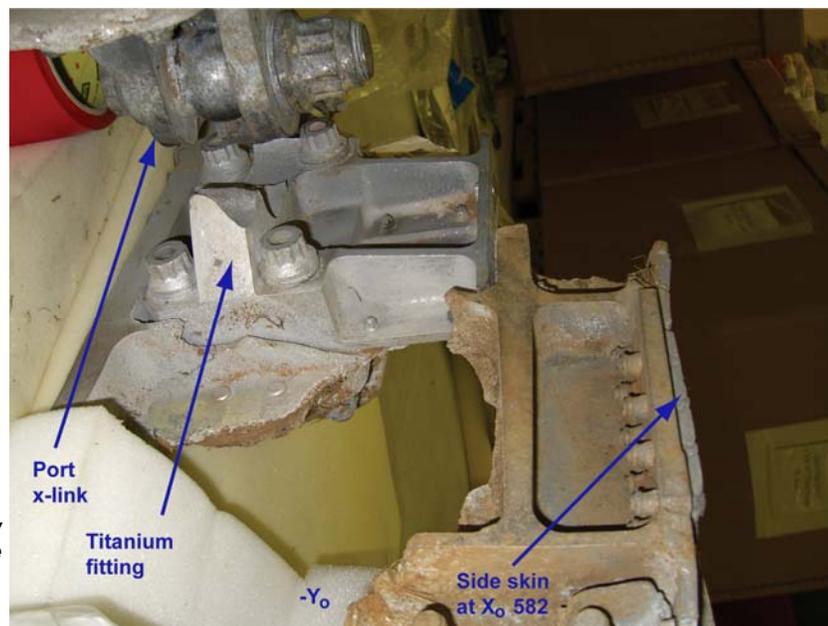
Figure 2.2-49. View looking up and aft at the port x-link.

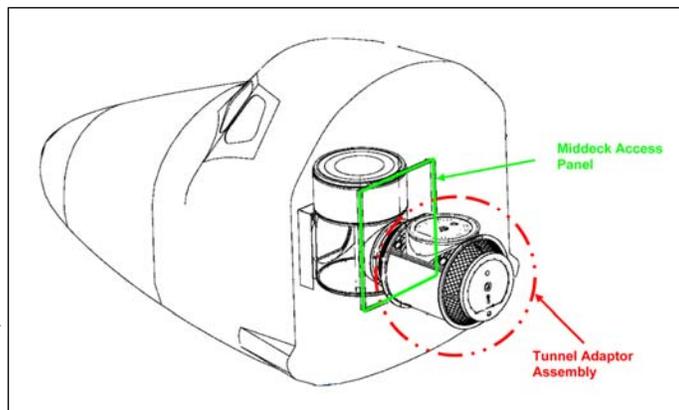
The tunnel adaptor assembly (TAA) provided the internal pressurized path for the crew to move between the middeck to the SPACEHAB in the payload bay (figure 2.2-50). The tunnel adaptor attached to the mid-deck access panel (MAP), which is a large removable panel in the X<sub>o</sub> 576 bulkhead.

Figure 2.2-50. Tunnel adaptor assembly and middeck access panel.

As shown in figure 2.2-50, the MAP is a significant element of the X<sub>0</sub> 576 bulkhead. The bulkhead is linked to the flight deck floor, the middeck floor, and the two partitions on both sides of the airlock. It is not likely that the MAP would fail without causing a massive failure of the whole aft section including the X<sub>0</sub> 576 bulkhead and the airlock, affecting the floors and partitions (figure 2.2-55). This supports the conclusion that no significant damage occurred to the bulkhead at the CE.

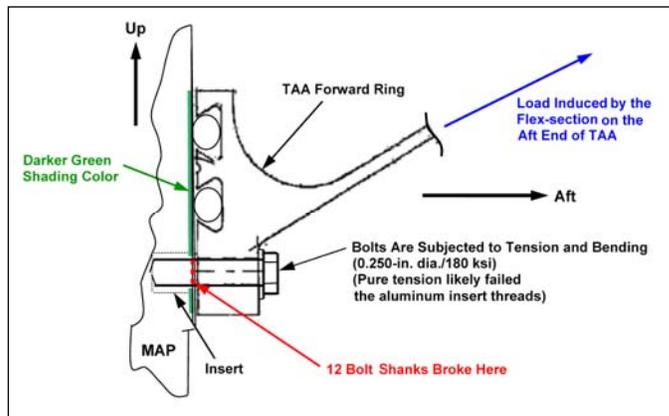
As shown in figures 2.2-51 through 2.2-54, the 12 high-strength bolts (180,000 pounds per square inch (psi)) that attached the forward ring of the TAA to the MAP failed with shanks still remaining in the inserts. This suggests that this area was subjected to high tension and bending while the remaining bolts were not subjected to the same loading. It implies that this TAA joint reacted to a bending moment ( $M_{TAA}$ ) plus aft tension loading (figure 2.2-54). When the aft end of the TAA was restrained by the SPACEHAB tunnel to the midbody, the forebody yawing left and pitching down relative to the midbody could create the same bending effects. This suggests that the TAA broke away from the MAP when the forebody separated from the midbody at the CE or shortly afterwards.

Figure 2.2-53. Cross section through tunnel adapter assembly mounting bolt.

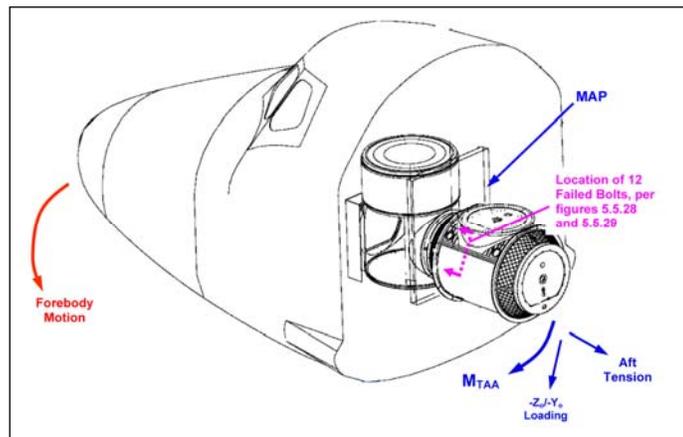
Figure 2.2-54. Predicted motion based on debris evidence.

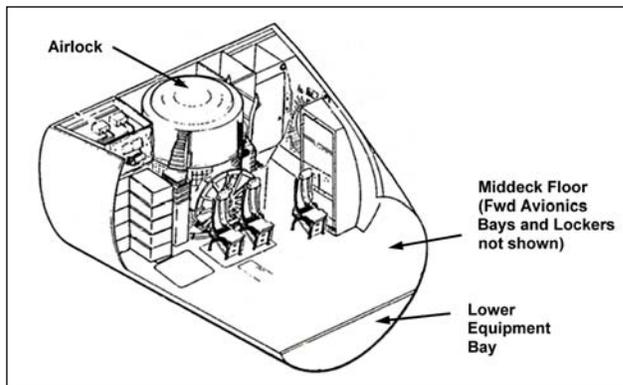
Figure 2.2-55. Airlock in the middeck.

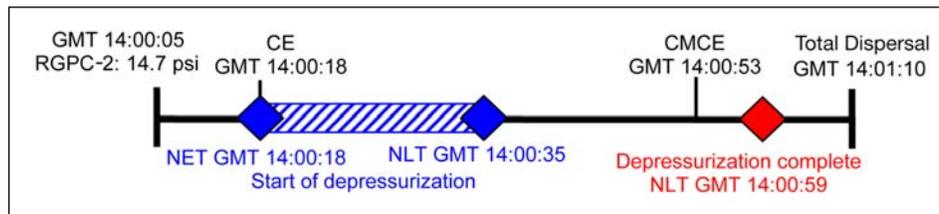
Debris field analysis, ballistics analysis, and video evidence were used to provide the NLT time for when the depressurization completed. The presence of significant CM structural debris items in the debris field indicated a loss of structural integrity of the CM and, therefore, the inability to maintain cabin pressure. Ballistic analysis on a middeck floor panel indicates a release time of GMT 14:01:02 ± 5 seconds. More than 200 pieces of CM structure were recovered west of this item, strongly suggesting that the CM lost structural integrity prior to this time. Video evidence indicated that major changes in the appearance of the CM and significant debris shedding occurred from GMT 14:00:58 to GMT 14:00:59. It is probable that the CM lost structural integrity and was fully depressurized NLT GMT 14:00:59. The CM was estimated to be over 135,000 feet altitude at GMT 14:00:59, so the crew was exposed to a high-altitude environment. Figure 2.3-1 shows the depressurization timeline with the start of depressurization NET and NLT times and the NLT time for when the cabin depressurization was complete.

Figure 2.3-1. Cabin depressurization timeline.

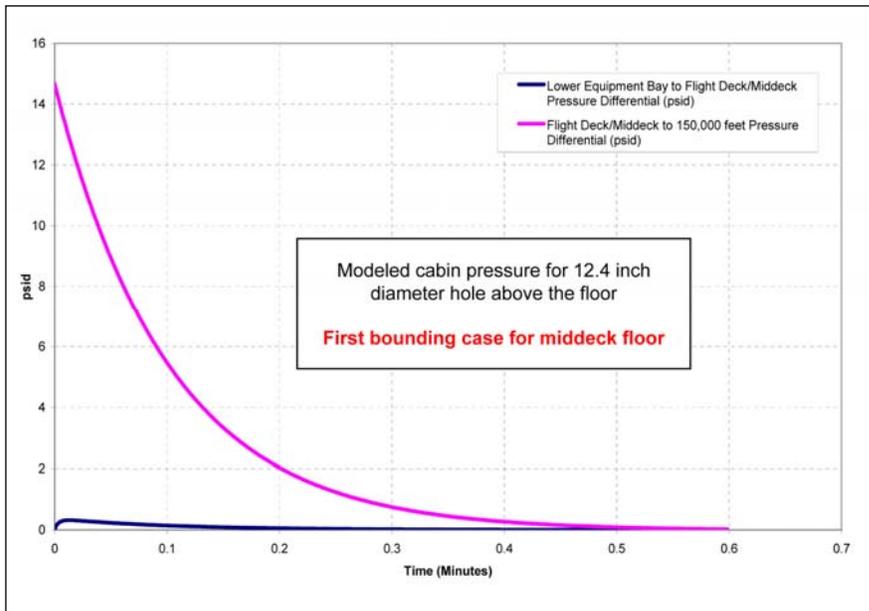
capability of the floor.<sup>10</sup> This model predicted that a hole larger than 12.4 in. diameter (or several smaller holes equivalent to 12.4 in.) *above* the middeck floor, or a hole larger than 4.8 in. in diameter *below* the middeck floor would result in a differential pressure across the floor greater than 0.32 psi (figures 2.3-2 and 2.3-3).

**Figure 2.3-2. Plot from a cabin depressurization model showing a 12.4-inch-diameter hole above the middeck floor. The maximum differential pressure across the middeck floor is 0.317 pounds per square inch (within middeck floor capability).**

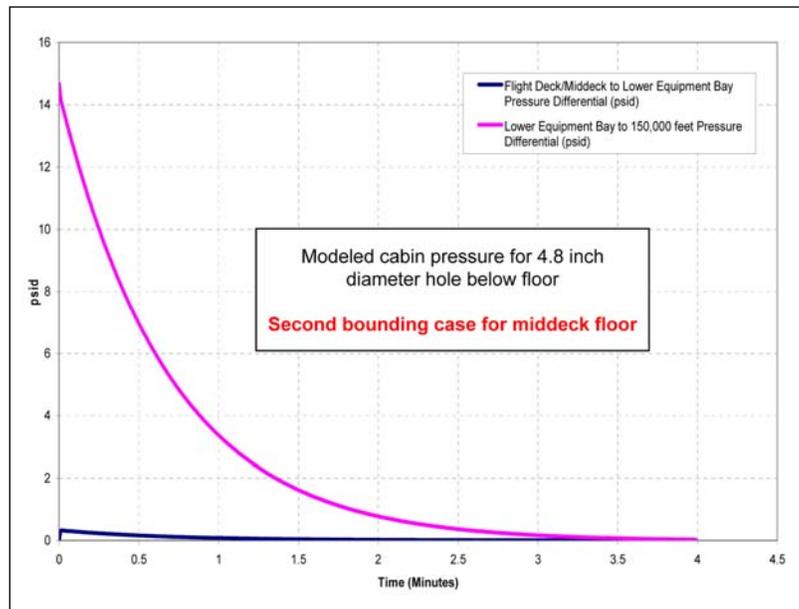
**Figure 2.3-3. Plot from a cabin depressurization model showing a 4.8-inch-diameter hole below the middeck floor. The maximum differential pressure across the middeck floor is 0.319 pounds per square inch (within middeck floor capability).**

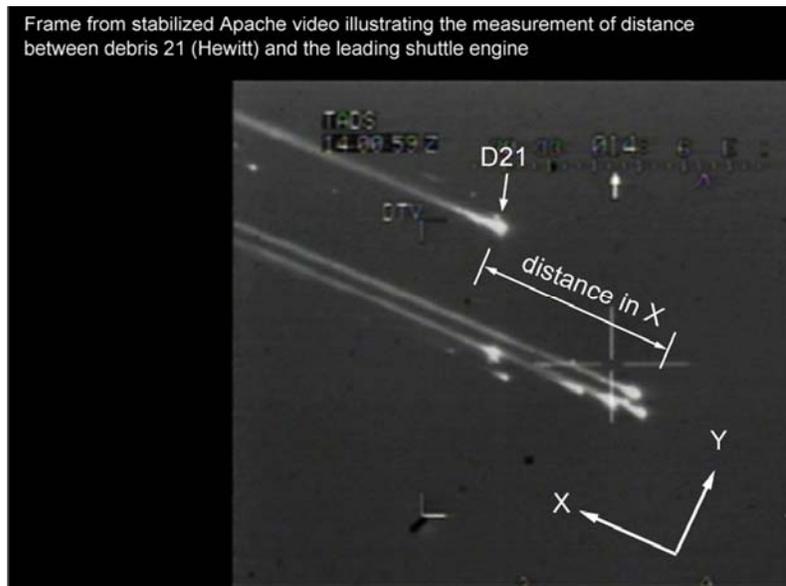
The second relative motion analysis was performed on the CM (identified as D21) and the aft engines post-CMCE in a stabilized Apache video (figure 2.4-3).

Figure 2.4-3. An analyzed frame from the Apache video.

The relative motion of the CM to the engines appears to suggest a high deceleration event occurred during the breakup of the forebody (between the CMCE and the TD). Later understanding of the breakup sequence revealed that this deceleration was related to the disintegration of the CM and the resulting cloud of debris. Rather than a specific high-G event that was experienced by an intact CM, it represents the cloud of individual items separating and rapidly decelerating. Heating was sufficient to keep the individual objects visible for a short period of time, and these items were close enough together that they could not be distinguished as separate items. This also explains why the CM's visible disappearance occurred in a fraction of a second, as the deceleration passed the threshold of sufficient heat generation for visibility in the video.

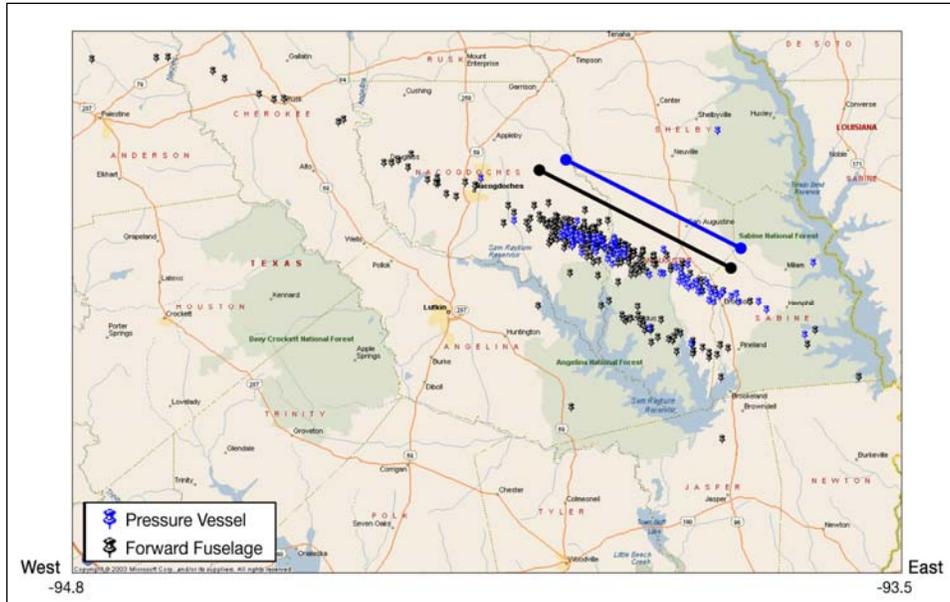
Figure 2.4-4. Debris field of the forward fuselage and crew module pressure vessel.

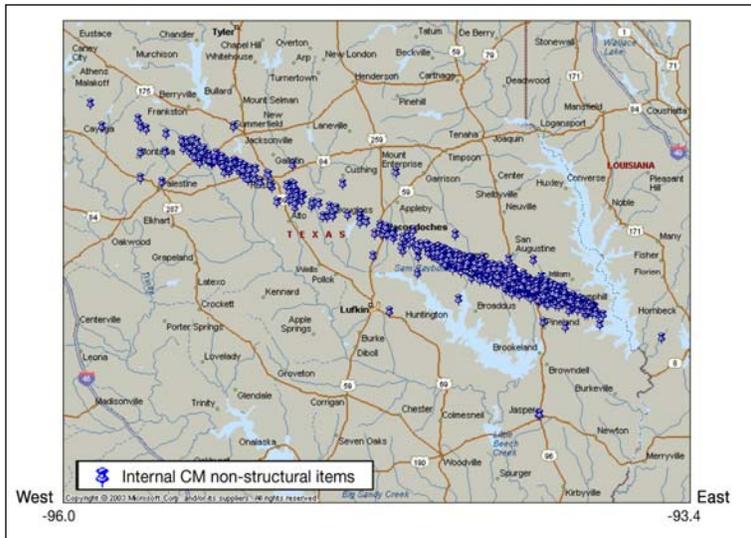
In general, small and light items did not travel downrange significant distances due to the ballistic properties of the object. Some paper/lightweight items were offset slightly northeast of the main debris footprints, probably due to the prevailing winds at the time of the accident. Figure 2.4-5 shows the debris field for nonstructural internal CM debris.

Many of the westernmost debris items came from internal stowage volumes. This implies that internal structural damage occurred at the CE. A full description of cabin depressurization is contained in Section 2.3. The integrated assessment concluded that depressurization occurred NET GMT 14:00:18 (CE) and NLT GMT 14:00:35. It ended NLT GMT 14:00:59, and most likely earlier.

Figure 2.4-5. Debris field of the nonstructural items from inside the crew module pressure vessel.

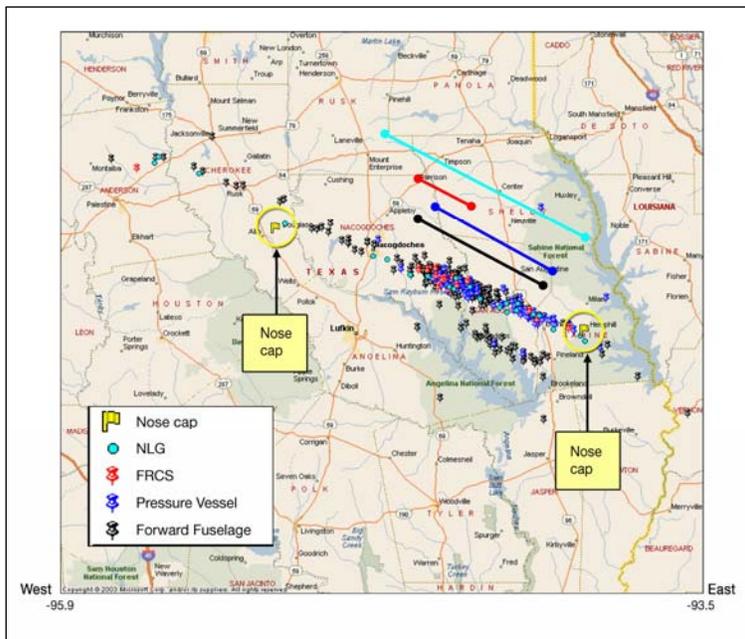
This section discusses the debris field clusters related to the CMCE and the breakup of the forebody. Figure 2.4-10 shows the major elements of the forebody including the CM pressure vessel, FF, forward RCS, nose, and nose landing gear debris. Figure 2.4-11 shows greater detail regarding specific items and highlights the scarcity of items recovered prior to the main FF/CM debris field.

Figure 2.4-10. Debris field of the forebody components.

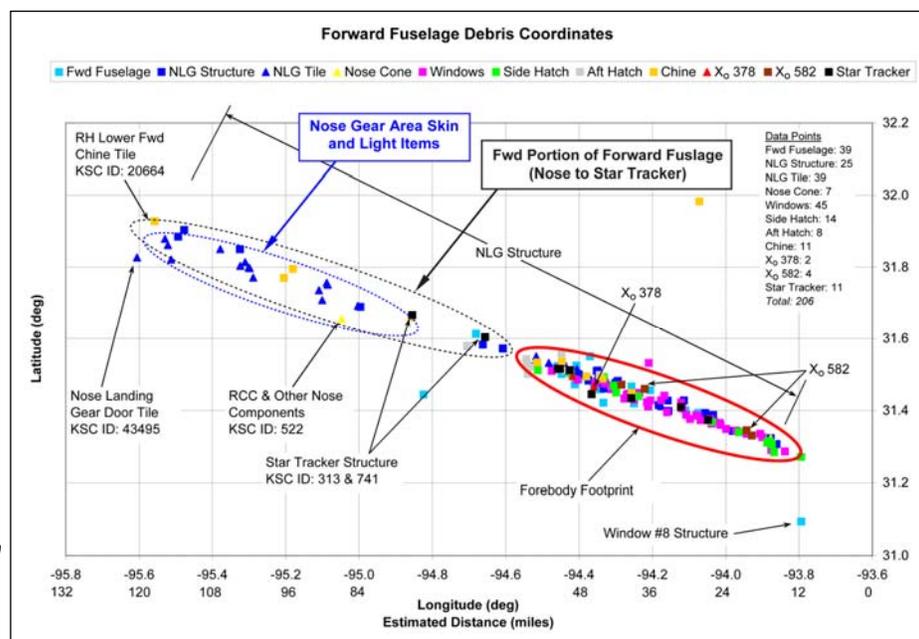
Figure 2.4-11. Forward fuselage debris field.

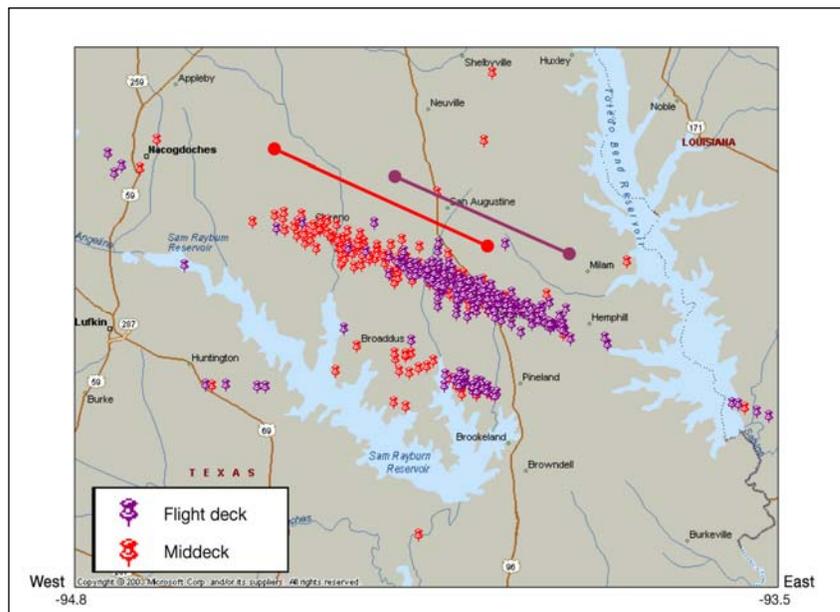
Figure 2.4-12 shows the distribution of middeck and flight deck structure. The middeck structure appears farther west in the debris field, while the flight deck debris cluster is concentrated at the eastern end. This suggests that the flight deck remained intact longer and traveled farther downrange than the middeck.

**Figure 2.4-12. Debris field of the middeck and the flight deck.**

This conclusion is supported by the fact that almost all of the middeck floor debris was in fair to very good condition. However, very little of the structurally stronger flight deck floor was recovered. Furthermore, the flight deck items that were recovered were heavily thermally eroded. This would be the case if the flight deck stayed together and received more thermal damage as a result of having a higher ballistic number than the individual middeck components.

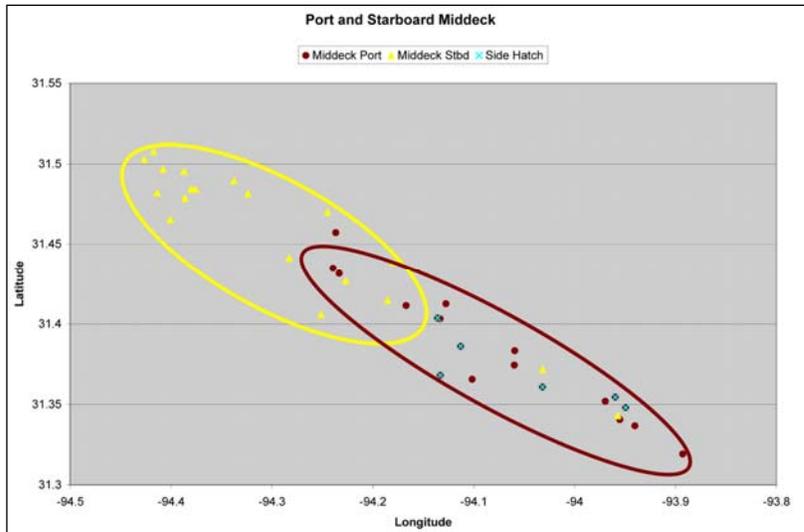
Figure 2.4-13. Middeck structural debris port vs. starboard.

There was a substantial amount of debris for the middeck analysis. Middeck starboard debris was recovered west of the middeck port debris, suggesting that the starboard side failed before the portside. Many of the items from the starboard side were lightweight items from the sleep station with low ballistic numbers, which may also affect this debris field. The debris field is consistent with a yaw to the portside, exposing the starboard side to greater thermal and aerodynamic loads. However, the flight deck panels appear inconclusive relative to a specific failure sequence of forward to aft or port vs. starboard. Not many panels were recovered from port or starboard, which makes interpretations risky.

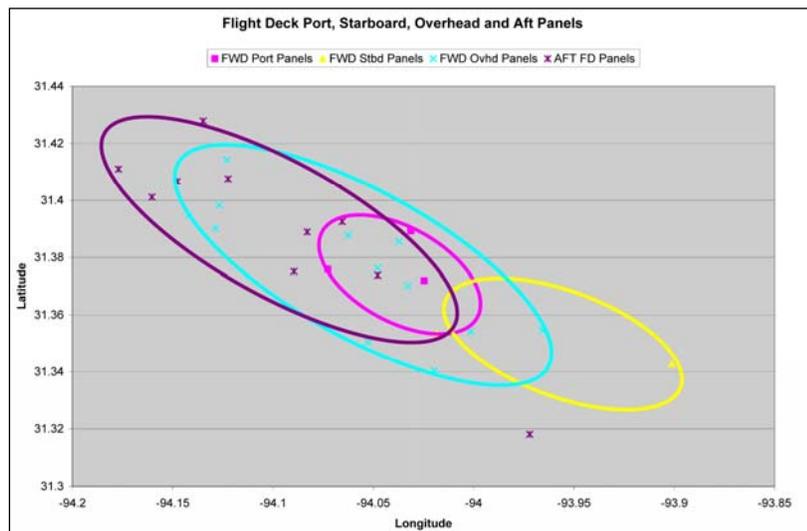
Figure 2.4-14. Flight deck panels by overhead, port, and starboard.

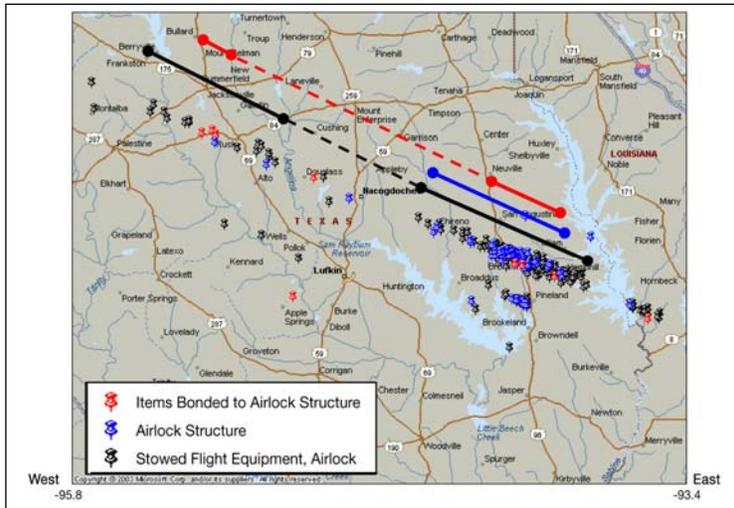
A few “loose” items, as well as a few items that were adhesively bonded to structure and a few pieces of secondary structure, were recovered in the western end of the debris field, indicating that these items were evacuated from the airlock when the TAA departed (figure 2.4-15). However, almost 80% of the airlock structure was recovered in the eastern portion of the forebody debris field (figure 2.4-16).

Figure 2.4-15. Debris field of the airlock structure, flight crew equipment stowed in the airlock, and items bonded to airlock structure.

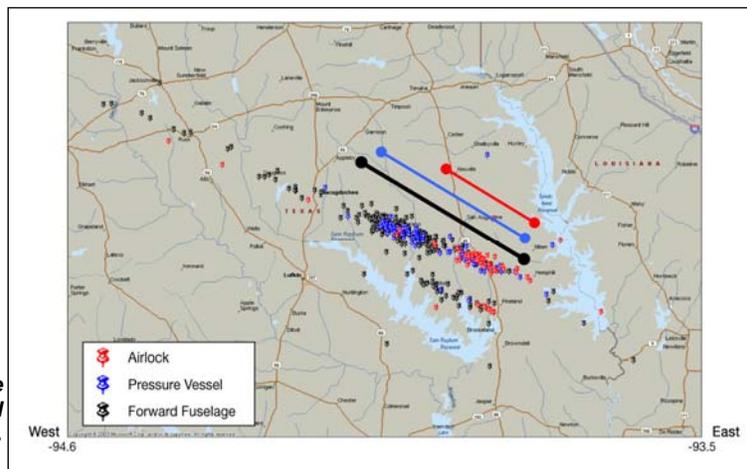
Figure 2.4-16. Debris field of the forward fuselage, pressure vessel, and airlock structure.

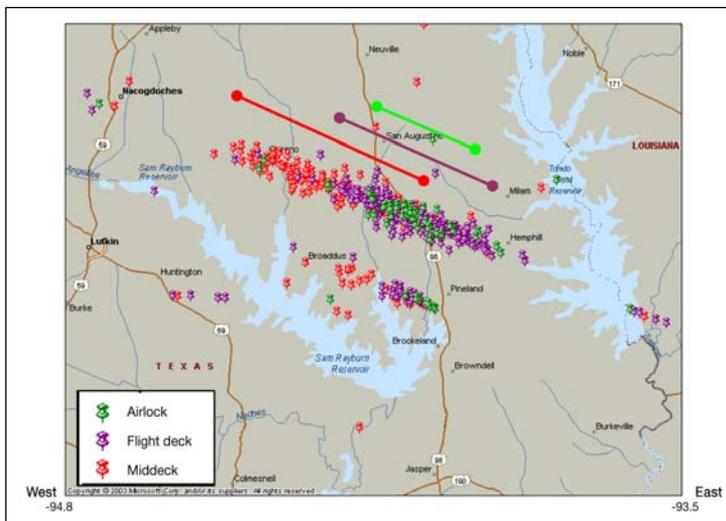
The internal airlock is structurally attached to the CM aft of the X<sub>0</sub> 576 bulkhead. It likely stayed with the aft bulkhead after the middeck departed. Figure 2.4-17 indicates that the airlock structural debris is also squarely in the middle of the flight deck structural debris. This suggests that the flight deck and airlock remained connected to each other by the aft bulkhead.

Figure 2.4-17. Debris field of the middeck, flight deck, and airlock.

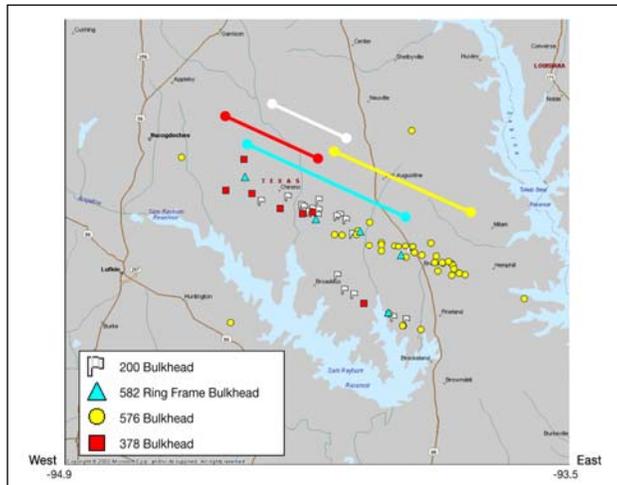
Figure 2.4-19 shows the bulkhead debris field clusters relative to each other. Figure 2.4-20 shows the CM ( $X_{cm}$  200 and  $X_o$  576) bulkhead debris fields relative to the middeck and flight deck debris fields.

Figure 2.4-19. Debris field of the key forebody bulkheads.

The debris field clusters suggest that the two forward bulkheads appeared to fail earlier than the aft bulkheads. Also, the outer (fuselage) bulkheads failed prior to their corresponding inner (CM pressure vessel) bulkheads. The debris footprint for the CM forward bulkhead ( $X_{cm}$  200) coincides with the center of the middeck debris field, suggesting that the  $X_{cm}$  200 departed with the middeck. The CM aft bulkhead ( $X_o$  576) appears to have remained with the flight deck until it disintegrated, likely also connected to the airlock since that debris field coincides as well.

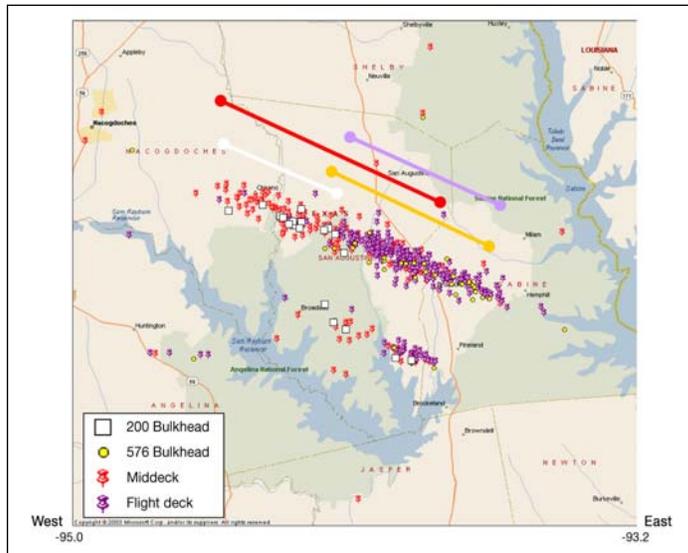
Figure 2.4-20. Debris field of the crew module bulkheads, middeck, and flight deck.

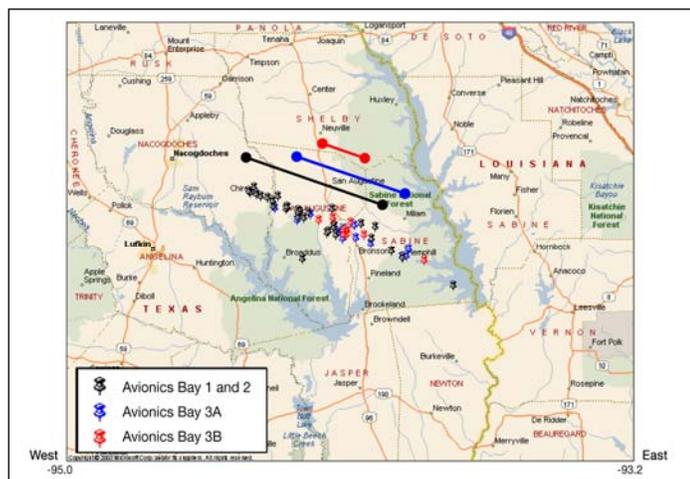
Figure 2.4-21. Debris field of the avionics bays.

Debris from Bays 1 and 2 was recovered west of Bays 3A and 3B. This order matches the CM bulkhead order, supporting that the front ( $X_{cm}$  200) bulkhead departed before the aft ( $X_o$  576) bulkhead.

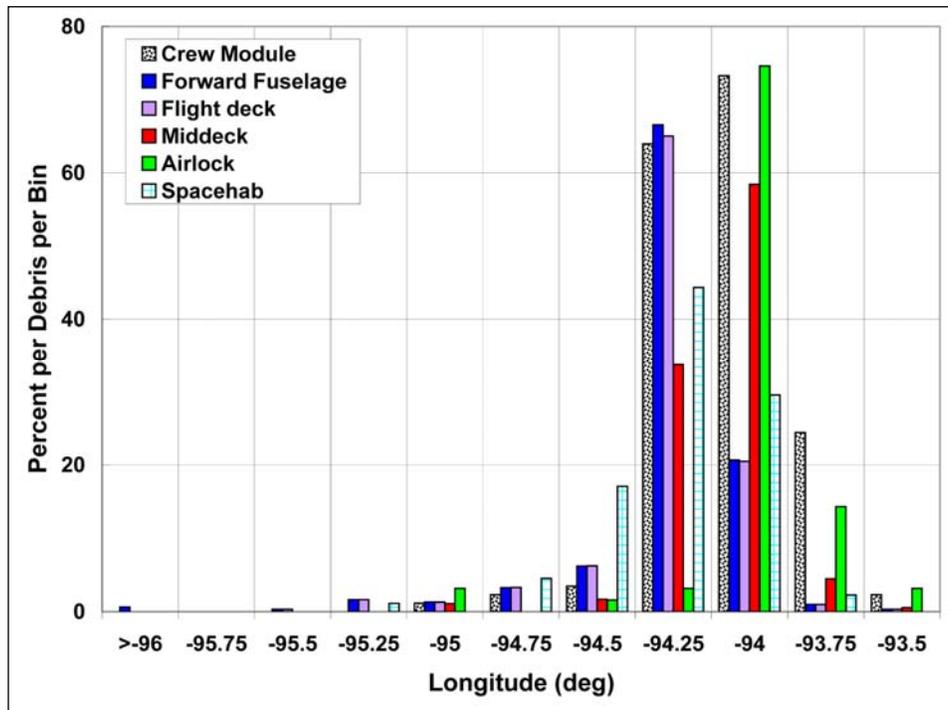
Figure 2.4-22 shows the relationships of some of the addressed forebody structures. The CM bulkheads are included in CM structure, and the X<sub>o</sub> 378 bulkhead is included in the FF structure. The percentages listed in the figure refer to percentage of recovered debris, not percentage of the original intact area.

Figure 2.4-22. Histogram of the forebody structural components, plus SPACEHAB.

To summarize the video and debris field findings, at the CE the CM was contained within the FF structure. The CM began to depressurize through a series of small breaches, with small amounts of FF debris being shed. Eventually, the FF structure failed, and the CM itself failed within a few seconds afterwards. The middeck and forward bulkhead (X<sub>cm</sub> 200) of the CM departed, while the airlock, flight deck, and aft bulkhead (X<sub>o</sub> 576) remained together for a short period longer until all elements separated and the TD occurred.

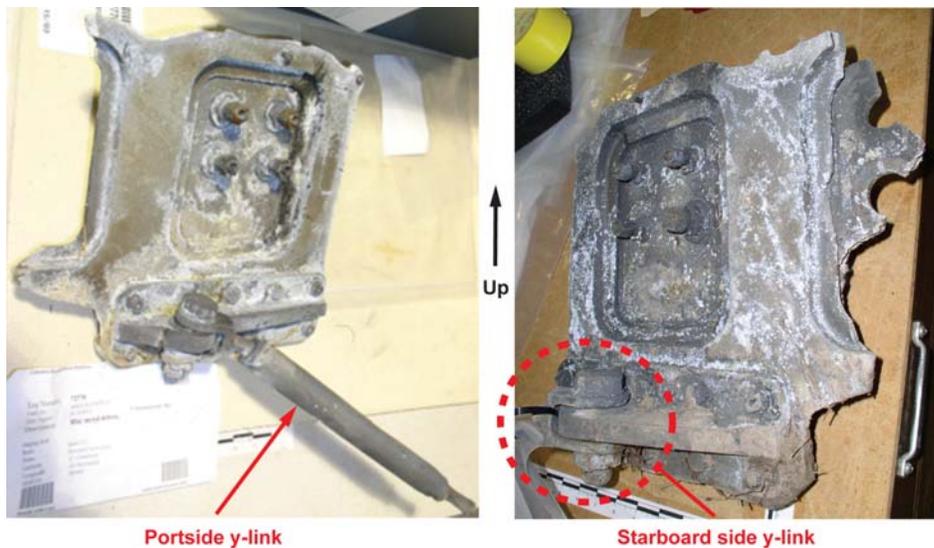
The y-links attach the aft bulkhead of the CM ( $X_o$  576) to the  $X_o$  582 ring frame bulkhead at the lower central portion of the bulkhead. It is possible that the two y-links remained intact at the CE, since most of the  $X_o$  582 ring frame bulkhead is believed to have stayed with the FF. After the CE, any Y-direction movement of the CM relative to the  $X_o$  582 ring frame bulkhead would exert high tension or compression loads on these links. Failure by tension is evident on the recovered debris of these links. The portside y-link shows that it also was softened by thermal exposure along with the tension failure. This portion protrudes beyond the  $X_o$  582 ring frame bulkhead, which would have been exposed periodically to hot gas flow following the CE as the forebody rotated (figures 2.4-28 and 2.4-29).

Figure 2.4-29. The y-link debris, still attached to the mounting on the  $X_o$  576 bulkhead, Columbia Reconstruction Database debris item nos. 72770 (left) and 9280 (right).

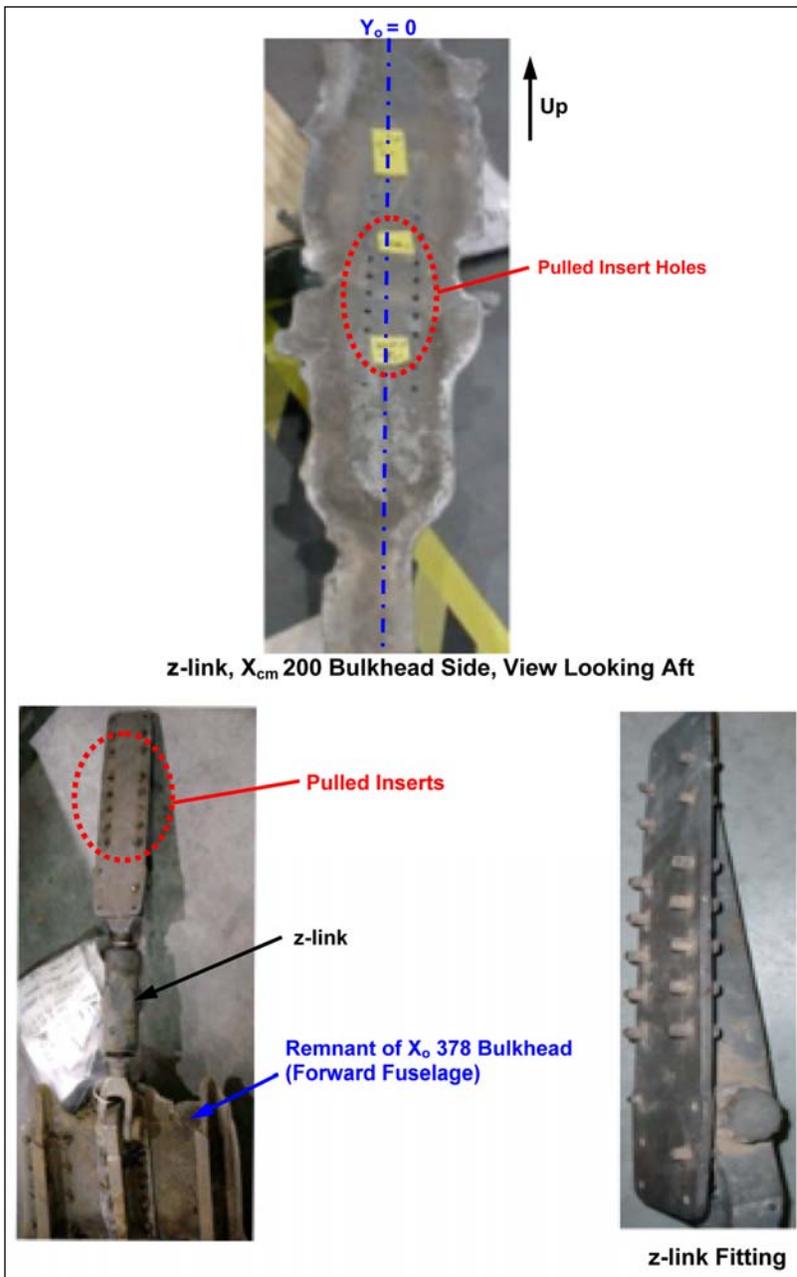
The z-link failed at the attach point to the  $X_{cm}$  200 bulkhead (figure 2.4-30). The joint failed by a combination of fastener tensile failure and fastener insert pullout. Insert pullout requires thermal weakening of parent material because, by design, the insert is stronger than the fastener (under normal temperatures, the fastener should fail before the insert pulls out). Heating may have been occurring as the forebody rotated, allowing hot gas into the plenum between the CM and the FF. Failure resulted at the CMCE.

Figure 2.4-30. The z-link debris photographs, Columbia Reconstruction Database debris item no. 53828 (top).

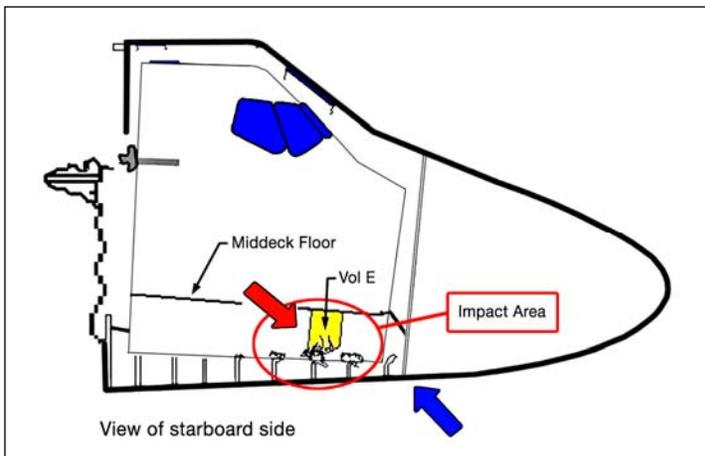
Detailed inspection of Volume E debris indicates that it was subjected to mechanical damage prior to thermal damage. The outer perimeter “picture frame” of the bottom panel was recovered and shows evidence of impact from below. Impact from the CM skin below Volume E would push the aft/outboard corner of the volume upward and then split the edge of the upper frame, as seen in the debris (figures 2.4-32 and 2.4-33).

**Figure 2.4-33. Scenario showing how the crew module pressure vessel could impact the forward fuselage, and the middeck Volume E could impact the crew module pressure vessel, with resultant damage.**

It is likely that at or shortly after the CE, the FF structure impacted the CM skin below Volume E and, in turn, caused an impact between the CM skin and Volume E. The impact was severe enough to crack open the Volume E box, possibly near the lower portion, spilling some of its contents, including the patches. The patches then escaped the CM during CM depressurization.

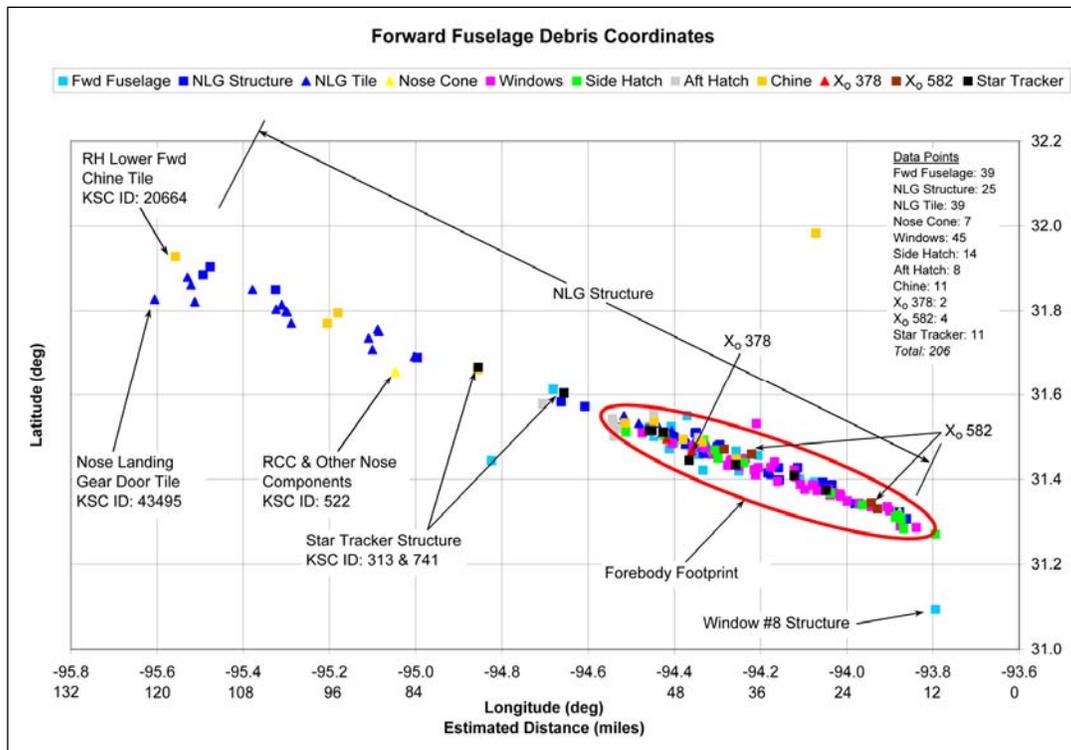
More impacts likely occurred as the forebody continued to rotate. From the CE to the CMCE, it is likely that the CM swung back and forth inside the FF, with both the CM and the FF experiencing impacts at multiple locations. The FF structures would have received damage, possibly creating paths for thermal inflow, as the forebody rotated. Impacts from the relative motion between the CM and the FF would damage the forward bulkheads (X<sub>o</sub> 378 and X<sub>cm</sub> 200), the fuselage frames, and the thinner areas of CM aluminum skin, star tracker well area, etc., depending on the attitude and the rotational movement. Recovered crew equipment debris also came from the forward lockers on the portside, not far from the star tracker wells, lending credence to this. Frame and bulkhead damage would destabilize the FF structures, perhaps popping open numerous items, including the star tracker panels, the TPS around the forward windows, the forward RCS module, the nose gear doors, and the side hatch outer layer. Review of forebody items found in the debris field prior to the main debris field support this conclusion, as portions of the nose gear, star tracker, and multiple tiles and portions of TPS made up this early released debris (figure 2.4-34).

**Figure 2.4-34. Forward fuselage debris field showing tile, nose landing gear door structure, and star tracker door structure west of the main forebody debris field.**

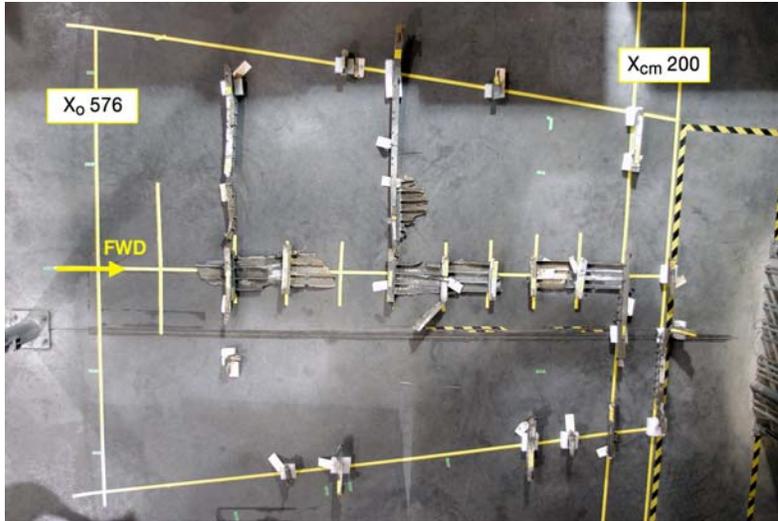
Very little CM skin structure survived. It is very thin, and probably melted quickly after breakup when exposed to entry heating. Only a relatively thicker region of skin strip (0.131-in. thick) along the bottom at the centerline was recovered in multiple pieces (figure 2.4-37).

Figure 2.4-37. Recovered crew module pressure vessel base skin.

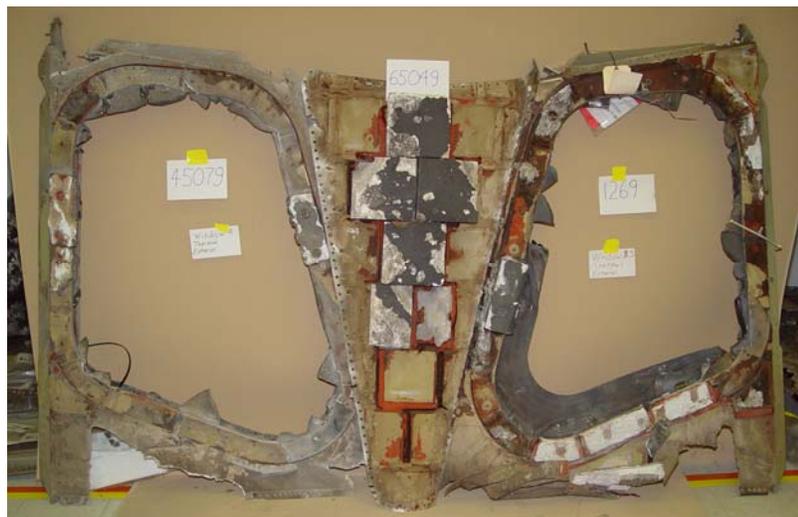
The “arrowhead” skin/TPS panel between Windows 3 and 4 (debris item no. 65049) (figures 2.4-38 and 2.4-39) on the front of the forebody was recovered near the middle of the forebody debris field. It appears to have been torn on the portside and pulled through on the starboard side by mechanical loading, probably initiated by a relative movement between the port Windows 1 through 3 and the starboard Windows 4 through 6.

Figure 2.4-38. Forward fuselage arrowhead panel and the forward two windows, facing in.

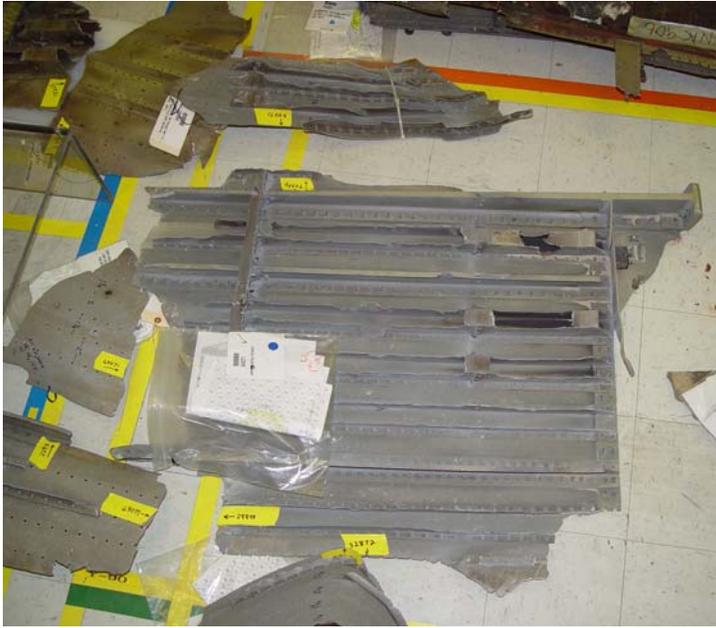
Figures 2.4-40 and 2.4-41 are of the FF skin debris items that lie below the CM. Many panels have little molten metal deposition on the inside surfaces. Broken edges show little thermal damage, and some still have intact primer. This indicates that the plenum behind these areas was not exposed to long durations of thermal flow. Some skin pieces even had stringers that were removed mechanically. Most of the recovered skin debris appears to have mechanically fractured edges. Many forward RCS structural items were recovered; it appears that the forward RCS was pulled away mechanically and broke up into pieces with low thermal effects. The conclusion was that it is likely that the FF skin panel peeled away and broke up quickly.

**Figure 2.4-41. Lower forward fuselage skin panel near external tank attachment.**

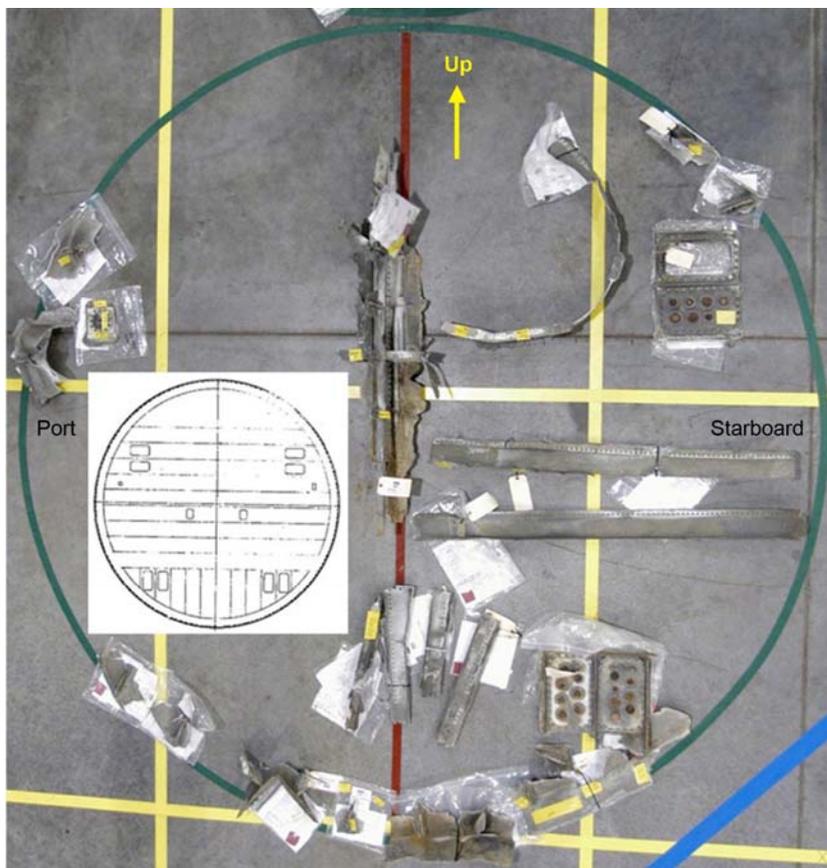
Figure 2.4-42 shows recovered CM forward bulkhead ( $X_{cm}$  200) debris on a grid that is the size of the original bulkhead. As described in the debris field cluster analysis, the CM forward bulkhead debris was recovered west of the aft bulkhead debris, and the middeck starboard debris was recovered west of the port debris. This suggests that the CM middeck starboard/forward was shed first and that the starboard and forward CM areas were exposed to higher heating first and/or faced the velocity vector at the time of the CM major breakup. The main CM breakup involved the departure of the middeck area, including the middeck floor and everything that was attached to that floor. Anything not firmly attached to the flight deck floor also came out with the middeck. Most equipment that was above and below the middeck floor was supported by the middeck floor; avionics bays are also supported by the side skins and bulkheads.

**Figure 2.4-42. View looking forward of the recovered crew module X<sub>cm</sub> 200 bulkhead debris.**

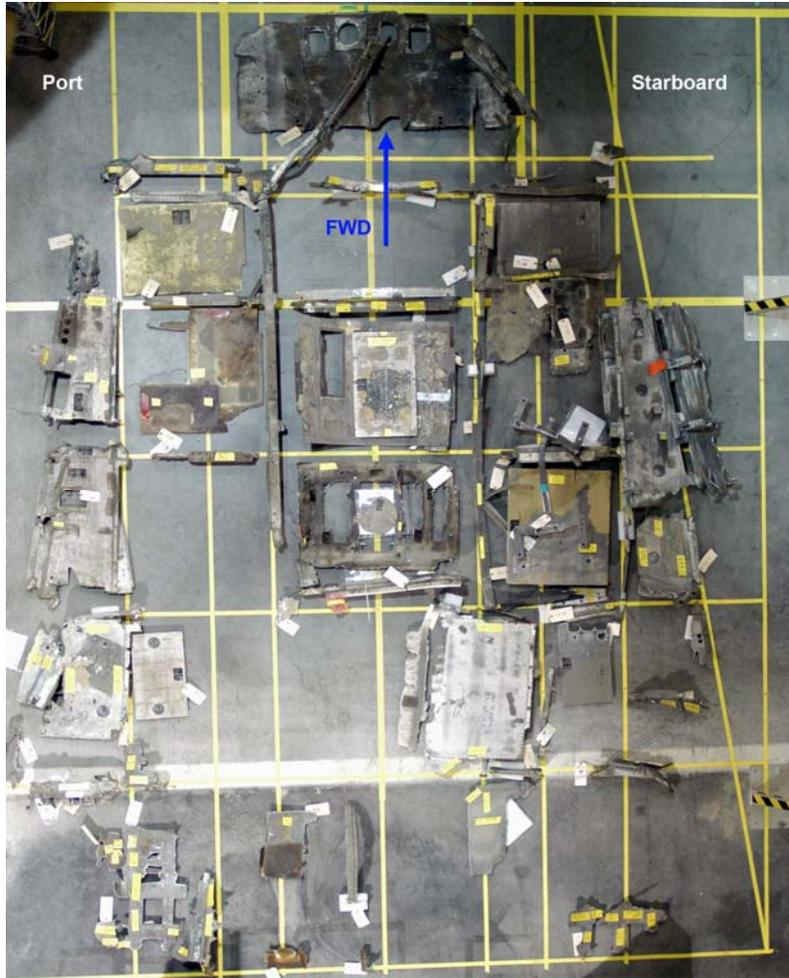
Structurally, the flight deck section is connected to the middeck section and the lower equipment bay is mainly connected by the CM side skin, avionics bay partitions, and the aft and forward bulkheads. The side skin and the forward bulkhead could be easily damaged by aerodynamic heating after the CM lost the protection from the FF shell. Therefore, as soon as the middeck side skin and forward bulkhead were compromised structurally, the lower half of the CM could have swung away from the flight deck portion by the effects of aerodynamic drag. It is likely that the whole middeck floor assembly came out together with the lower equipment bay. The hinge line appears to be at or near where the middeck floor attaches to the aft bulkhead. This motion would expand the middeck compartment (similar to opening a clam shell) and release all items attached to the middeck floor as well as other items stowed beneath that floor. Because the middeck floor disintegrated into many smaller parts without being significantly heated, it appears that the middeck floor failed as a result of structural loading. This may help to explain why more than 65% of the middeck floor was recovered without significant thermal erosion (figures 2.4-43 and 2.4-44).

Figure 2.4-43. Top view of the crew module middeck floor debris.

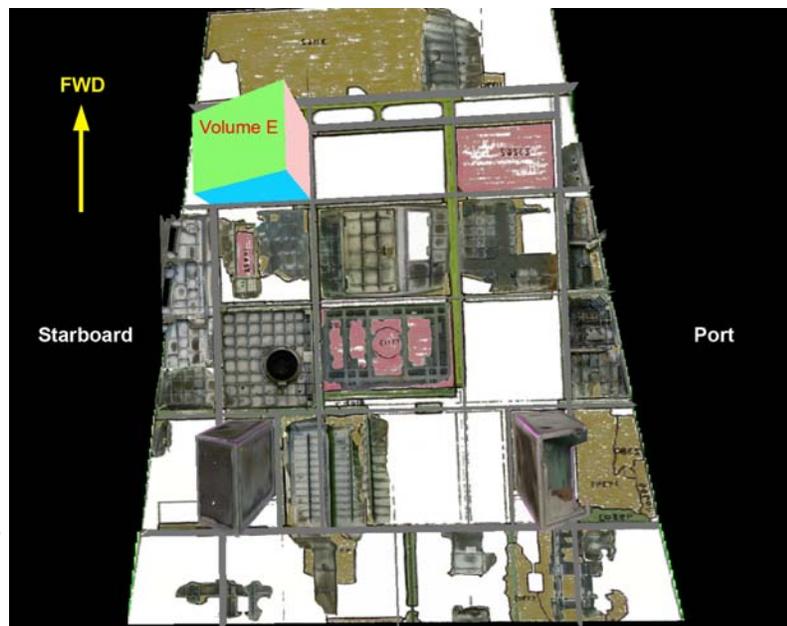
Figure 2.4-44. Bottom view of the recovered middeck floor items from virtual reconstruction.

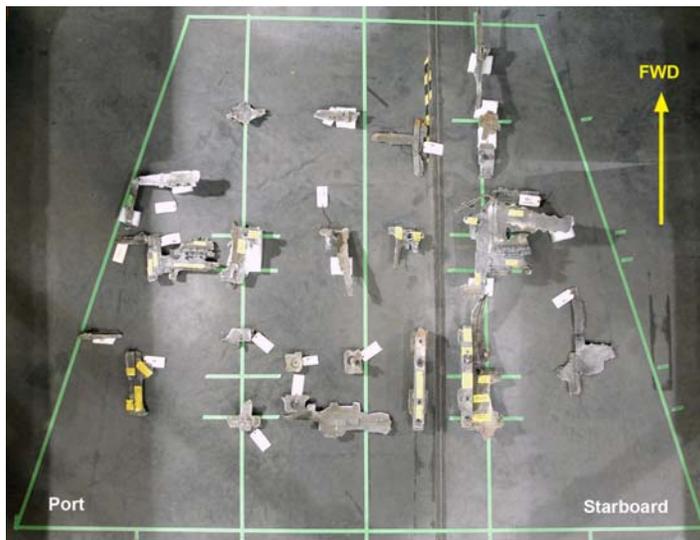
The CM debris field suggests that after the forward bulkhead and the middeck floor departed, it was followed by the airlock, the flight deck, and the aft bulkhead. The flight deck floor debris exhibited much more thermal damage than the middeck floor debris.

Figure 2.4-45. Top view of the crew module flight deck debris.

From the thermally eroded state of the flight deck debris, it appears that the flight deck stayed nearly intact for a period of time following the departure of the middeck area. This explains why so little of the flight deck floor was recovered (figure 2.4-45). Based on debris field evidence, the internal airlock, which was supported by the MAP (which is part of the X<sub>o</sub> 576 bulkhead), likely stayed together with the bulkhead and the flight deck.

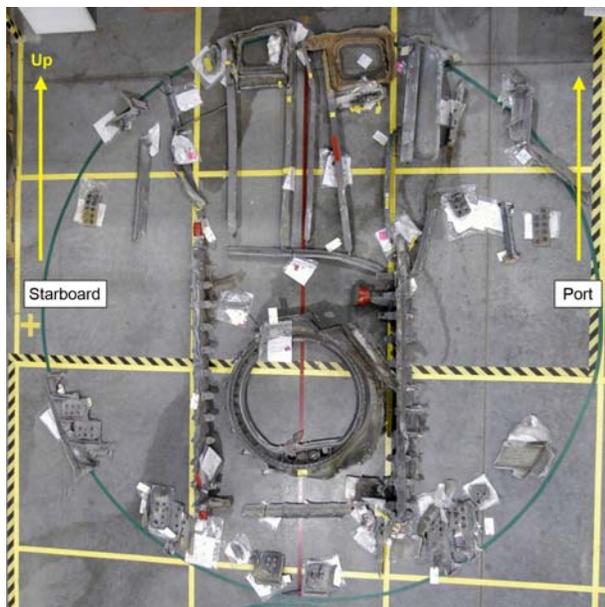
In general, heavy portions of the X<sub>o</sub> 576 bulkhead (including the MAP) survived the entry heating (figure 2.4-46). This is possibly due to the high heat absorption property of the aluminum bulkhead.

Some “T”-section stiffeners survived with little heat damage, possibly because of the early departure of these elements before the high thermal event that consumed the bulkhead.

Figure 2.4-46. View looking aft of the recovered X<sub>o</sub> 576 bulkhead debris.
