**Port x-link assessment**

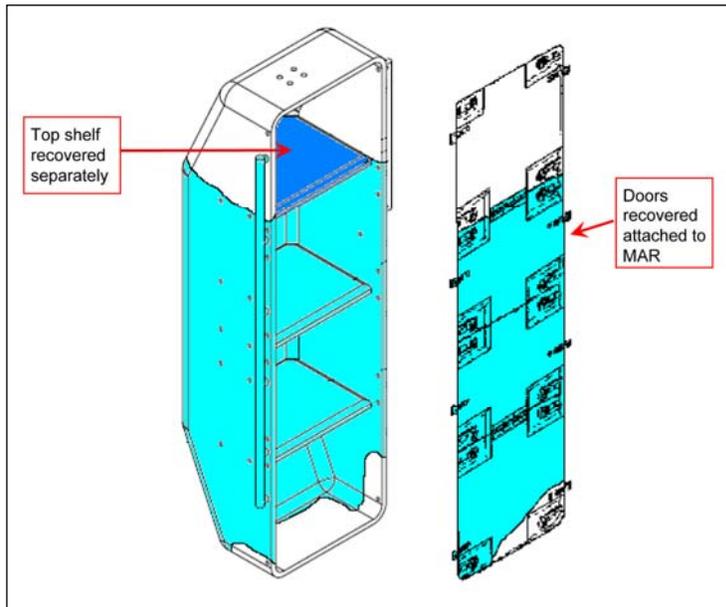
Approximately 75% of the MAR structure was recovered, mostly intact. The blue areas in figure 2.4-48 represent the MAR structure that was recovered. The portions that were not recovered included the upper one-fourth of the MAR structure (including the upper attachment bracket), the top half of the upper door, a portion of the bottom half of the lower door, and the bottom surface of the MAR structure (including floor attachment brackets).

Figure 2.4-48. Recovered middeck accommodations rack structure (shown in blue).

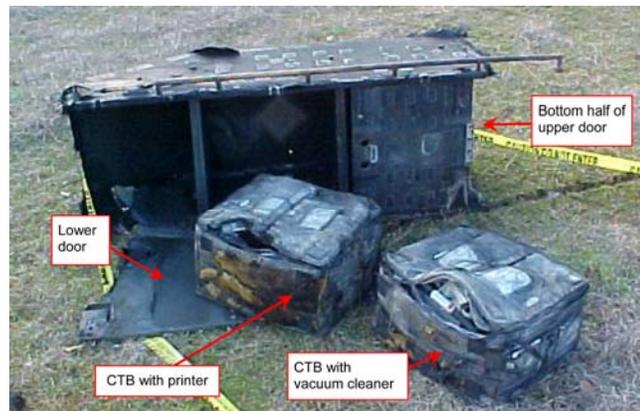
The MAR was recovered with the middle and bottom shelves still attached. The top shelf was recovered separately. The lower door and the bottom half of the upper door were recovered with the MAR structure, as were the contents of the compartment between the middle and bottom shelves (CTBs with the printer and the vacuum cleaner (figure 2.4-49)). The contents of the compartment between the middle and top shelves and the contents of the compartment below the bottom shelf were recovered separately from the MAR structure and were highly fragmented.

Figure 2.4-49. Main middeck accommodations rack structure, as found.

The lack of impact witness marks on the MAR aft handle and the aft wall upper surface indicates that the MAR did not impact the CES pole, which is mounted just inches aft of the MAR. The lack of impact witness marks on the MAR starboard surfaces indicates that the MAR did not impact the seat 5 structure, which is mounted inches starboard of the MAR. Ballistic analysis indicates that the MAR separated from the CM shortly after the CMCE. Based on the failure of the fasteners securing the MAR attachment bracket to the middeck floor, it is concluded that the MAR separated from the middeck floor mostly to fully intact. These conclusions support the general findings that the middeck breakup was rapid and expansive, with very little interaction between major structures, and occurred at the onset of the CMCE.

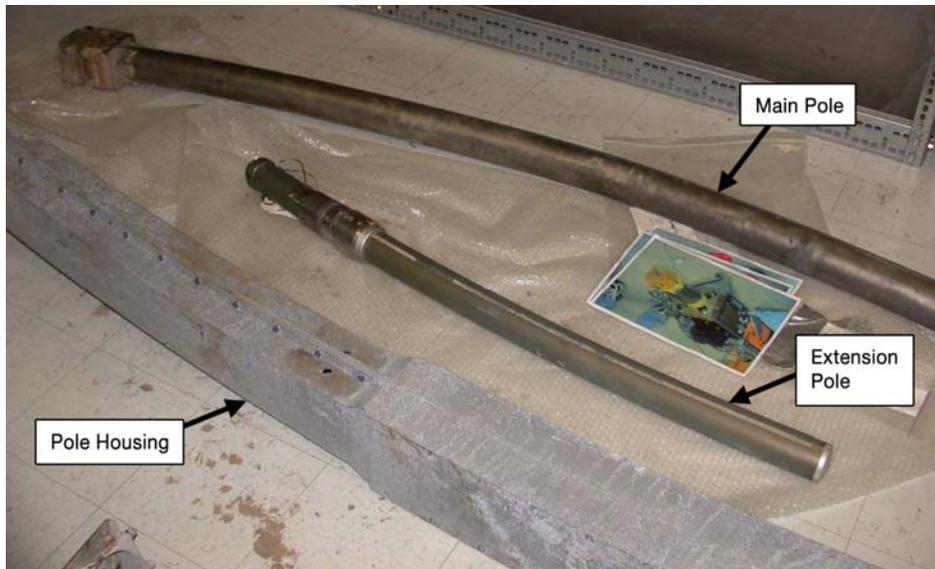
The debris indicates that the pole was installed in the launch/landing position. There is no evidence to suggest that the pole had been deployed (or that the side hatch had been jettisoned<sup>3</sup>). The pole housing, the main pole, and the extension pole (figure 2.4-52) were recovered separately. The starboard end of the housing, including the middeck ceiling mounting bracket, shows evidence of thermal damage. The main pole and extension pole (figure 2.4-53) were recovered in relatively good condition, showing little mechanical or thermal damage. The main pole deployment spring was recovered separately from the housing, with the starboard end cap of the pole housing attached to the spring. Additionally, the portion of the CM port wall to which the pole attaches was recovered and analyzed. Several lanyards were recovered separately, but the lanyard magazine was not recovered.

Figure 2.4-52. Pole housing, main and extension poles.

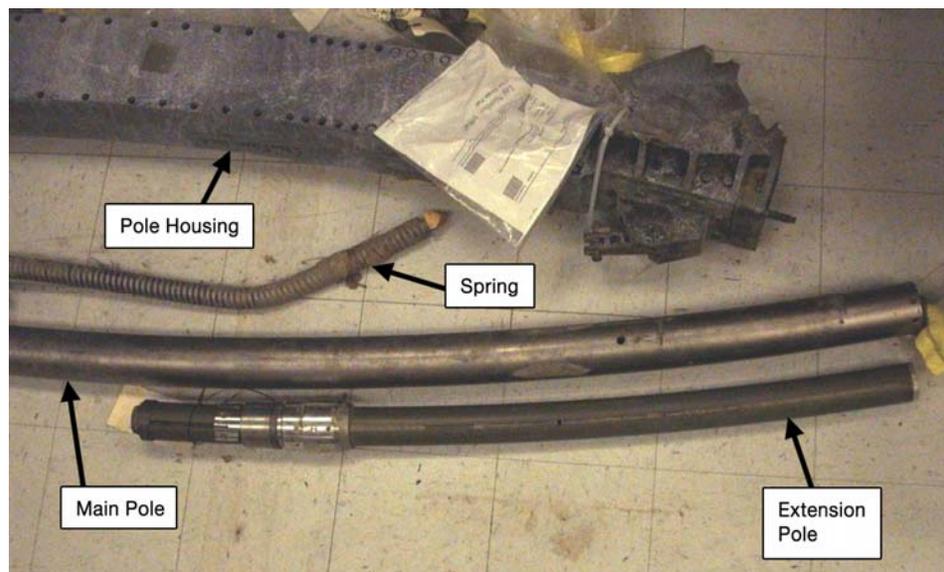
Figure 2.4-53. Port ends of housing, deployment spring, and main and extension poles.

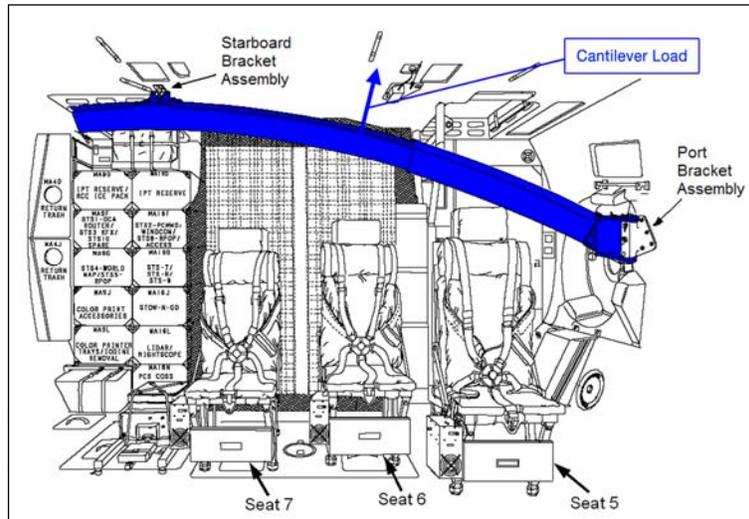
Deformation of the upper portion of the knuckle that attaches to the CM indicates that it experienced an upward cantilever load (figure 2.4-54). This could be caused by the starboard end of the pole moving upward. This suggests that the flight deck separated from the middeck roughly at the flight deck floor/middeck ceiling level.

**Figure 2.4-54. Crew escape pole in launch/landing position, middeck, looking aft, with direction of cantilever load noted from debris.**

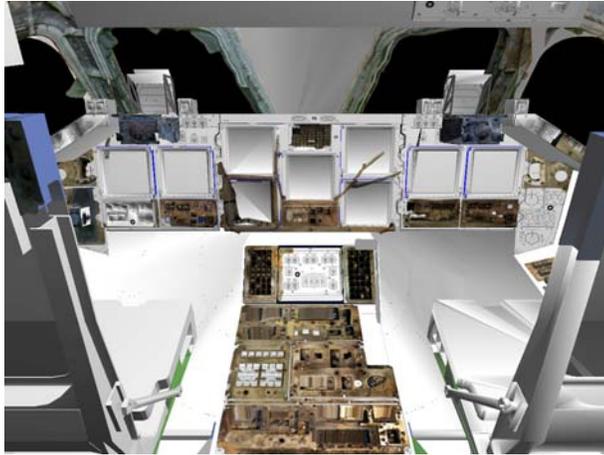
**Figure 2.4-56. Virtual reconstruction of the recovered Columbia flight deck panels.**

This virtual reconstruction was studied to investigate whether there were clear indications of a thermal or structural breach. However, adjacent panels were seen to have received significantly different amounts of thermal damage. This indicated that some panels broke off earlier than other panels, or were temporarily shielded from the thermal flow during the breakup. The damage varied greatly from one panel to the next, indicating a chaotic breakup sequence. No clear evidence of the initial breach location could be determined.

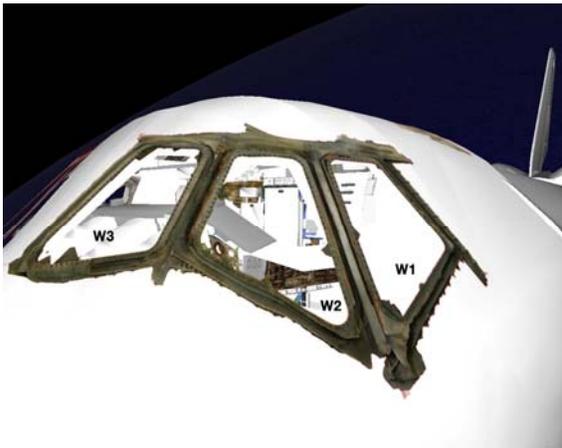
At least one window frame (CM or FF) was recovered from every window. Two large debris assemblies were recovered (figures 2.4-57 and 2.4-58). Each large piece is a complete assembly of three CM forward window frames (Windows 1, 2, and 3 and Windows 4, 5, and 6) with some broken glass pieces still captured in their retainers. Three CM window frames of Windows 7, 9, and 10 were recovered in separate pieces since they were not connected to each other by heavy CM skin structures (figure 2.4-59). Five thermal frames (FF) were also recovered.

**Figure 2.4-57. Port view looking aft, recovered Columbia crew module Windows 1, 2, and 3.**

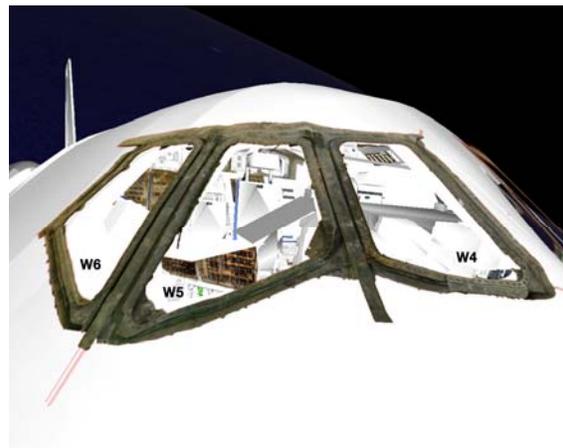
**Figure 2.4-58. Starboard view looking aft, recovered Columbia crew module Windows 4, 5, and 6.**

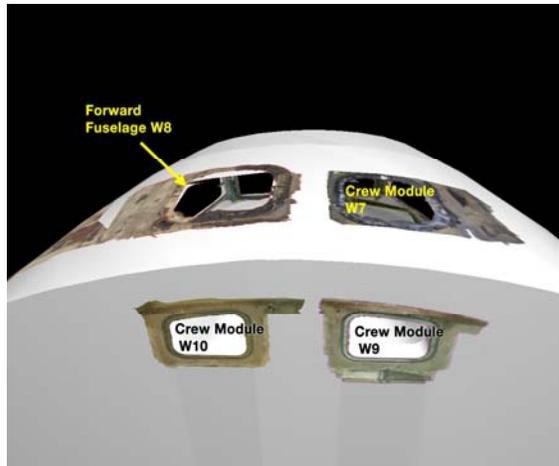
**Figure 2.4-59. View looking forward, recovered Columbia crew module Windows 7, 9, and 10 and forward fuselage Window 8.**

Debris evidence suggests that most of the CM skin structures surrounding the CM flight deck windows had been melted away during the event. One exception is the upper edge of CM aft Windows 9 and 10, which shows mechanical fracture edges.

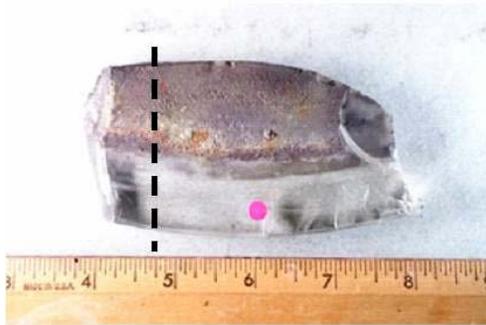
**Figure 2.4-60. Window fragment removed from the thermal pane frame from Window 8. The black dashed line denotes the sectioning plane. The red dot was used to indicate the outward face of the pane.**

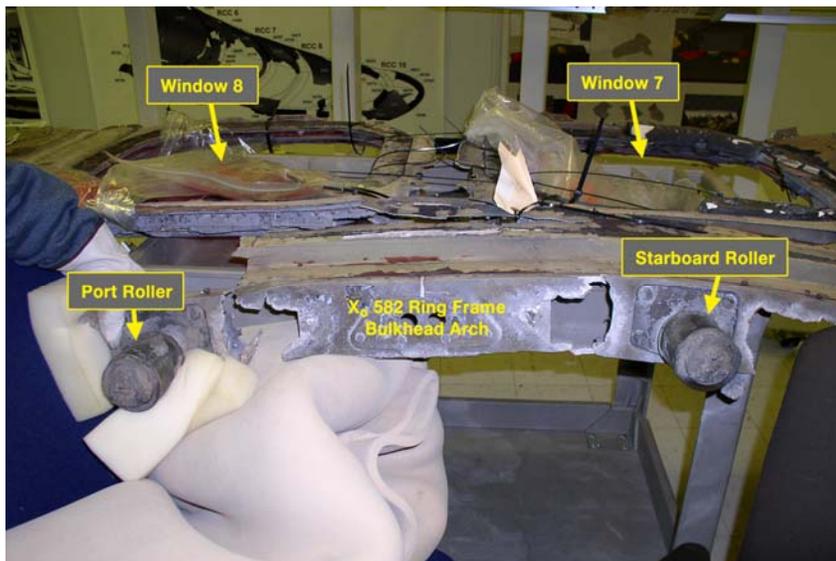
Figure 2.4-63. Columbia debris for same location. Note eroded rollers and eroded region of the X, 582 Ring Frame Bulkhead Arch.

The recovered rollers for the location closest to the overhead windows both showed significant signs of erosion. While these rollers were not the only components made of titanium, they were the only ones recovered that possessed the proper material, proximity, and thermal indications and were, therefore, concluded as the source location. Given these findings, the rollers were the most probable source of titanium causing the deposition on the windows.

Since the rollers are located on the X<sub>0</sub> 582 ring frame bulkhead arch aft and below these two windows, and protected by the PLBDs, the PLBDs must have been compromised or fully departed while the bulkhead arch was still attached to the CM. Additionally, the forebody must have been traveling aft-end forward for some period of time to have the directional thermal flow that caused the titanium to “vaporize” flow over the glass external surface of the thermal panes or on the external surface of the Windows 7 and 8 redundant panes, it can be concluded that the thermal panes were intact at the time of this event. This is consistent with other findings showing that the FF remained with the CM until breakup of both elements.

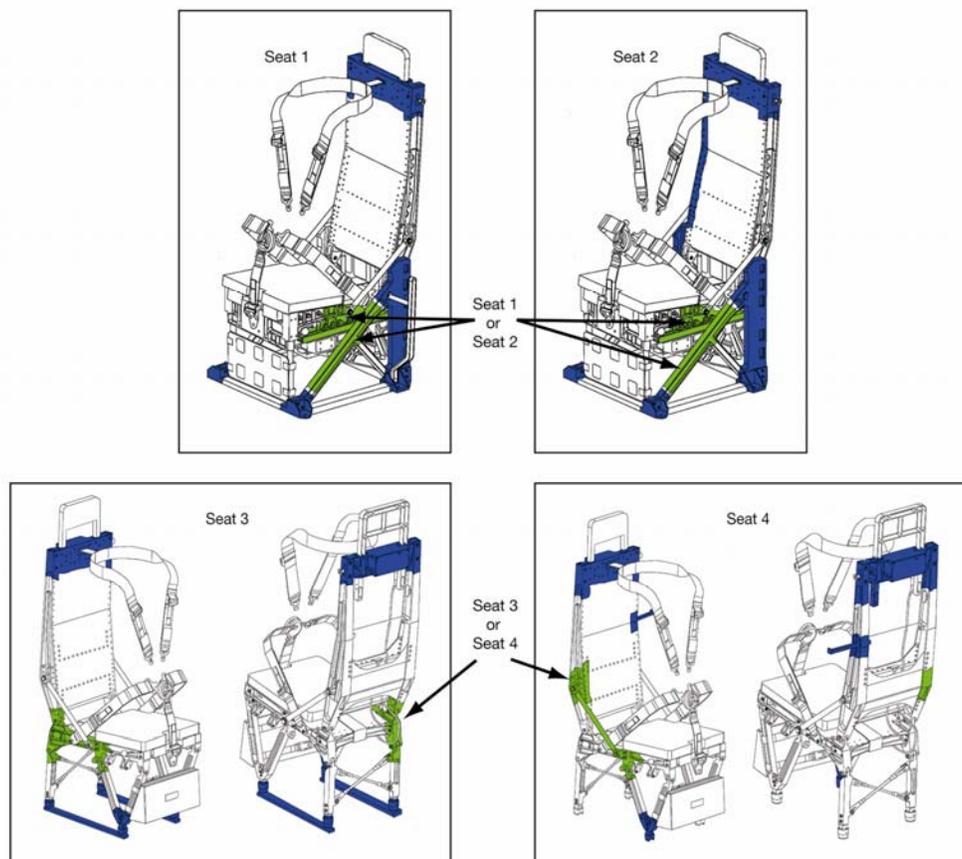
**Figure 3.1-6. Identified debris from the flight deck seats. [Adapted from the Space Shuttle Systems Handbook]**

Figures 3.1-6 and 3.1-7 show seat structure pieces that were identified to each seat location. The blue items in these figures represent items that were positively identified to a seat location. The green items are those items that could be from one of two seats. Figure 3.1-8 shows the major seat structure debris pieces that could not be identified to a specific seat location (the colors in this figure distinguish the different pieces and are otherwise inconsequential). Although represented in figure 3.1-8 on just two seats, the seatback and seat restraint items could be from any of the seven seats. However, the seat pan items could only be from the Mission Specialist seats.

Blue items are positively identified to a specific seat;  
green items could be from either one of the two indicated seats.

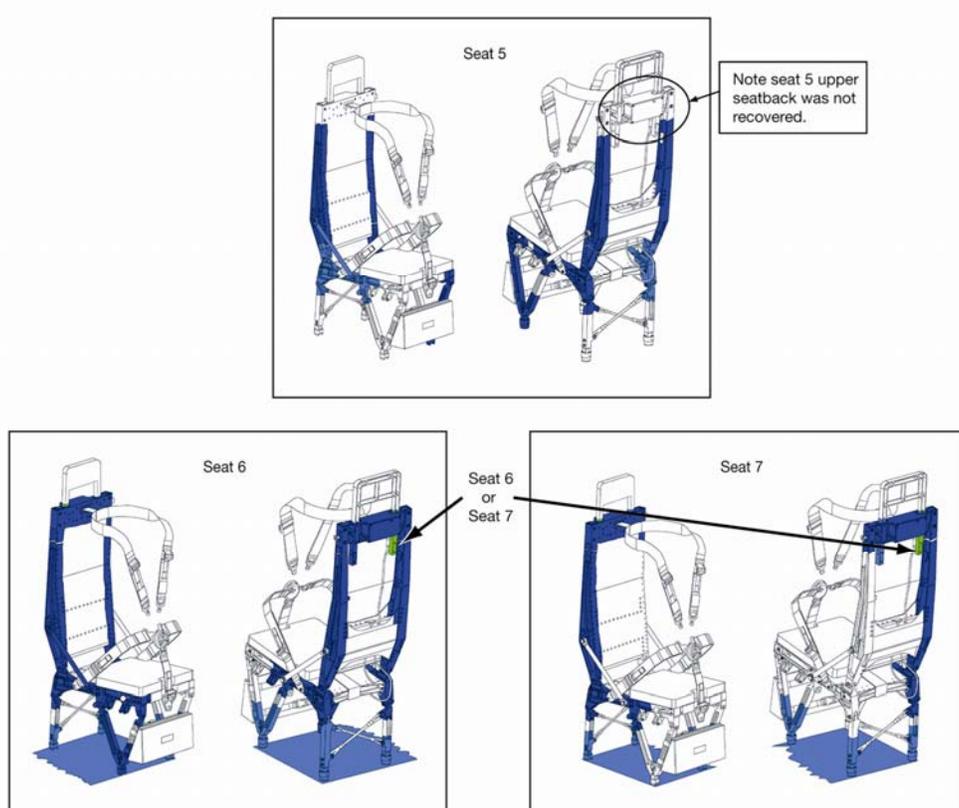
**Figure 3.1-7. Identified debris from the middeck seats. [Adapted from the Space Shuttle Systems Handbook]**

Blue items are positively identified to a specific seat;  
green items could be from either one of the two indicated seats.

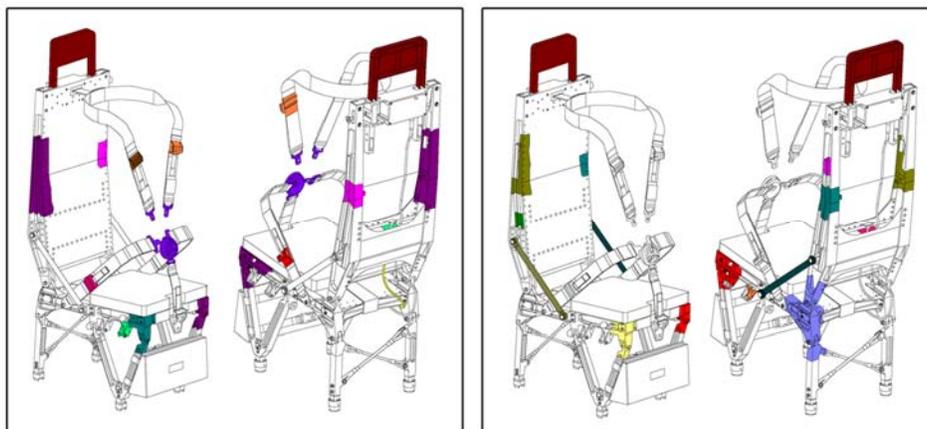
**Figure 3.1-8. Debris from unknown seat locations. [Adapted from the Space Shuttle Systems Handbook]**

Colors are used only to distinguish different debris items.

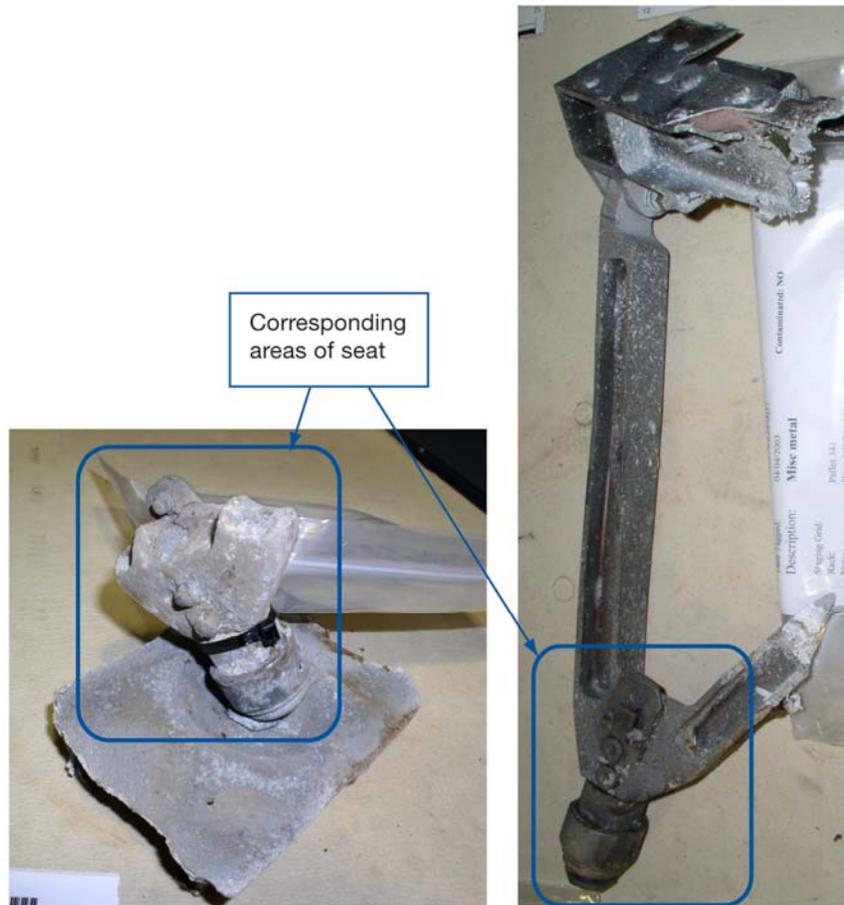
**Figure 3.1-10. Comparison of seat debris from a flight deck Mission Specialist seat (left) and a middeck Mission Specialist seat (right).**

The magnitude and distribution of heating of flight deck seat components indicates a prolonged attachment to other crew module (CM) structure during exposure to heating. This indicates that the flight deck seat components were released from the CM later in the breakup sequence than the middeck seat components. Ground plots of debris recovery locations also support this conclusion (figure 3.1-9). Figure 3.1-10 compares a portion of the seat leg from a flight deck Mission Specialist seat component with a similar component from a middeck seat.

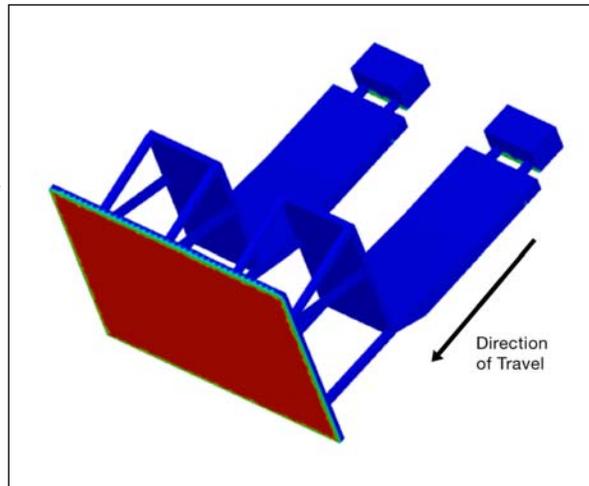
**Figure 3.1-11. Stable attitude of the lithium hydroxide door/seat 6/seat 7 combination, as indicated by deposition.**

Although all seat components experienced significant heating, the middeck seats were less eroded and fragmented when compared to the flight deck seats. Material analysis revealed that the seat 6 and 7 components collected significant deposits of melted aluminum from the lithium hydroxide (LiOH) door to which they were attached. Unlike the flight deck seat components, analysis revealed no materials consistent with the pressure shell deposited on the middeck seats. The CAIB Report concluded,<sup>5</sup> and this report concurs, that seats 6 and 7 remained attached only to the LiOH door during a period of significant thermal exposure and material deposition. The highly directional nature of the deposition indicates that the LiOH door/seat 6/seat 7 combination attained a stable attitude (figure 3.1-11) during thermal exposure. The close proximity of debris recovery locations indicates that the seat 6 and 7 components separated from the LiOH door shortly before ground impact.

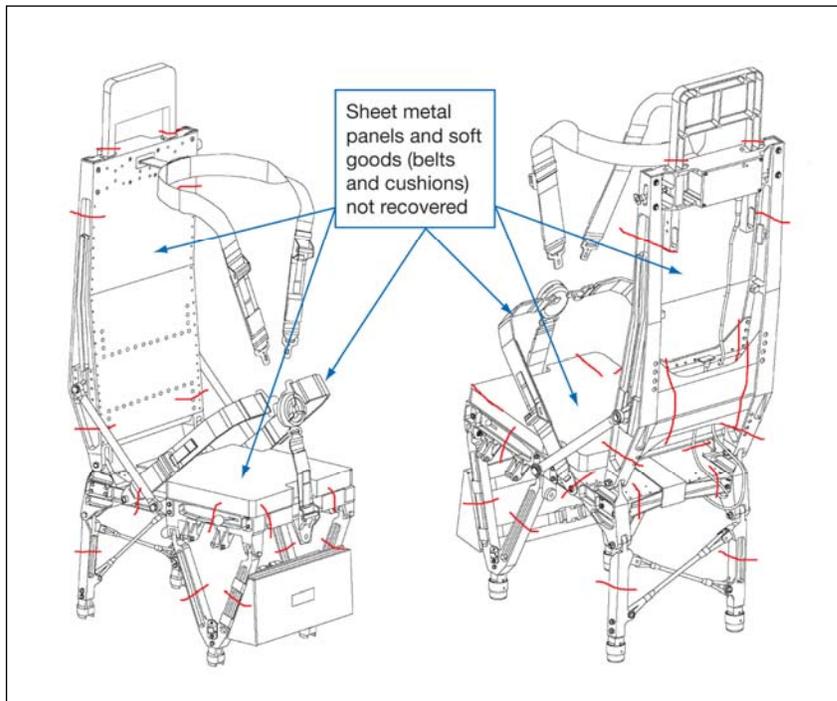
**Figure 3.1-12. Common seat failure locations (shown in red). [Adapted from the Space Shuttle Systems Handbook]**

Nearly all seat fractures occurred at minimum thermal cross-sectional areas (minimum thermal mass), away from any large heat sink locations.<sup>6</sup> Common seat fracture locations are shown as red lines in figure 3.1-12. It is also noteworthy that nearly all thin-sheet aluminum materials (closeout panels on the seat pan and seatback) are missing (i.e., overloaded/melted away). Additionally, with the exception of the inertial reel straps, very little belt material and seat cushion material was recovered.

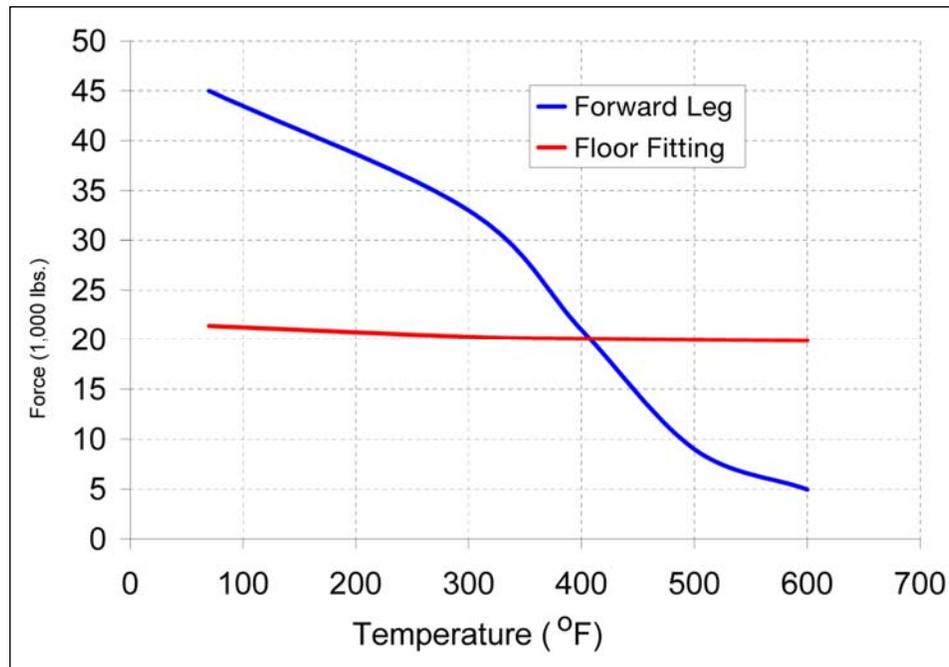
Figure 3.1-15. Failure force of seat forward leg and floor fitting vs. temperature.

A force of 21,400 lbs. is required to fracture the floor fitting at room temperature. This force decreases to 20,300 lbs. (~95% of room temperature strength) at 300°F (149°C), 20,100 lbs. (~94%) at 400°F (204°C), and 19,900 lbs. (~93%) at 600°F (316°C). These values are plotted in figure 3.1-15.

This plot reveals that heating greater than 400°F (204°C) is needed to weaken the materials such that the leg failure would occur at the mid-leg location. Otherwise, the forward legs should have failed at the floor fitting, which did not occur.

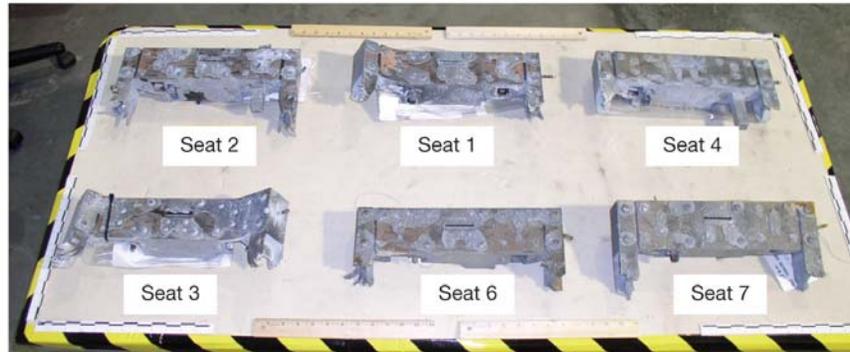
Figure 3.1-19. Upper seatbacks (front view).

As with the general seat failures that were described previously, all of the fractures at the upper seatback location occurred at the minimum thermal cross section, away from heat sinks on either side. Fracture surfaces did not exhibit melting or materials deposition, indicating that the upper seatback fractures occurred near the end of the period of heating and material deposition. Figure 3.1-19 shows all six recovered upper seatback items. Table 3.1-1 summarizes the upper seatback findings.

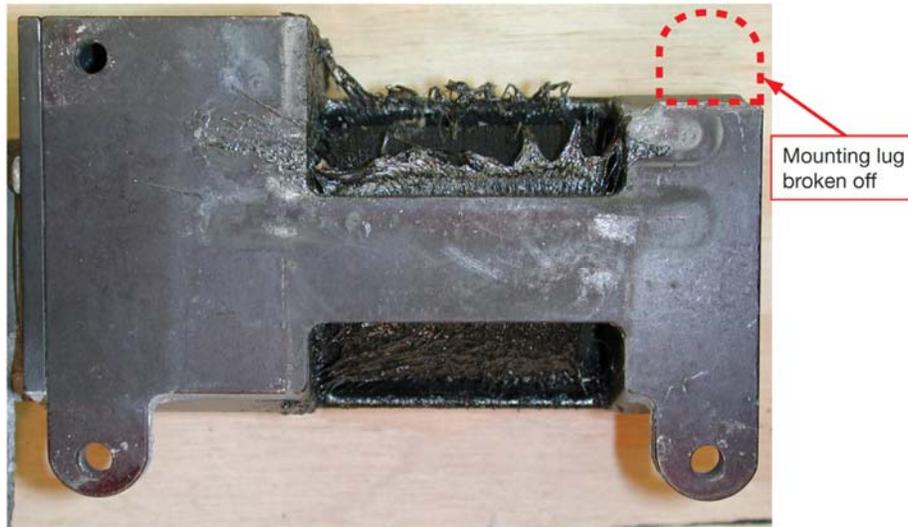
Figure 3.1-21. Seat 3 inertial reel, looking aft.

Only seat 3 showed deformation of the inertial reel housing mounting hardware. All four mounting bolts were bent slightly. One inertial reel housing mounting lug was broken with melted metal deposits on both fracture surfaces; i.e., the fracture surface of the lug and the fracture surface of the inertial reel housing (figure 3.1-21). The inertial reel mounting hardware for the other five recovered upper seatbacks exhibited no deformations.

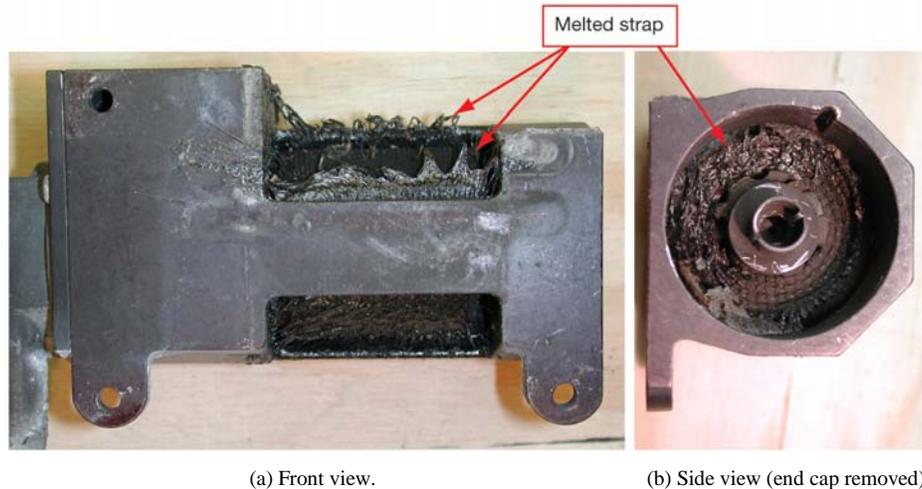
Figure 3.1-23. *Inertial reel melted strap material.*

In all cases, the inertial reel straps were melted only in areas that were immediately adjacent to the strap pass-through openings and along the lateral edges of the strap (figure 3.1-23). The strap material in other areas was not melted and appears normal.

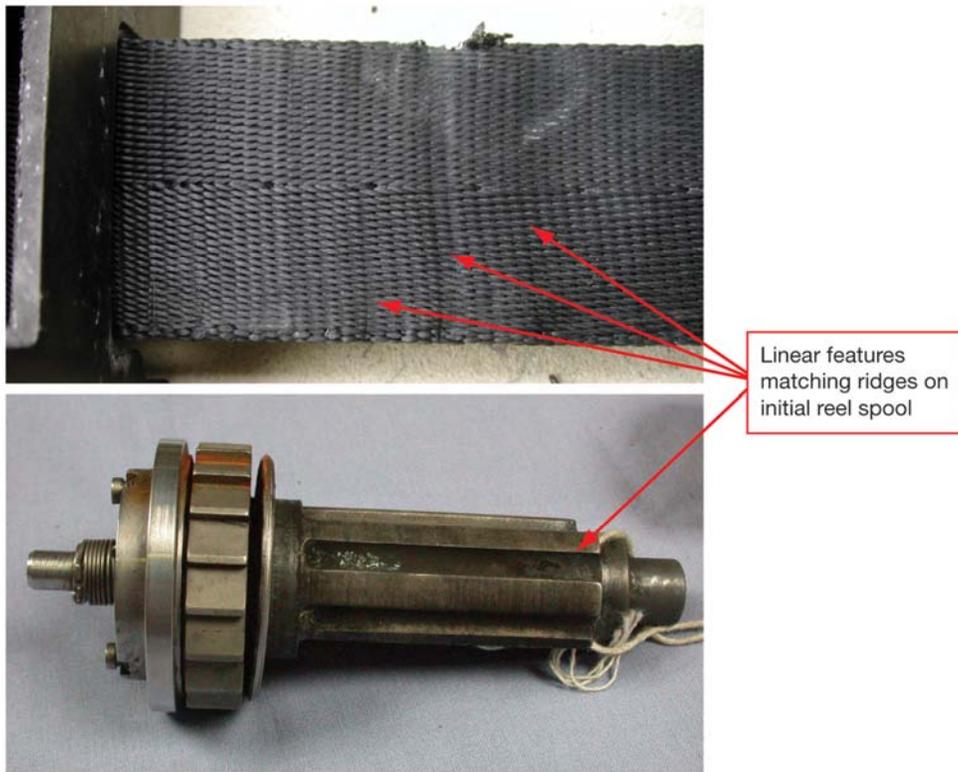
**Figure 3.1-25.** Example of linear waves on inertial reel straps.

Indentations matching the linear ridges on the inertial reel spool were observed 0 to 4 in. from the strap attach location (figure 3.1-25). These linear indentations near the inertial reel, were present on all the straps (except the seat 1 strap, which failed next to the inertial reel attachment). Inertial reel straps for 11 other shuttle flight seats in inventory (not *Columbia* debris) and training seats were inspected for similar linear features. The inertial reel straps for all seats exhibited the same waves that were found on the *Columbia* inertial reel straps. Therefore, the waves are a result of strap stowage, not an indication of loading on the strap.

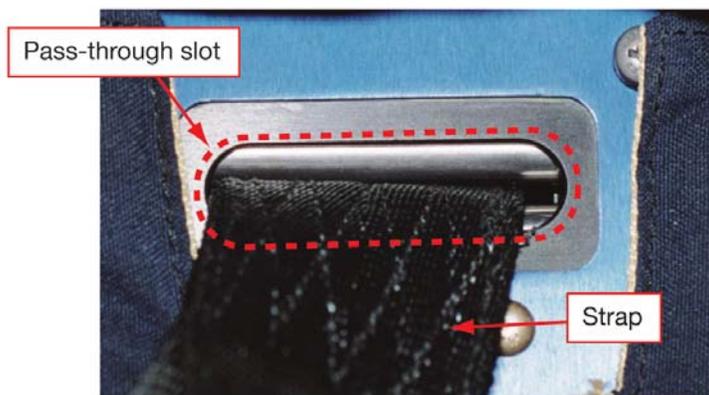
Figure 3.1-27. Seat strap pass-through slot (intact seat shown). [Picture from a shuttle training mockup in the JSC Space Vehicle Mockup Facility]

**Finding.** The seat 2 inertial reel strap exhibits “strap dumping” failure features. The strap failed progressively, possibly due to damage to the lateral edge of the strap from contact with the sharp edge of the strap pass-through slot.

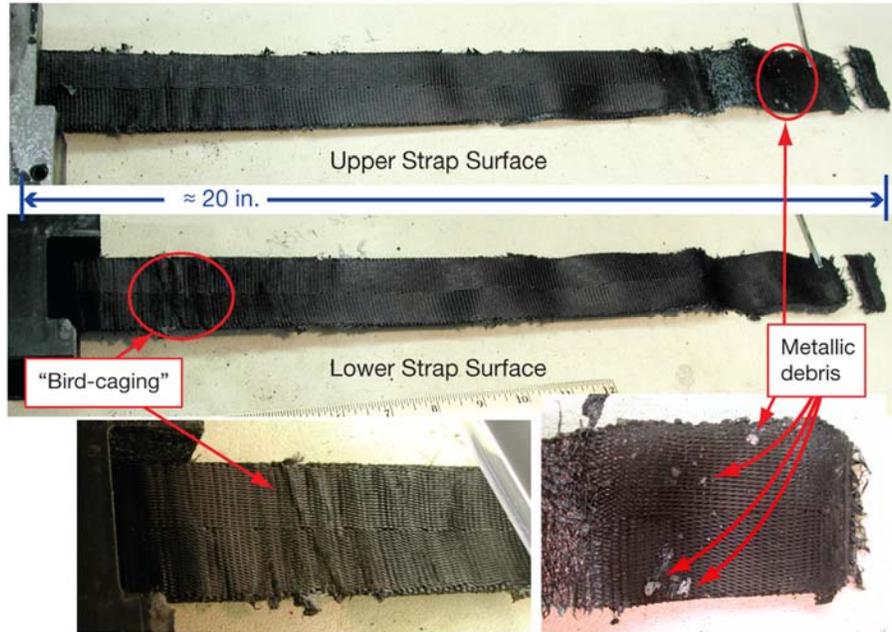
Figure 3.1-28. Seat 3 inertial reel strap.

<b>Seat 3</b>	The strap failed at approximately 90% of the extended length, in proximity to the attachment to the shoulder harness y-split (~20 in. away from the inertial reel, out of the original 22 in. of strap). Strap failure appears to have occurred in close proximity to the shoulder split attachment, probably at the stitch stress concentration. Two raised sections at a slight angle (~20 degrees) from perpendicular to the strap axis, observed 2 to 4 in. from the strap attach location. Marks are similar to “bird-caging” features found in dynamic failures of cable/cord. Approximately 10 small metallic bits of debris, largest approximately 1/8 in. in diameter located approximately 16.5 to 18 in. away from reel attachment.	The strap melted only at the exposed strap pass-through areas and the lateral edges of the inertial reel housing. The strap is melted completely through one layer near the upper pass-through. The strap material that was shielded by the inertial reel housing is not melted. This suggests mechanical failure before significant thermal exposure.

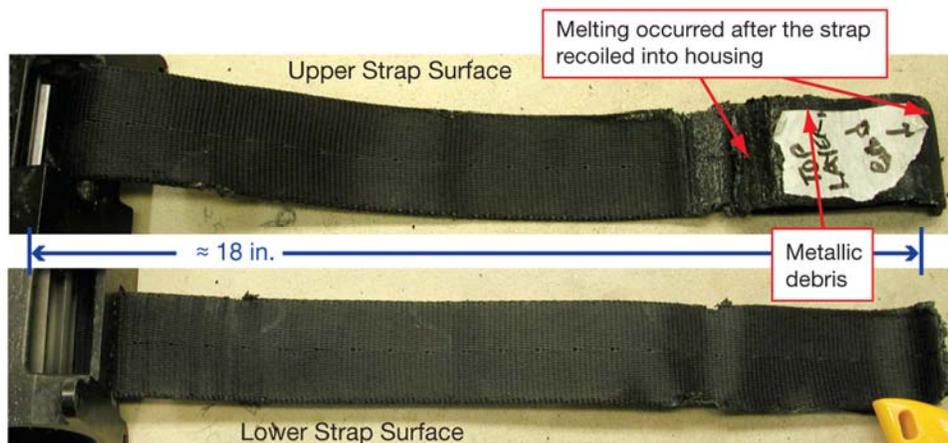
Figure 3.1-29. Seat 4 inertial reel strap.

The seat 4 inertial reel strap (figure 3.1-29) failed at approximately 80% of the extended length, which is in proximity to the attachment at the shoulder harness y-split (~18 in. away from the inertial reel). One very small ball of melted metallic material (< 1/16 in.) was located approximately 14 in. from the inertial reel attachment on the lateral edge of the upper strap surface (the debris came off during inspection.). No witness marks were observed along the entire strap length.

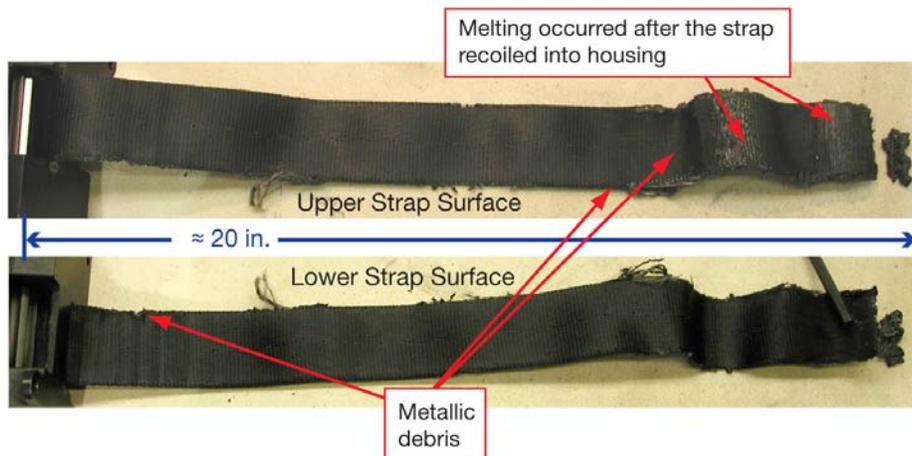
The seat 6 inertial reel strap (figure 3.1-30) failed at approximately 90% of the extended length (~20 in. away from the inertial reel). Strap failure occurred in close proximity to the shoulder harness y-split attachment (the expected failure point if the strap was not fully extended). No witness marks were observed along the entire strap length. Three pieces of metallic debris were deposited on the strap surfaces: a small ball of melted material (< 1/32-in. dia.) deposited on the upper surface, approximately 16 in. from the reel

attachment (debris came off during inspection); a small fragment of melted material (< 1/32-in. dia.) deposited on the lateral strap edge located approximately 13 in. from the reel attachment; and a small fragment of melted material (< 1/32 in. dia.), which was deposited on the lateral strap edge located approximately 1.75 in. from the reel attachment. The strap was melted completely through one layer near the strap pass-through opening.

Figure 3.1-30. Seat 6 inertial reel strap.

**Recommendation L2-6.** Perform dynamic testing of straps and testing of straps at elevated temperatures to determine load-carrying capabilities under these conditions. Perform testing of strap materials in high-temperature/low-oxygen/low-pressure environments to determine materials properties under these conditions.

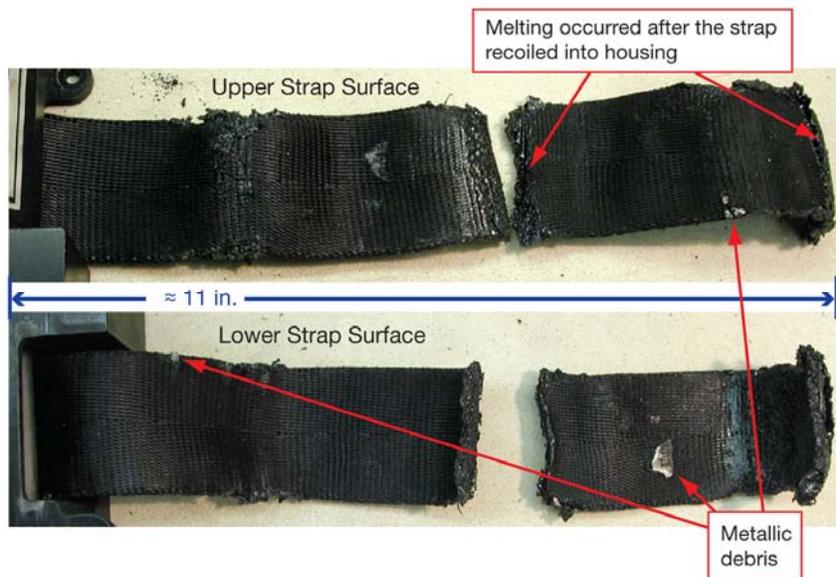
The seat 7 inertial reel strap (figure 3.1-31) failed at approximately 50% of its length (~11 in. away from the inertial reel). No witness marks were observed along the entire strap length. Three areas of metallic debris deposits were noted on the strap: one approximately 1/10-in.-diameter, roughly spherical piece of metal debris stuck to the edge (the right side of seat) of the lower surface of the strap, approximately 1.5 in. from the inertial reel; one 0.5-by-0.3-in. roughly triangular (~0.05-in.-thick) piece of metal debris stuck to the lower surface of the strap, approximately 8 in. from the inertial reel; and several small, roughly spherical metal debris items stuck to the upper side of the strap fragment, along the edge, approximately 2 in. from the end. Localized melting caused the strap to separate into two pieces after the strap had recoiled into the housing.

Figure 3.1-31. Seat 7 inertial reel strap.

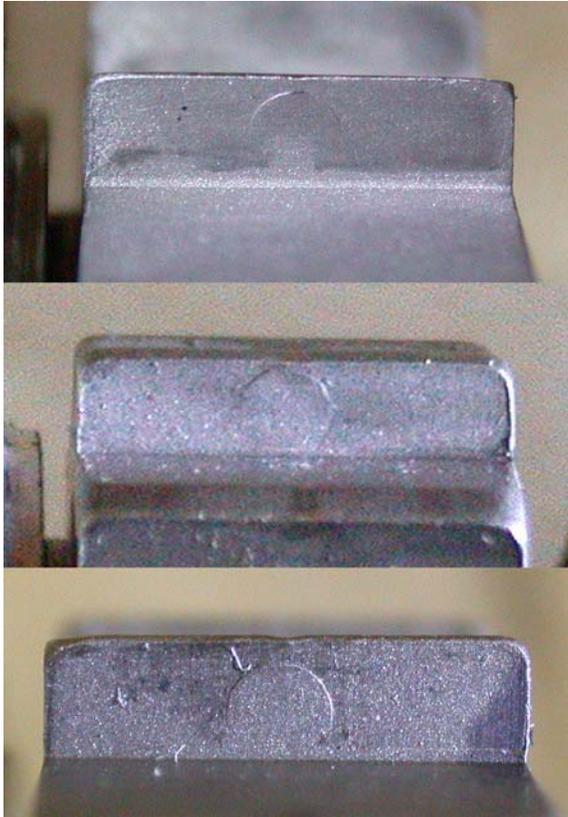
It was initially thought that the witness marks were an indication of inertial reel strap loading during the accident. However, extensive investigation of inertial reels from training seats and other flown shuttle seats as well as a new inertial reel revealed identical circular witness marks (figure 3.1-34).

Figure 3.1-34. Circular witness marks on inertial reels from a training seat (top), a flight (non-Columbia) seat (middle), and a new (unused) flight-qualified inertial reel (bottom).

All inertial reels/straps of this type are proof-tested by the manufacturer with a 3,350-lb. static load prior to delivery to the customer. Because these inertial reels (and the *Columbia* inertial reels) were proof-tested, the investigation concluded that the witness marks on all of the inertial reels are a result of proof-testing. The absence of a second witness mark on the inertial reel led to the conclusion that the inertial reel straps failed at forces below the equivalent of a 3,350-lb. static load. However, it is probable that the straps failed under dynamic loading. As discussed above, the straps' load-carrying capabilities under dynamic loading are unknown.

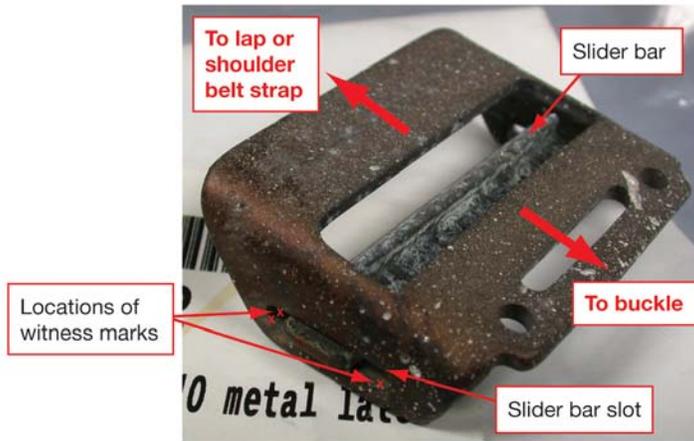
Three of the four adjusters exhibited witness marks within the slider bar slot surface (figure 3.1-37). Tension on the belt will cause the slider bar to contact the slider bar slot as the bar rotates and slides within the slot. The witness marks in the adjusters are a result of significant loading on an intact restraint belt.

Figure 3.1-37. Recovered belt adjuster rear view.

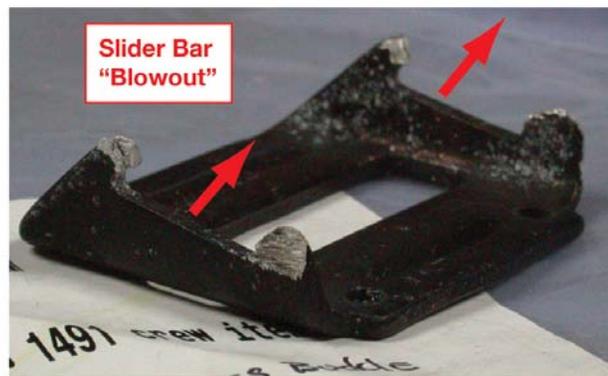
The fourth adjuster was missing the slider bar, and experienced fractures on both the left and the right slider bar slots. These fractures were apparently caused by the slider bar “blowing out” away from the body surface (figure 3.1-38).

Figure 3.1-38. Fractured belt adjuster.

The fracture surfaces exhibited delamination fractures (the “broom-straw” fractures described in section 3.1.3), indicating material property degradation due to elevated temperature exposure combined with high strain rate loading. The heating occurred quickly and allowed material degradation of the metallic belt adjuster to occur without compromising the material properties of the nylon restraint belt to the point that the belt could not transmit forces to the adjuster.

The slider bar “blowout” on one of the four strap adjusters was the result of significant loading on an intact restraint belt. It cannot be determined positively when this strap adjuster failure occurred.

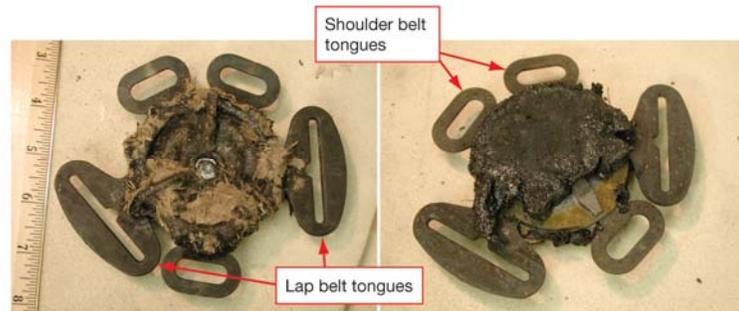
One of the seven 5-point seatbelt buckles on board *Columbia* was recovered (figure 3.1-40). Positive identification to a seat position was not possible. Although the buckle experienced significant entry heating, resulting in substantial melting of the outer plastic housing, the structure remained intact with all five belt tongues still in place.

Figure 3.1-40. *Recovered five-point seatbelt buckle (front and back).*

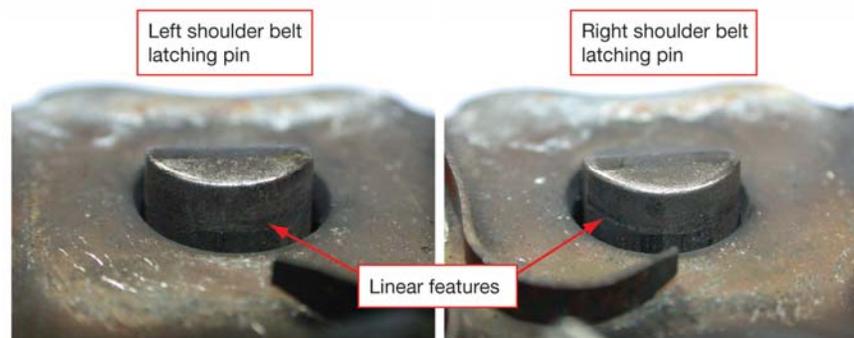
The buckle assembly was disassembled for analysis. The two shoulder belt tongues and the two lap belt tongues were bent outward slightly (i.e., away from the crew member). Both of the shoulder belt tongue latching pins had very shallow linear features corresponding to the mating surfaces of the belt tongue (figure 3.1-41). These features may be witness marks as a result of dynamic loading events that were experienced in flight by the restraint system or of forces imparted to the five-point attach buckle during disassembly by the CAIB investigation team. A definitive conclusion cannot be made based on these witness marks alone. The other latching pins did not exhibit any noticeable marks or deformations.

Figure 3.1-41. *Indentations on latching pins, looking from center of buckle towards outer edge.*

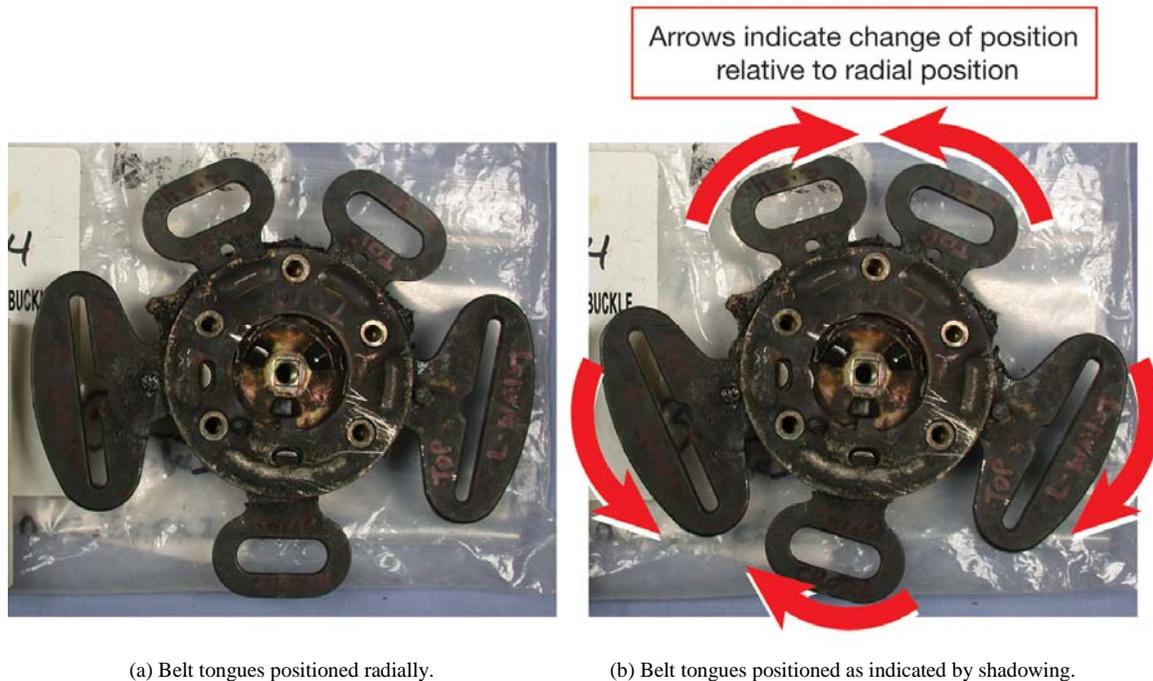
Shadowing<sup>14</sup> on the belt tongues indicates that the belt tongues were in the position shown in figure 3.1-42(b). These positions, when compared to the positions of the tongues being straight out from center of buckle (radially, figure 3.1-42(a)), are: the shoulder belt tongues are moved toward the centerline (medially), the crotch belt tongue is moved toward the right side of the seat, and the lap belt tongues are moved down. It cannot be determined positively when the deposition (and shadowing) occurred, so no conclusions can be made relative to timing.

**Figure 3.1-42. Belt tongue positions.**
